Inspection Report

Property Address:
30 Matheson Road
Woodville/Bolsover Ontario K0M2T0

Know Your Home Inspections Inc.

Date: 4/5/2021	Time: 02:00 PM	Report ID: 04-05-21
Property: 30 Matheson Road Woodville/Bolsover Ontario K0M2T0	Customer: Ron Young Joan Young	Real Estate Professional: David Donais Kawartha Waterfront Realty

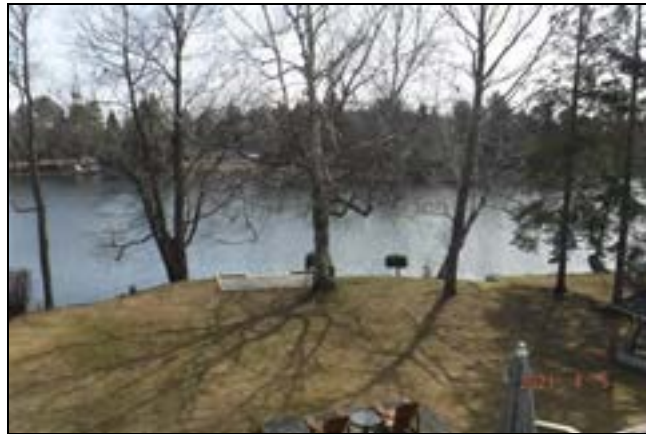
1.0 There is a low slope of the lot towards the water. There is a gradual decline at the location of the boat docking system and at the other corner of the lot. Item 1(Picture)

1.0 Item 1(Picture) Low slope to water

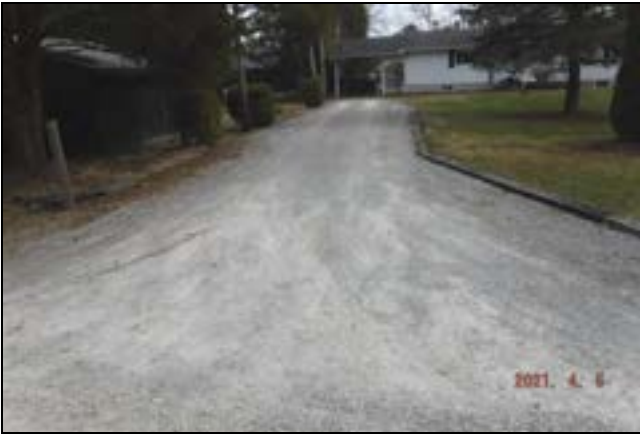
1.2 The driveway is flat and gravel covered. Item 1(Picture)

1.2 Item 1(Picture) Driveway

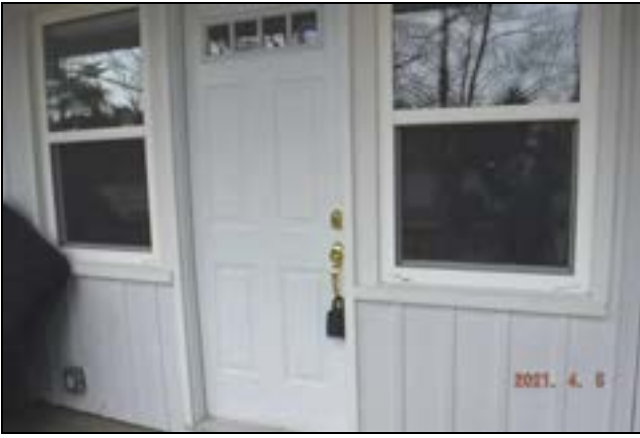
2.1 There is a metal insulated door to the entrance room off the deck. Item 1(Picture)

2.1 Item 1(Picture) Entrance door

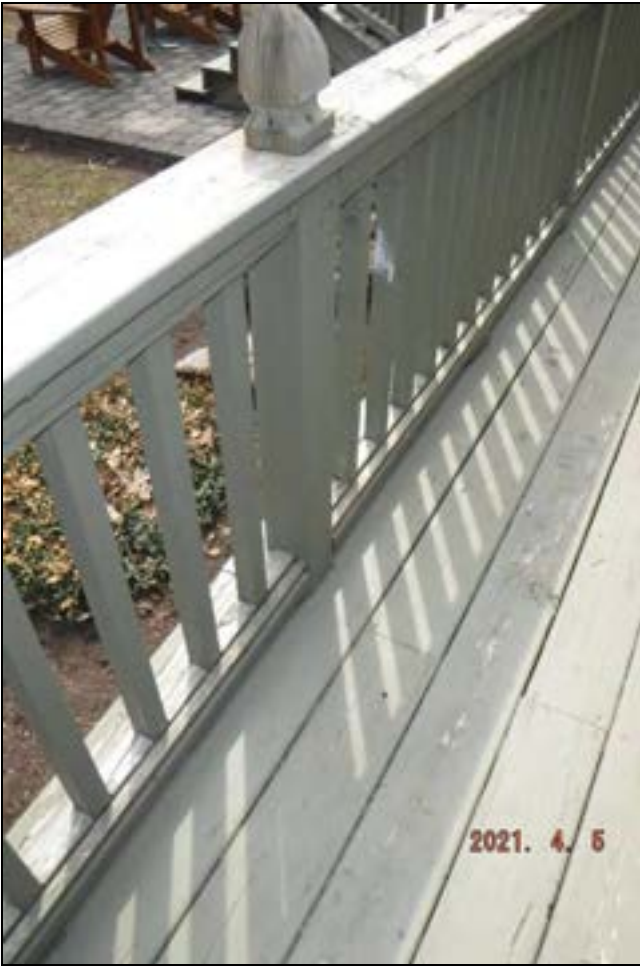
(2) The railing on the deck is not 42 inches high for safety. Newer deck railings would be installed at 42 inches high to prevent adults from falling over. It is well secured to the deck. It is made out of wood and requires regular maintenance. Item 3 (Picture)

2.4 Item 4(Picture) Deck about 4 ft high

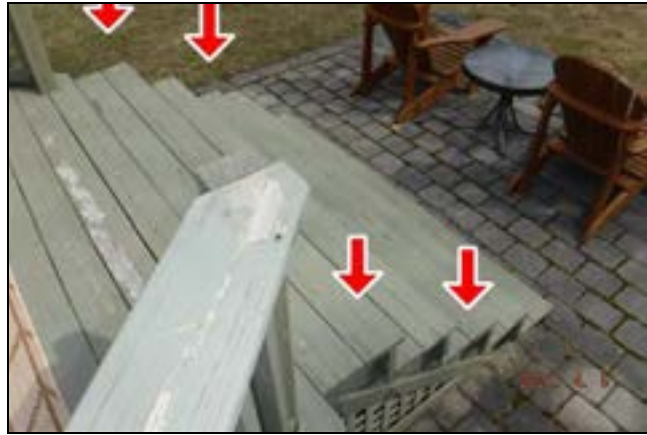
2.4 (1) Add railings to the stairs at the front concrete porch entrance, the each set of stairs to the back deck. This is a safety concern. Item 1(Picture) Item 2(Picture) Item 3(Picture)

2.4 Item 5(Picture) Add railing

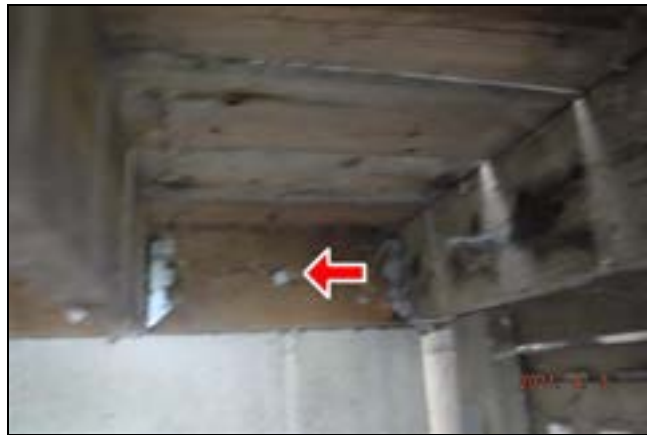
(3) The deck is secured to the house with proper lag bolt attachments. The deck hangers are properly installed.

2.4 Item 7(Picture) Deck structure

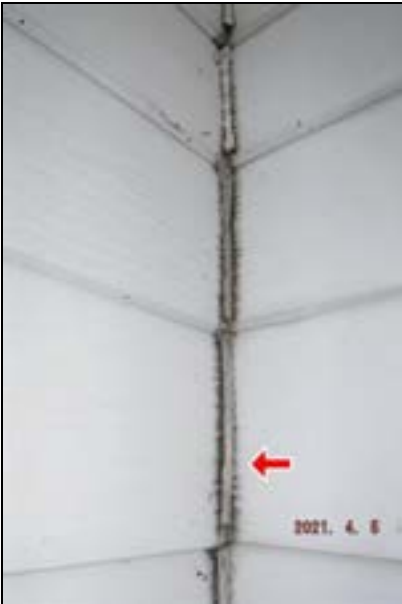
2.6 Caulking is a regular maintenance requirement. The exterior caulking near the enclosed entrance area on the exterior of the house requires removing and re-caulking. See photo. Item 1(Picture) Item 1(Picture)

2.6 Item 1(Picture) Caulking failing

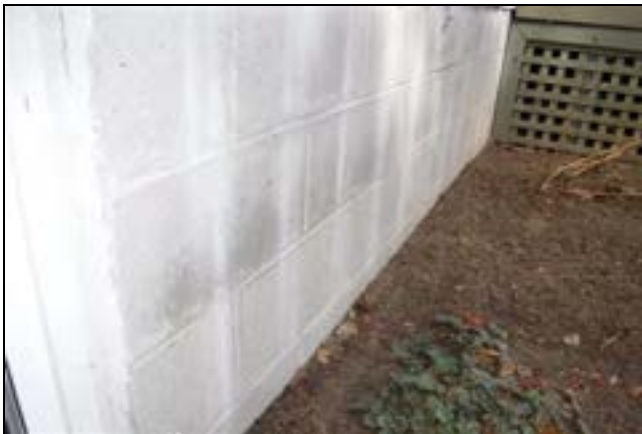
3.0 The foundation is concrete block. No major cracks were visible. The foundation shows that drainage system was installed to assure that the basement stays dry through all seasons. This was completed by Clark Basement.

3.0 Item 1(Picture) Block foundation

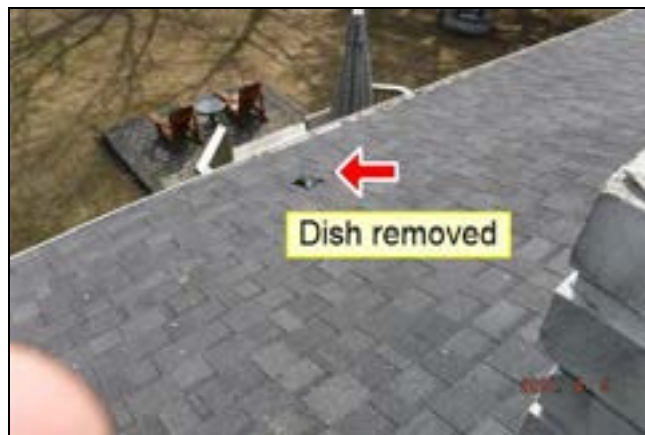
4.0 There is a bracket for a satellite dish secured to the roof. Item 2(Picture) The dish was removed at this lake side location. There is a satellite dish on the carport roof.

4.0 Item 2(Picture) Bracket for dish

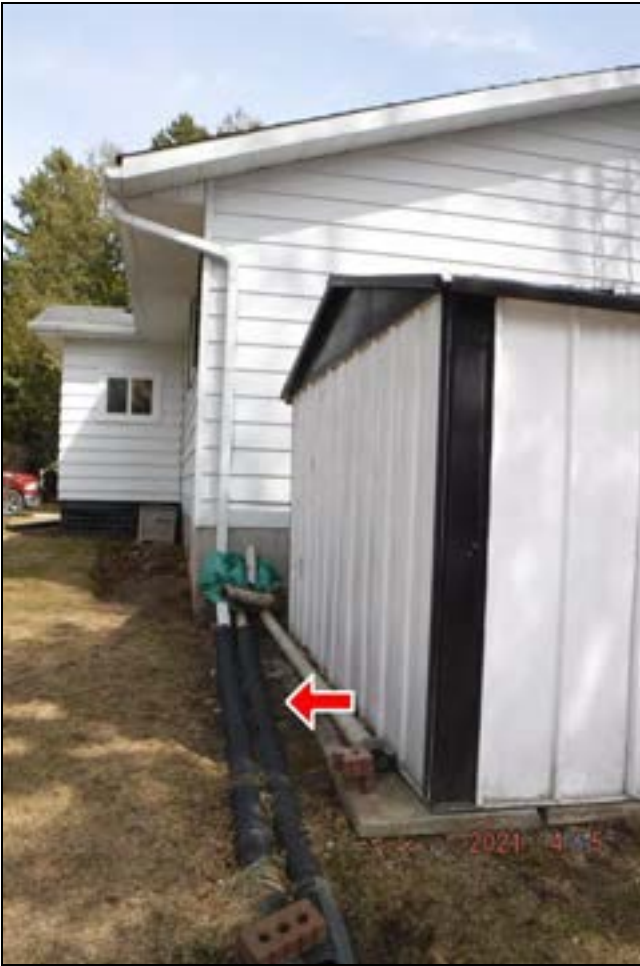
4.3 (1) Eaves troughs, downspouts, and big O directs water away from the foundation. Item 1(Picture)

4.3 Item 1(Picture) Water directed away

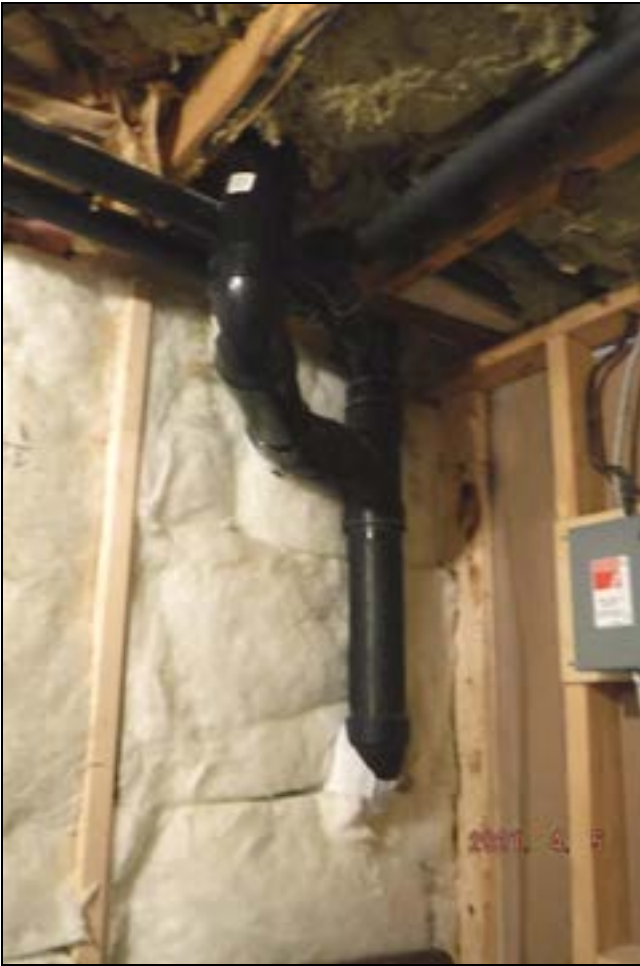
5.0 (1) The waste line to the septic system is partially visible. There are p traps to above appliances visible in the basement utility area. Item 1(Picture) Item 2(Picture)

5.0 Item 1(Picture) Waste to septic

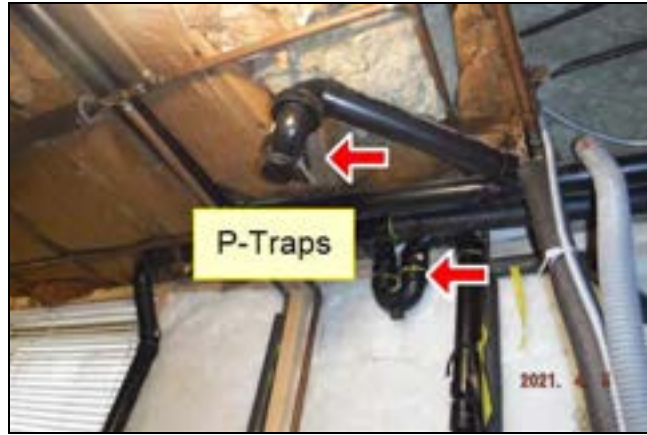
5.0 Item 2(Picture) Waste lines

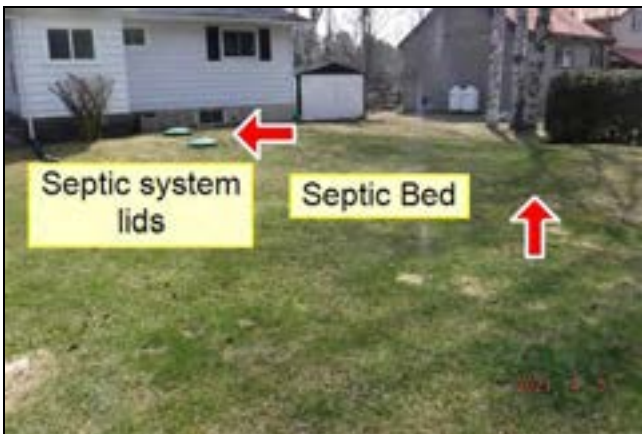
(2) It is important not to drive vehicles or snowmobiles over the septic system. The weight of vehicles may cause damage to the components. Item 1(Picture)

5.0 Item 3(Picture) Septic system

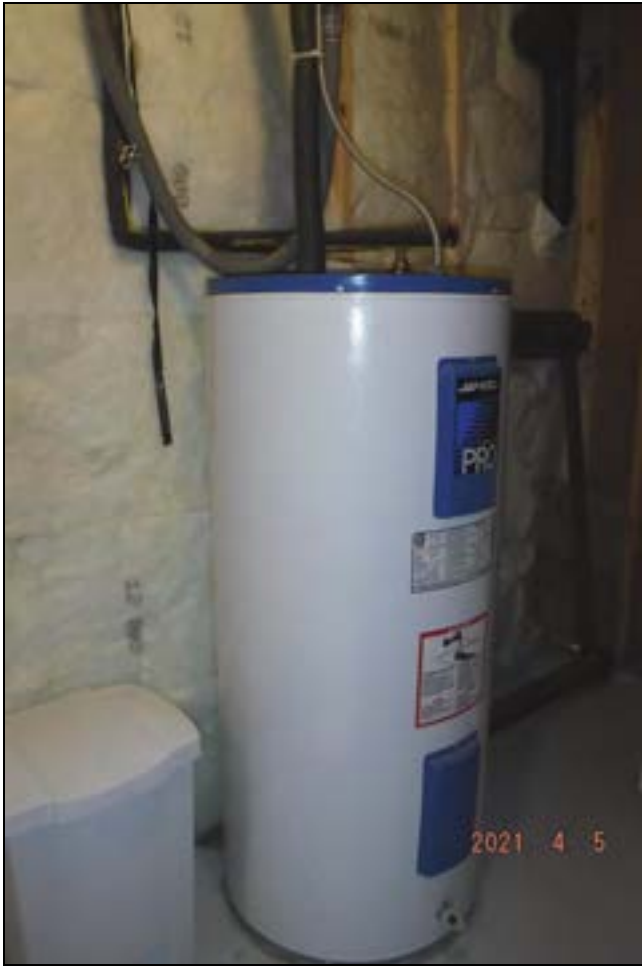
5.4 The hot water tank is a John Wood Model number JW505DE130 and Serial # Uo812F702459. It is a 184 litre tank. Recommend an extension on the Pressure temperature release valve to extend 6 to 12 inches from the floor. This is import so if there is a release the steam or hot water are not at face level. Item 1(Picture) Item 2(Picture) It is recommended that the hot water tank be shut off if away for extended periods of time.This will reduce hydro use if hot water is not being used. Item 2 (Picture)

5.4 Item 1(Picture) Hot water Tank

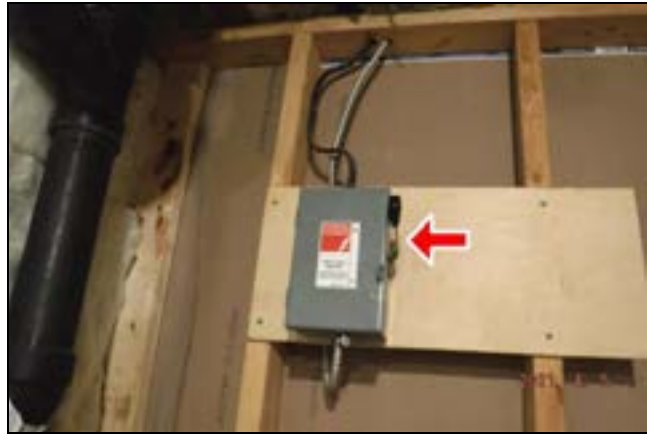
5.4 Item 2(Picture) Hydro to DHW tank

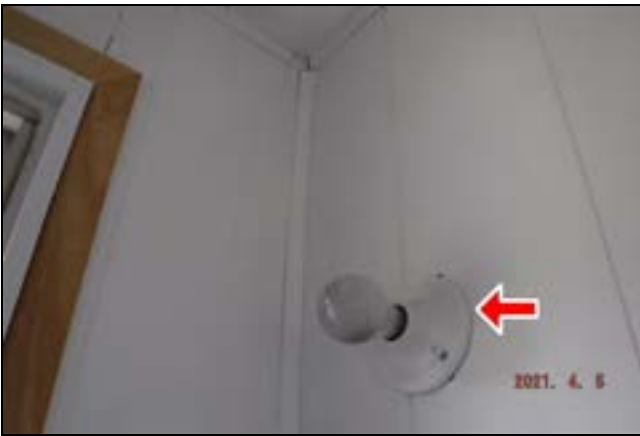
6.4 Recommend replacing the light fixture on the enclosed entrance way with a fixture that protects the bulb. Item 1(Picture)

6.4 Item 1(Picture) Enclosed porch light

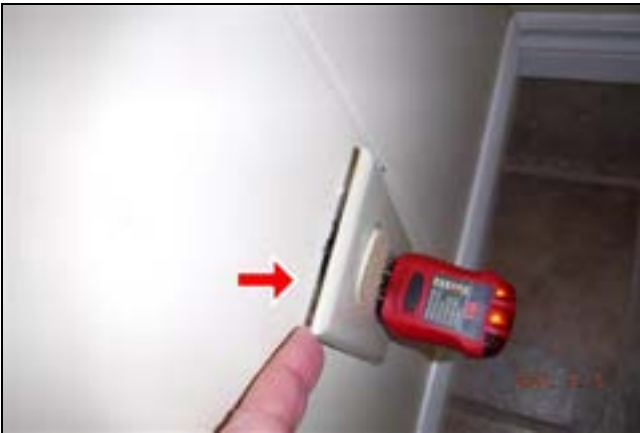
6.5 Item 1(Picture) One interior receptacle was not secured to the wall properly. It is near the entrance door from the carport. This is a safety concern and should be secured for safety. Item 1(Picture)

6.5 Item 1(Picture) Loose installation

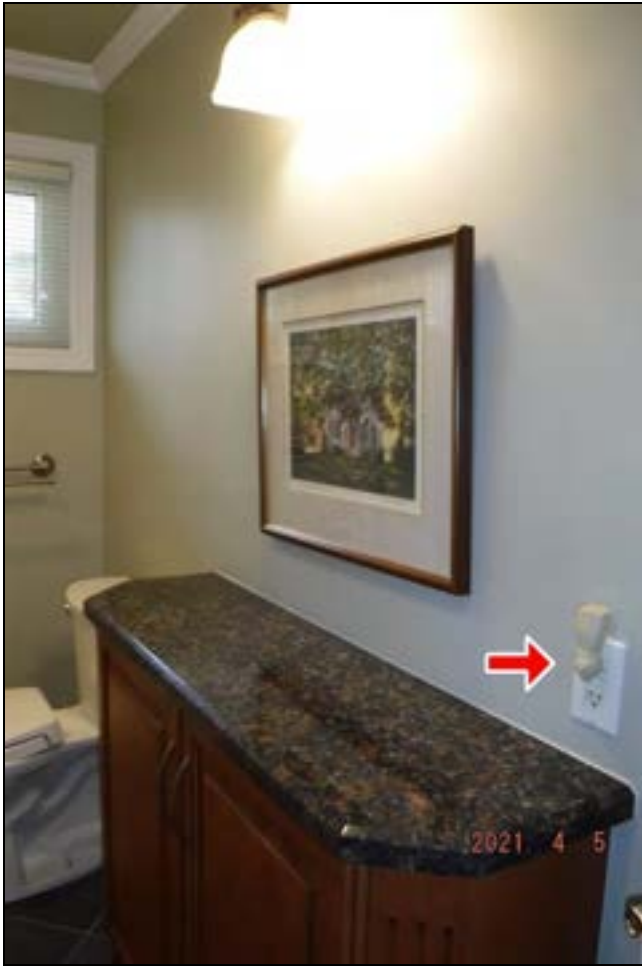
6.6 The GFCI receptacles are working in the bathroom. Test occasionally to assure they remain in working condition. There is not a GFCI receptacle in the kitchen area. Item 1(Picture)

6.6 Item 1(Picture) GFCI protected receptacle

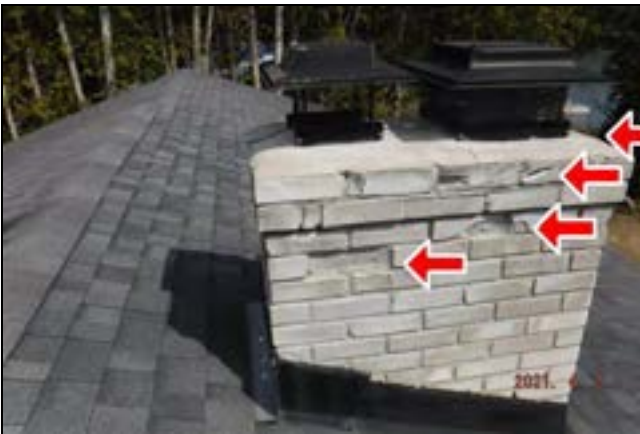
7.2 The chimney structure is in need of repair. The brick is deteriorating. Moisture can get into the brick and mortar chimney and freeze in the winter which can lead to deterioration of the chimney structure. Repairs are required. The chimney cap requires redoing. There should be a drip edge around the chimney cap to prevent water from flowing down the sides of the chimney structure causing further damage to the chimney structure. The drip edge would limit or prevent the damage to the brick chimney structure due to water entering a freezing. Recommend hiring a WETT Professional or qualified mason to repair to prevent further damage.

7.2 Item 1(Picture) Failing mortar and brick

The chimney structure is in need of repair. The brick is deteriorating. Moisture can get into the brick and mortar chimney and freeze in the winter which can lead to deterioration of the chimney structure. Repairs are required. The chimney cap requires redoing. There should be a drip edge around the chimney cap to prevent water from flowing down the sides of the chimney structure causing further damage to the chimney structure. The drip edge would limit or prevent the damage to the brick chimney structure due to water entering a freezing. Recommend hiring a WETT Professional or qualified mason to repair to prevent further damage.

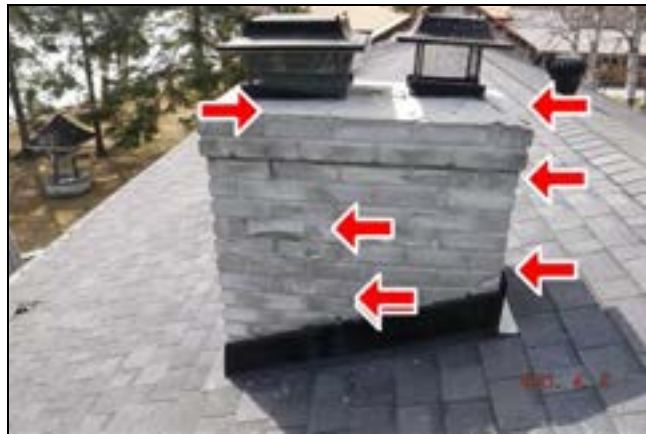
7.2 Item 2(Picture) Repairs required

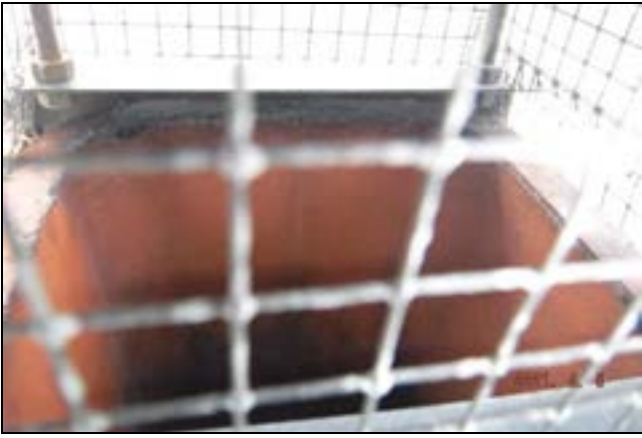
The flues are clay lined. The interior view of the chimney was not accessible. Be sure to have the chimney cleaned before use and at the end of each heating season. When cleaning the condition of the clay lining should be inspected to assure they remain aligned properly and there are no cracks or breaks. Item 3(Picture)

7.2 Item 3(Picture) Clay liner

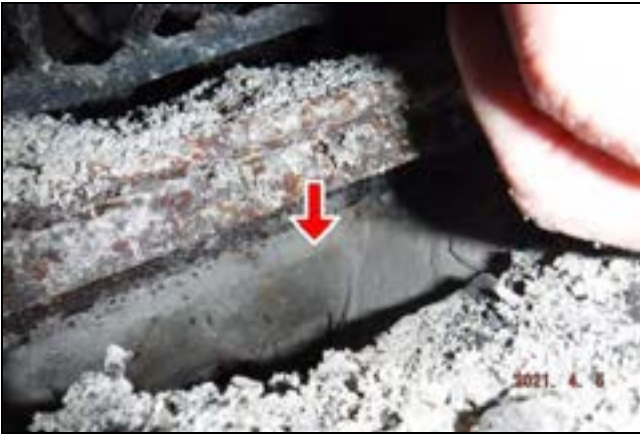
7.3 Item 5(Picture) Opening in fire box

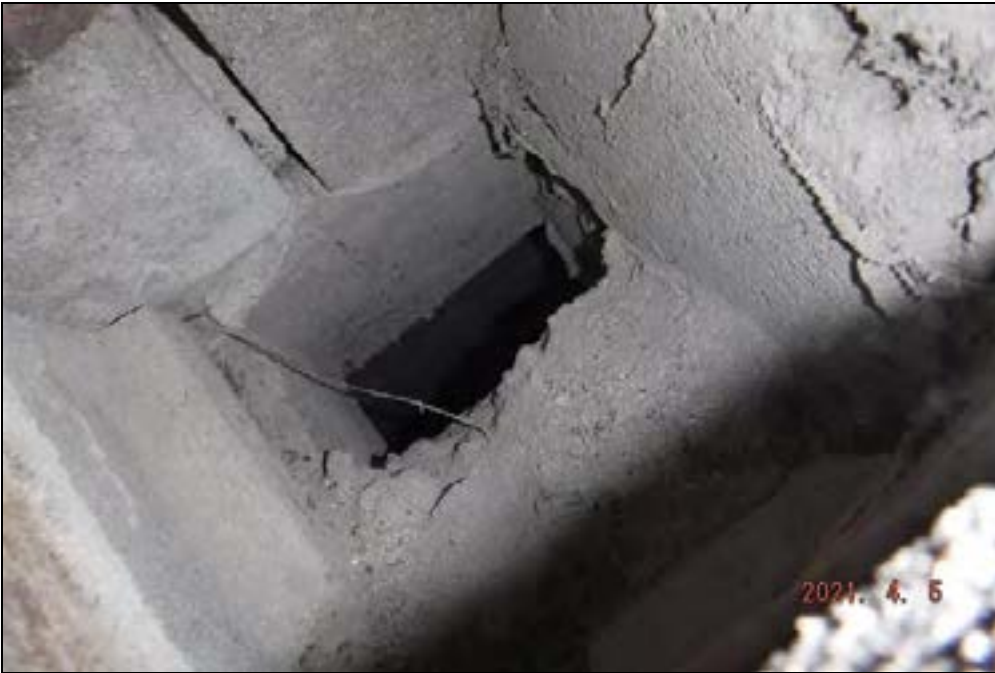
7.3 There is a built in fireplace in the living room area. It was built at the time the house was constructed. There is a natural air flow heat ventilator to increase heat from the unit to the room. Item 2(Picture) There is a bend in the metal lining - likely from overheating - but it remains a continuous metal fire box. Monitor. The draft system was in working order. Item 4(Picture) The location of the clean out could not be located due to the finished drywall around the fireplace structural support in the basement. Locate clean out. The metal cover was not secured and could easily be removed when cleaning or lost in this clean out vent. Improve. Item 5(Picture)

7.3 Item 9(Picture) Clean out not accessible

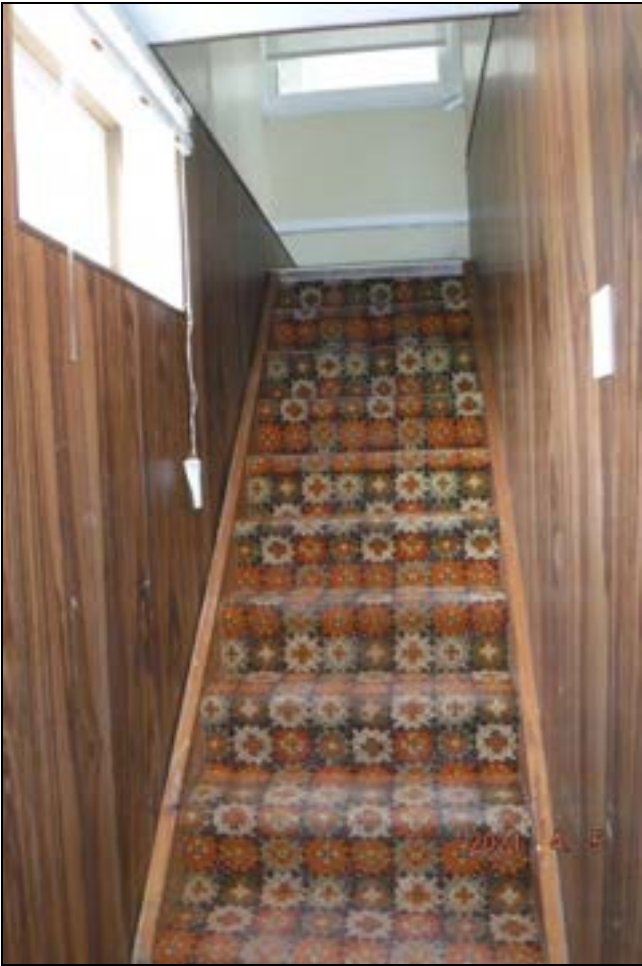
8.3 Add a railing to the stairs to the basement. The railing should be about 42 inches high for safety. It is understood that a railing was removed to allow room for a washer or dryer. Item 1(Picture) Re-install railing for safety.

8.3 Item 1(Picture) Add railing

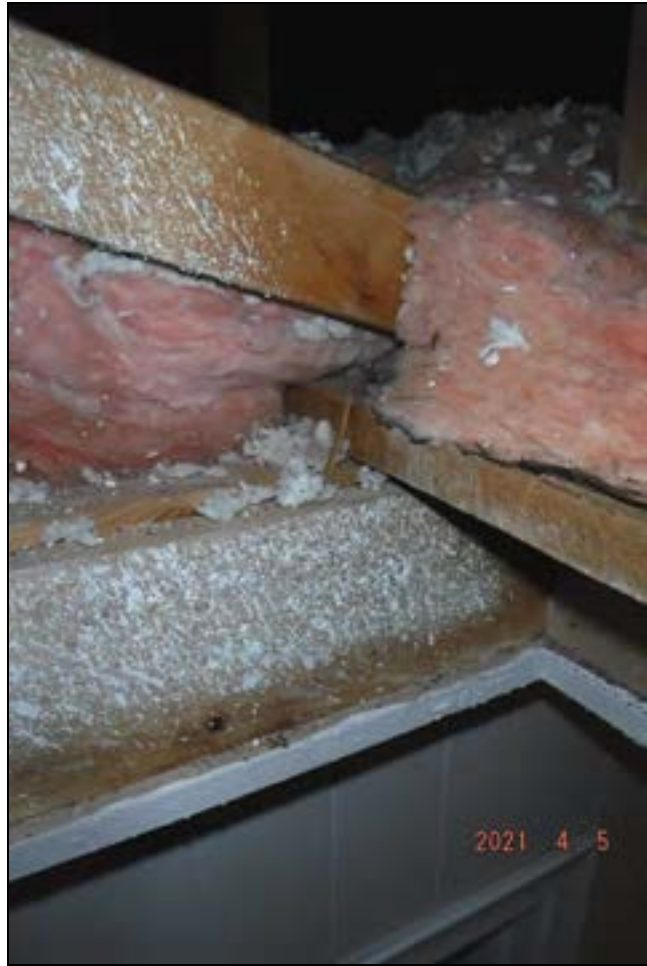
(2) The attic has cellulose and batt insulation visible. It was not clear if the baffles were installed at the soffit areas for good ventilation. Consider increasing the baffles for air flow if there is a concern with ice damming in the future. See Keeping the Heat In, free on line from Natural Resources Canada, for more detailed information. Item 4(Picture)

9.0 Item 4(Picture) Attic insulation

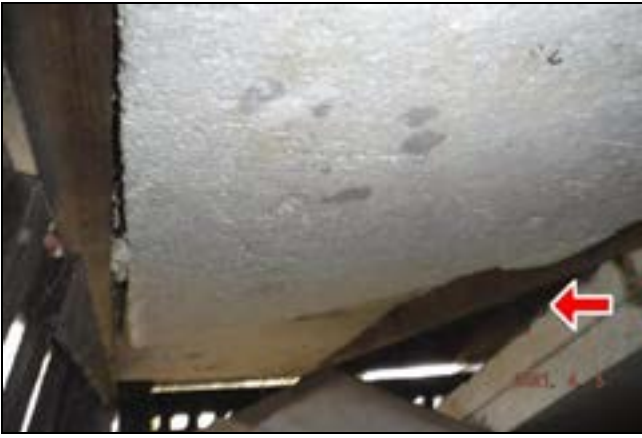
9.3 The floor of the road side enclosed entrance way is insulated with foam board under the flooring. Some of the foam board has fallen. Improve and secure in place to keep warmth in the enclosed porch area. Item 1(Picture)

9.3 Item 1(Picture) Foam Board insulation
