Inspection Report

6972 hwy 35
Coboconk Ontario K0M 1K0

Date: 3/30/2021	Time: 01:00 PM	Report ID: 03-30-21
Property: 6972 hwy 35 Coboconk Ontario K0M 1K0	Customer: David Donais	Real Estate Professional: David Donais Kawartha Waterfront Realty

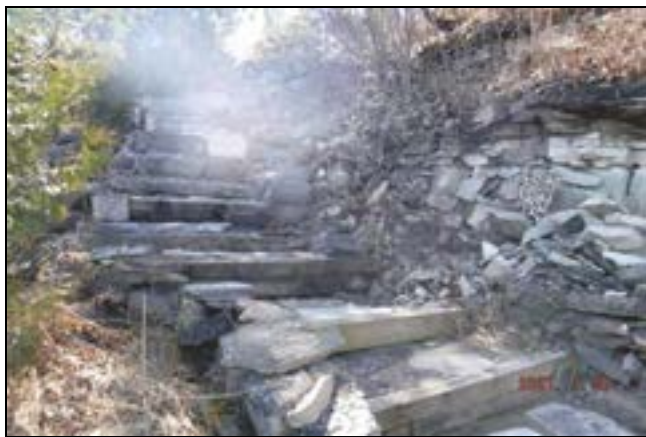
2.4 Item 6(Picture) Some frost heave

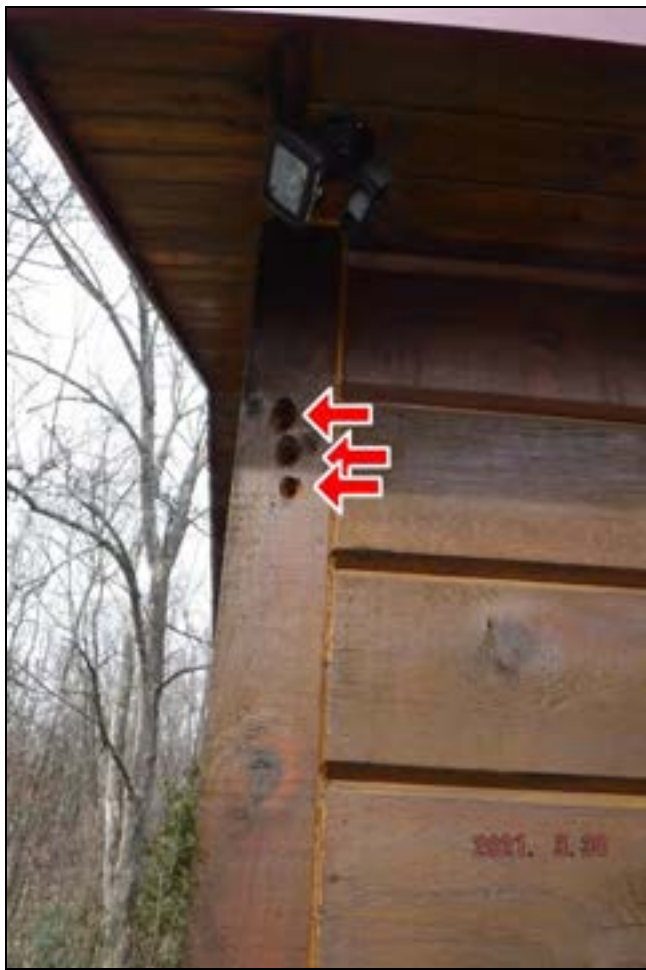
2.5 (1) There is a 2 x 4 constructed garage. There is a metal garage door. There are holes in the siding which appear to be from woodpeckers. It is important to keep the wood siding and logs treated so insects will not penetrate the wood leading to woodpecker damage.

2.5 Item 5(Picture) Garage siding

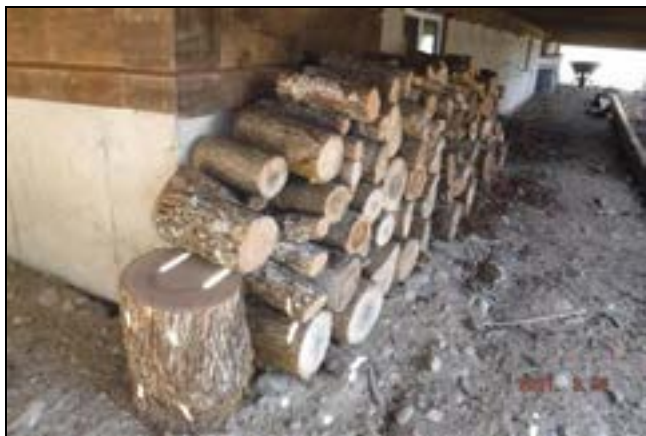
2.5 Item 6(Picture) Move log pile

(2) Recommend removing logs that are near the wood house structure. This will help prevent wood boring or wood eating insects from entering the wood structure.

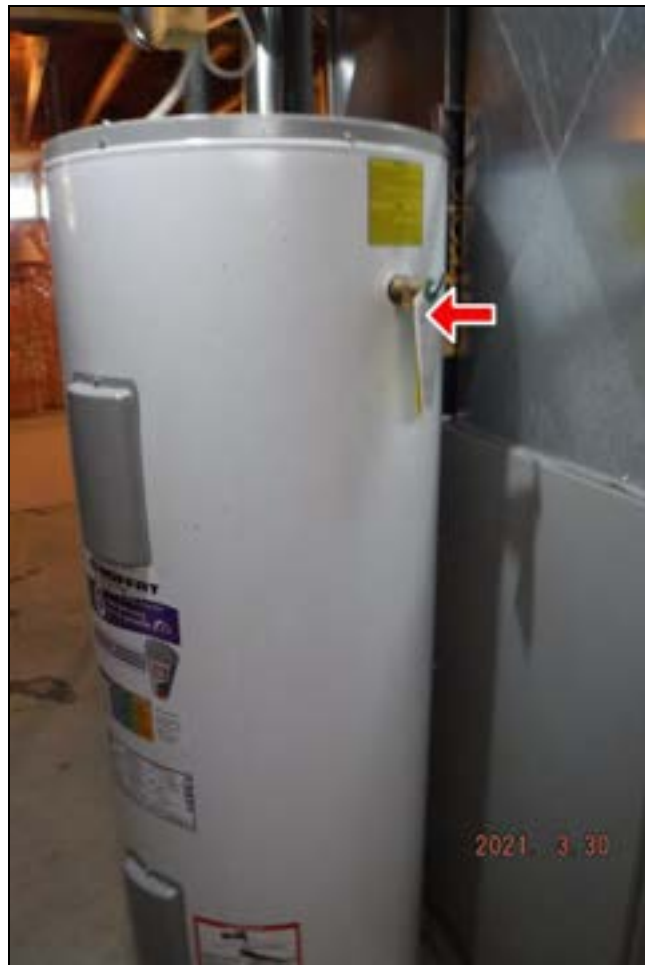
5.4 Item 2(Picture) Add extension to valve

5.4 The hot water tank is a Moffat GSW Model # 6G90SDE1 Serial # S0937F705054. Add an extension to the pressure temperature release valve to 6 to 12 inches from the floor. This is a safety concern to assure that if it releases it does not release at face level.

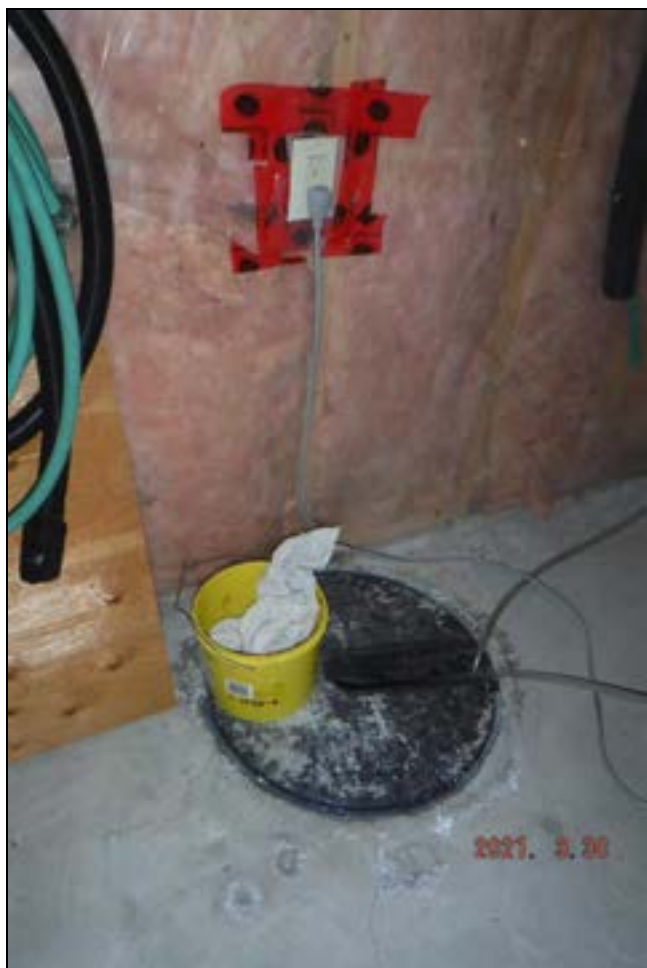
5.5 There was no sump pump in the sump pump well in the basement. Consider adding. There appeared to be a hose size hole in the bottom of the well which may be for natural drainage. Further investigation is required. There is a dehumidifier that empties into the well. The well was dry at the time of inspection. Item 2(Picture)

5.5 Item 1(Picture) Sump pump well

There was no sump pump in the sump pump well in the basement. Consider adding. There appeared to be a hose size hole in the bottom of the well which may be for natural drainage. Further investigation is required. There is a dehumidifier that empties into the well. The well was dry at the time of inspection. Item 2(Picture)

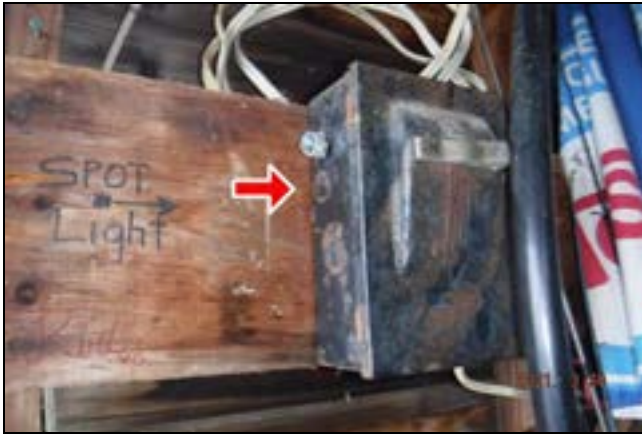
(3) There is a rusted panel in the storage shed by the lake. The breaker at the main panel to this system was off. It was not tested. Recommend updating with GFCI protection.

6.2 Item 5(Picture) Rusted panel

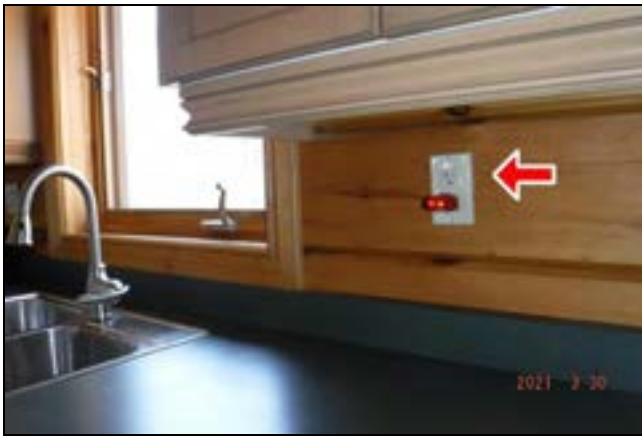
6.6 The electrical outlet near the kitchen sink was not GFCI protected. Consider upgrading to GFCI outlet for safety near the water appliance (sink). GFCI in the bathrooms were in working condition.

6.6 Item 1(Picture) Kitchen area

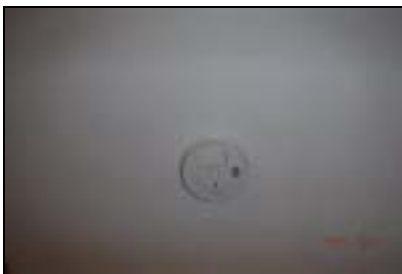
A smoke detector in the basement appears to be battery operated? Consider upgrading by adding detectors that are interconnected. Consider adding detectors to each bedroom for safety. Check smoke and CO detectors monthly.

6.7 Item 1(Picture) Smoke Detector

Add CO detectors as required for health and safety. Consult local requirements and manufacturer recommendations.

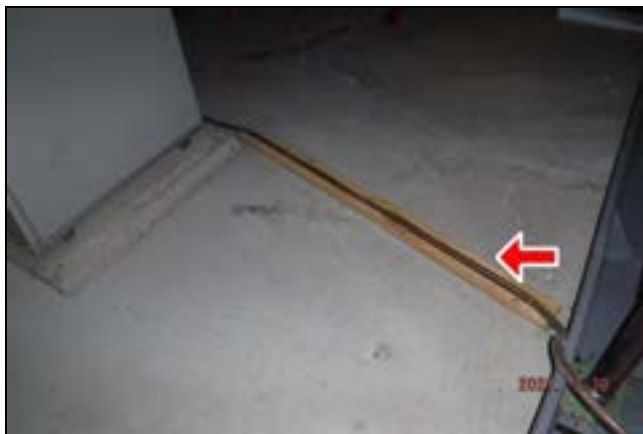
(2) **The protective cover over the oil line is no longer continuous.** This line should be replaced with a protected sheathing for safety. Consult a professional oil technician to bring replace this line with the code approved type. **This is to help prevent oil leak if the copper is damaged.** Item 7(Picture)

7.0 Item 9(Picture) Oil line to Furnace

(2) **The protective cover over the oil line is no longer continuous.** This line should be replaced with a protected sheathing for safety. Consult a professional oil technician to bring replace this line with the code approved type. **This is to help prevent oil leak if the copper is damaged. Item 7(Picture)**

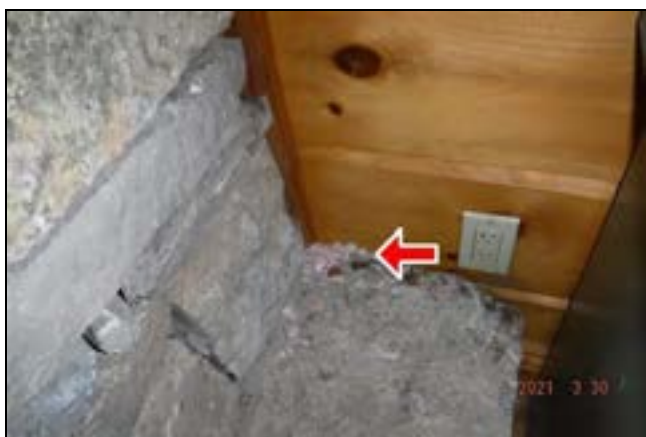
There is often a draft where the fireplace meets a back wall. It appears that insulation was used to attempt addressing a potential draft. Consult a fireplace expert on how to improve this potential draft area safely. Item 4(Picture) INSulation was visible on the hearth. Item 5(Picture)

7.4 Item 5(Picture) Insulation

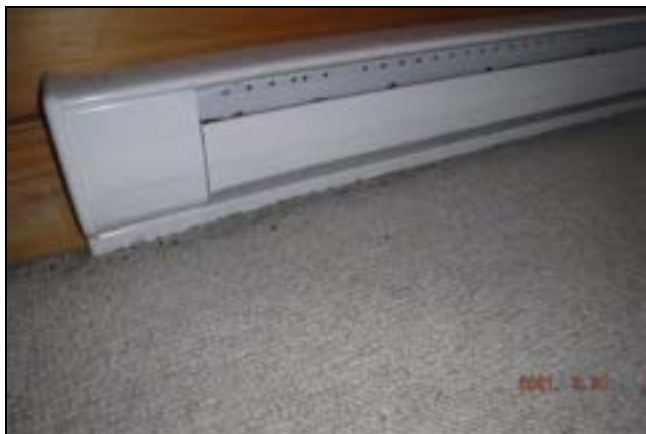
7.7 There is baseboard heating in the two second floor bedrooms and the 2nd floor bathroom. They are all in working condition. Recommend removing curtains in contact with the heating units. This is a safety concern. Also consider turning off

7.7 Item 1(Picture) Baseboard heaters

the electric baseboards at the electrical panel in the basement when they are not being used in the non heating season. This can save energy. Item 2(Picture)

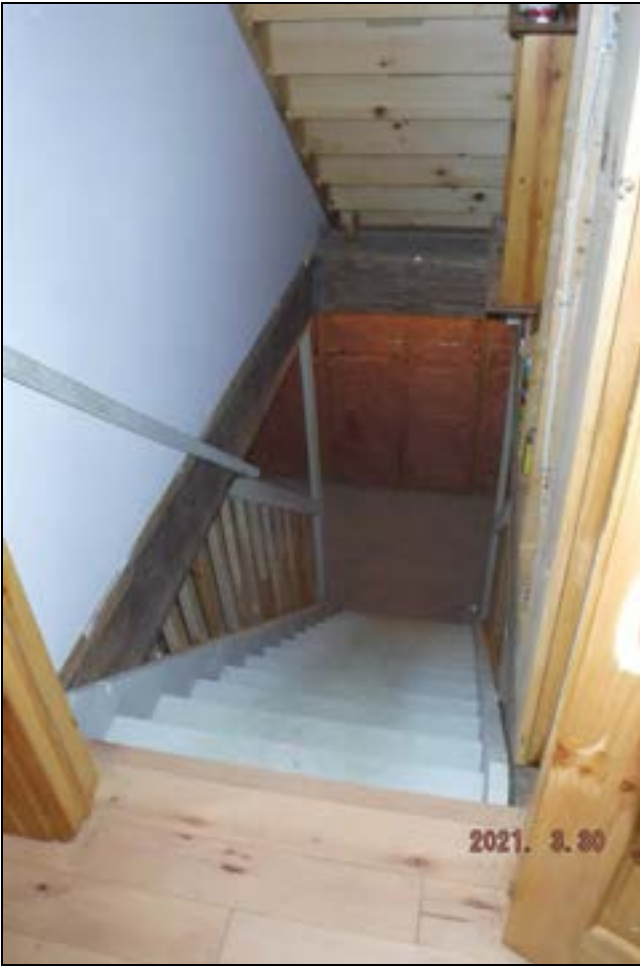
8.3 Item 1(Picture) Basement stairs

8.3 Consider improving the railing so it is accessible at the top before going down the stairs.Item 1(Picture)

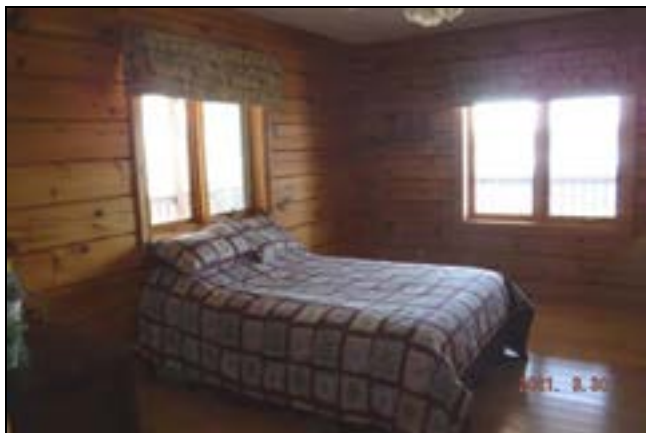
(3) There was a crack in the drywall ceiling in the main floor bedroom closet. The cause was not determined. There did not appear to be a continuation of the crack in any other areas.

8.7 Item 3(Picture) Main floor Bedroom
