AE Home Inspection Services

Inspection Report

1070 Sunrise Dr

Inspected on Mon, May 3 2021 at 2:30 PM

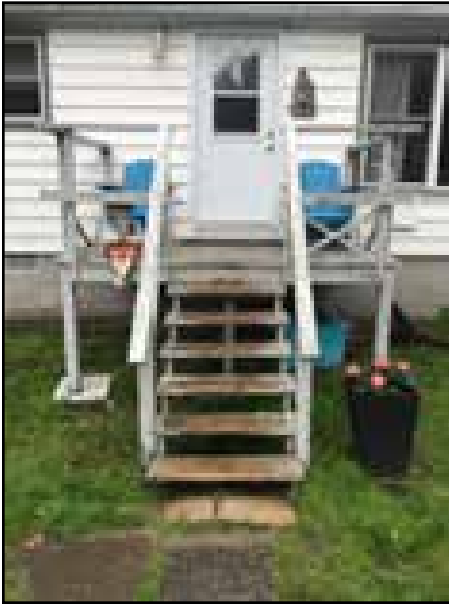
Figure 1-1

Main entry to home is in good overall condition. Elevated wooden deck at entry is aging but in working condition.

Support posts rest on concrete pads, ledger lagged to building.

recommend refinishing wood with a good exterior paint to help protect the wood and prolong the life of the deck.

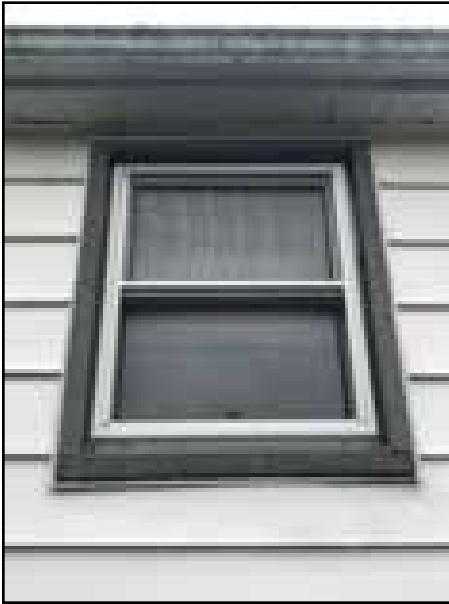
Figure 2-1

Windows on the home are in good overall condition. No signs of damage to seals.

Sill a long bottom of large front window lean slightly backwards towards the home. Recommend annual inspection of caulking to ensure moisture does not get into the home. Reseal as required.

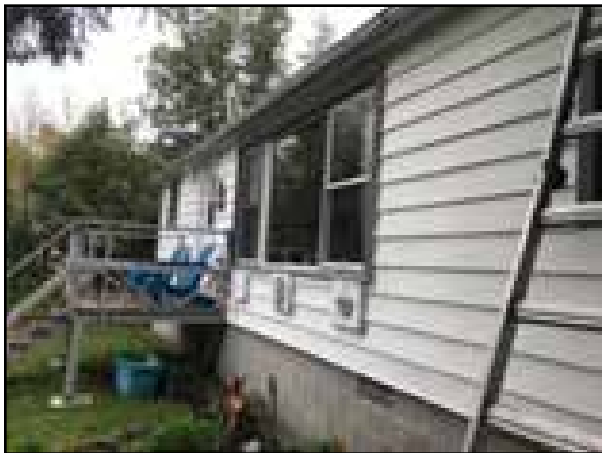
Figure 3-1

Siding on the home is in good overall condition. No signs of structural issues at the time of the inspection.

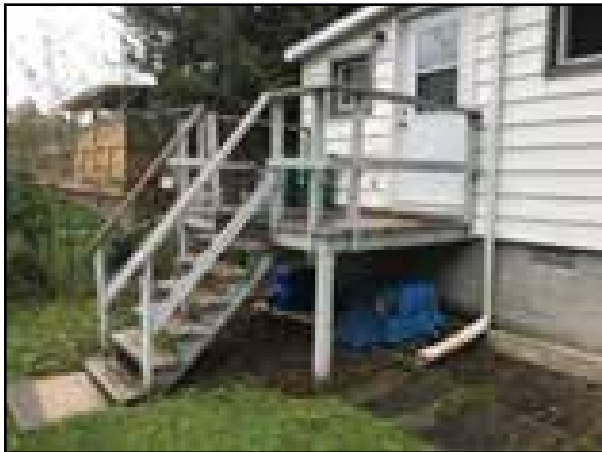
Figure 4-1

Elevated wood deck located at rear of building at entry door. Similar to front the wood is ageing and would require refinishing to protect from the elements.

One of the support posts is angled on concrete pad. Recommend re-leveling concrete pad to ensure stability.

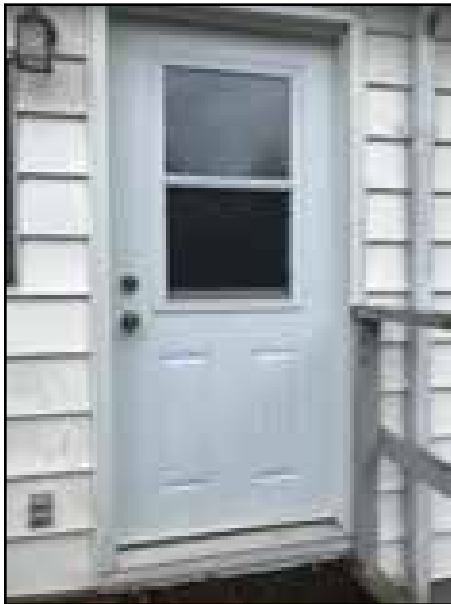
Figure 5-1

Entry door at rear of home is in good overall condition.

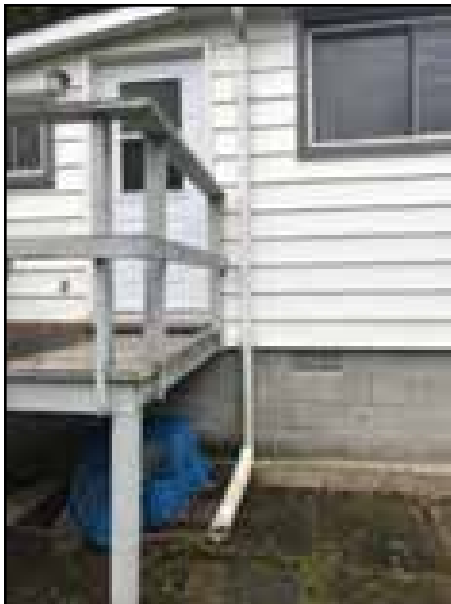
Figure 6-1

Downspout at rear of home is in good condition. Extension has been attached. This will help move rainwater away from the foundation of the home.

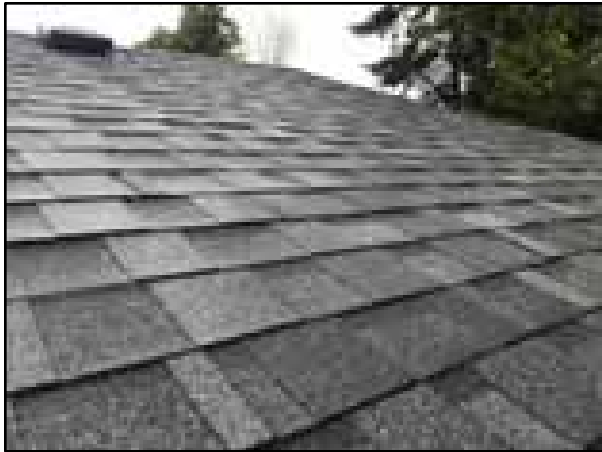
Figure 7-1

Shingles on home are in good overall condition. Estimated age of shingles is 7 to 10 years.

Estimated life expectancy remaining on shingles is 7 to 10 years.

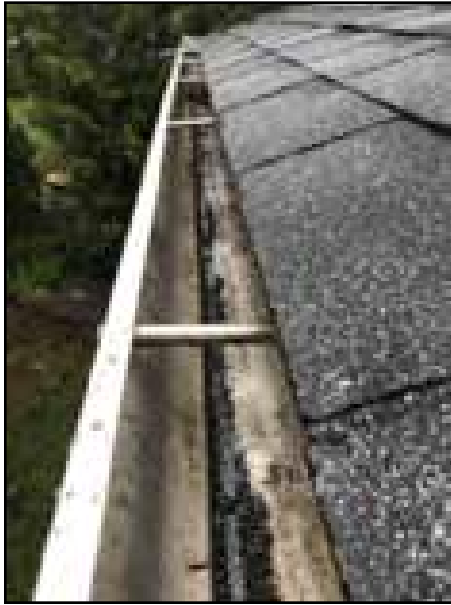
Figure 8-1

Gutters on the home are in good overall condition. Minor amounts of debris remaining in trough, recommending routine cleaning.

Large amounts of debris remains in trough under trees at right hand side of home. Recommending cleaning to maintain water flow.

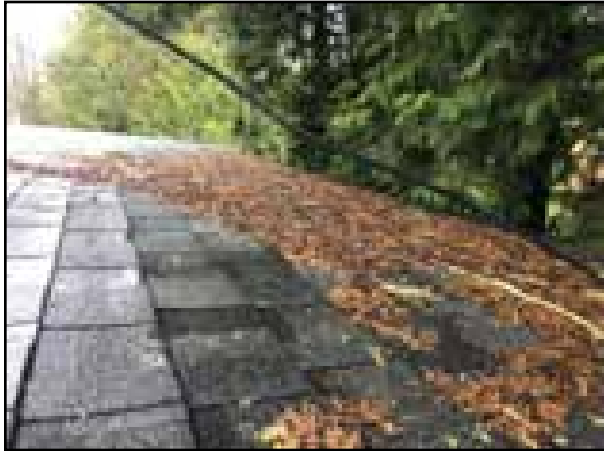
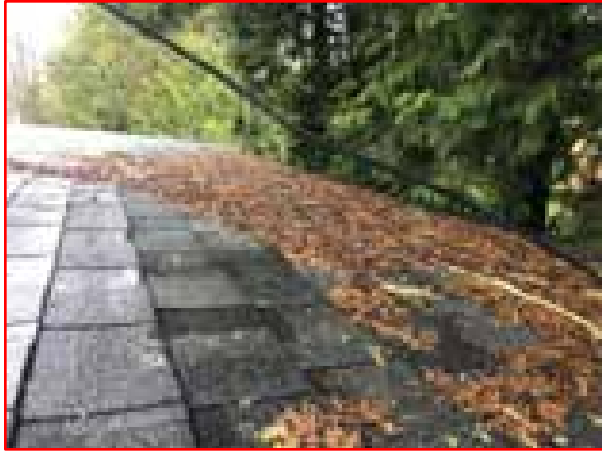
Figure 9-1

Low slope roofing along right hand side of home has some tree debris.
Recommend cleaning to protect the life of the shingles.

Recommend trimming of cedar trees along the side of roof to limit the amount of branches making contact with home.

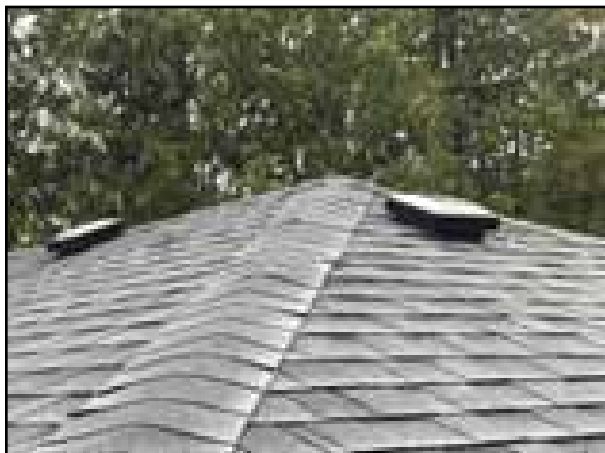
Figure 10-1

Ventilation on roof appears to be adequate for the size of the house.

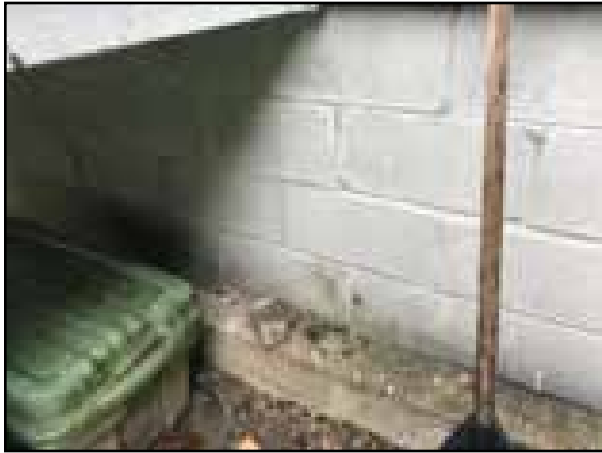
Figure 11-1

Concrete block foundation around the property is in good condition. No signs of any major structural issues.

Common settling cracks can be seen in mortar joints, recommend resealing as needed.

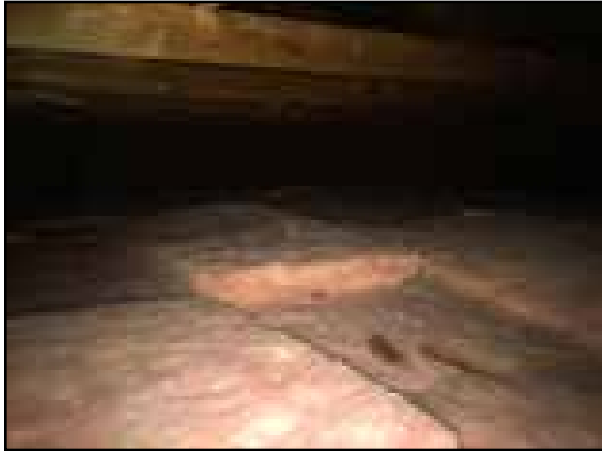
Figure 12-1

Fibreglass batt insulation located throughout the attic space. Two layers of R12 insulation can't be seen throughout. This offers the home an R24 value. This is adequate for the age of the home.

Recommend increasing attic insulation for additional heat loss resistance.

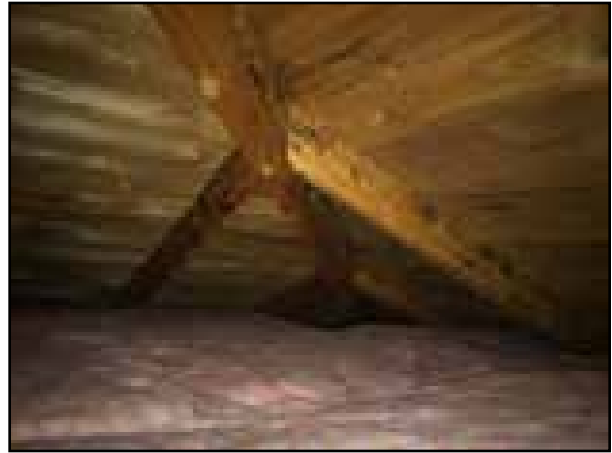
Figure 13-2

Roofing structure is in good condition at the time of the inspection. No signs of structural issues could be seen.

No signs of moisture issues or discoloration.

No signs of mold or mildew at the time of the inspection.

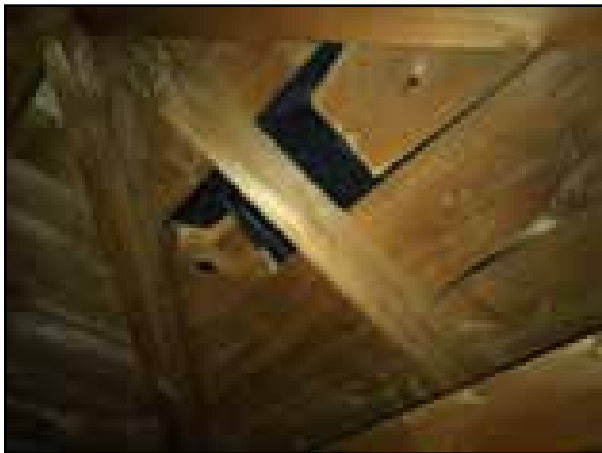
Figure 14-1

Roofing vents can be seen from the interior of the attic space. All appear to be in good condition.

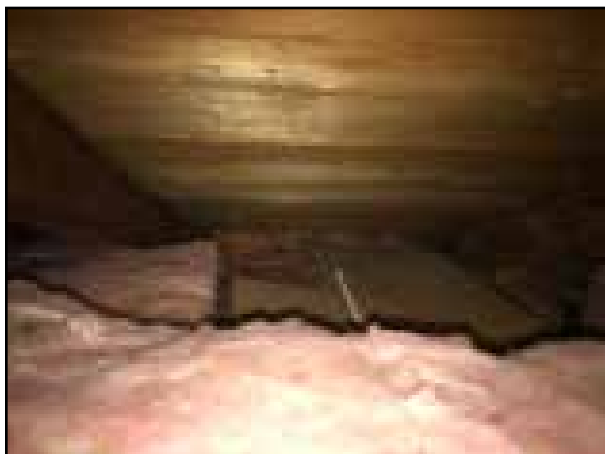
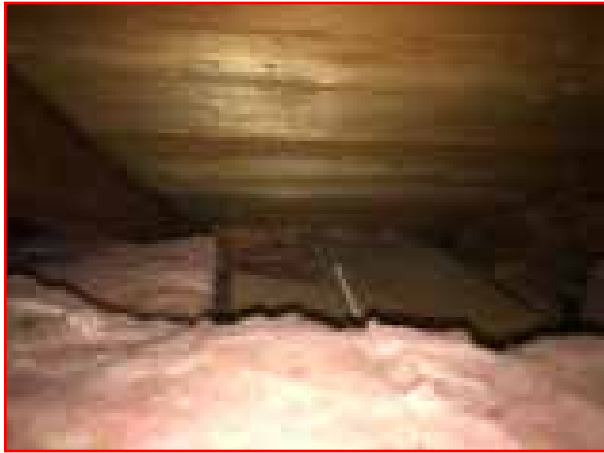
Figure 15-1

Attic insulation has been stuffed in roof cavities down into the soffit area. This can prevent air flow throughout the attic.

Recommend pulling fibreglass insulation back from the soffit area to improve airflow.

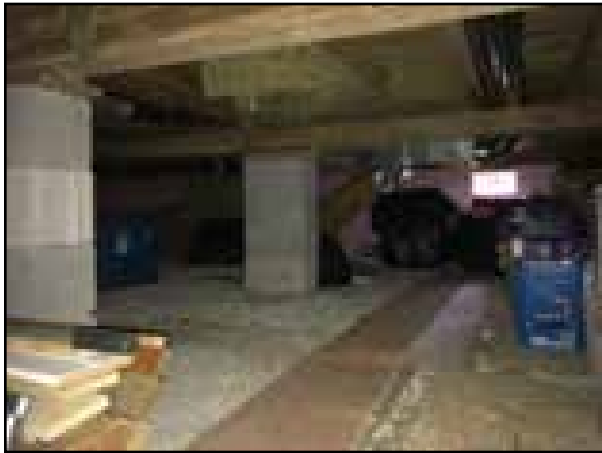
Figure 16-1

Supports throughout the crawl space are in good condition.

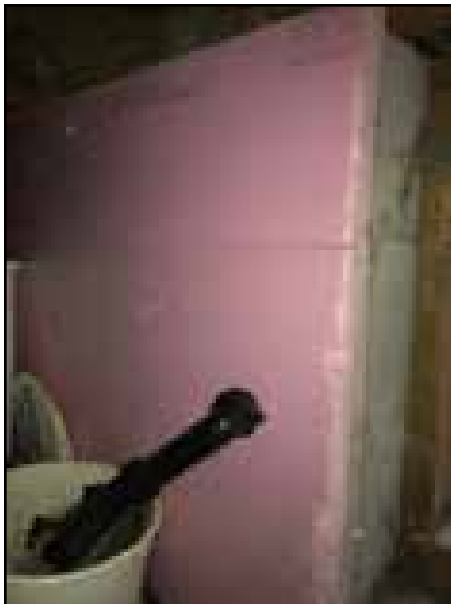
Figure 17-1

Rigid insulation around the crawl space is in good condition.

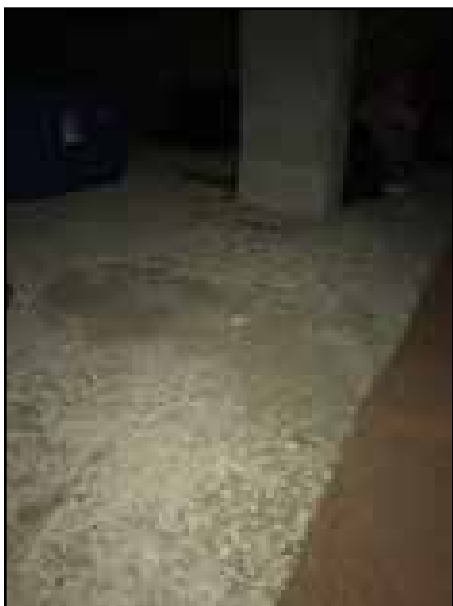
Figure 18-1

Concrete floor is in good condition.

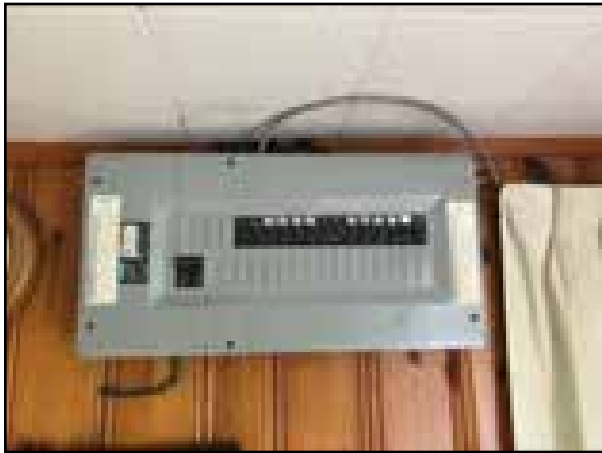
Figure 19-1

Comment 19:
100amp panel located in living room.

Wiring is copper and in good condition. No signs of charred or melted casings which would indicate overdrawn circuits.

Proper size breaker located for stove.

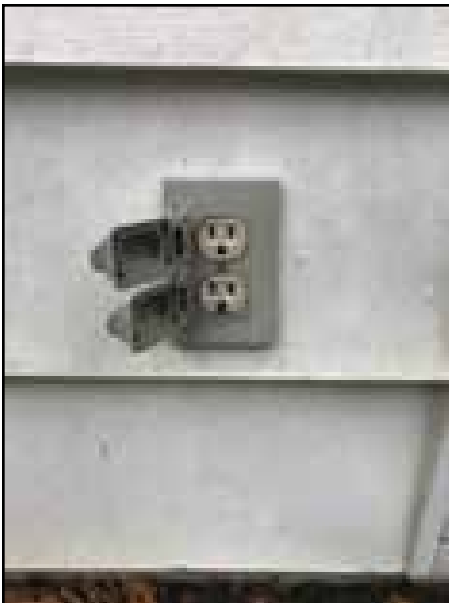
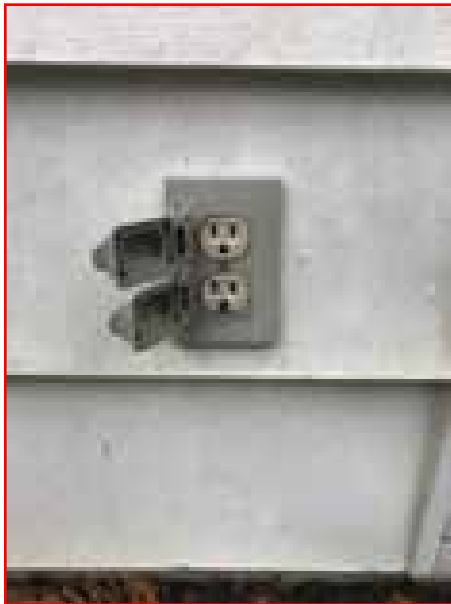
Figure 21-1

Electrical outlet at rear door should be equipped with a GFCI receptacle.
Recommend replacing.

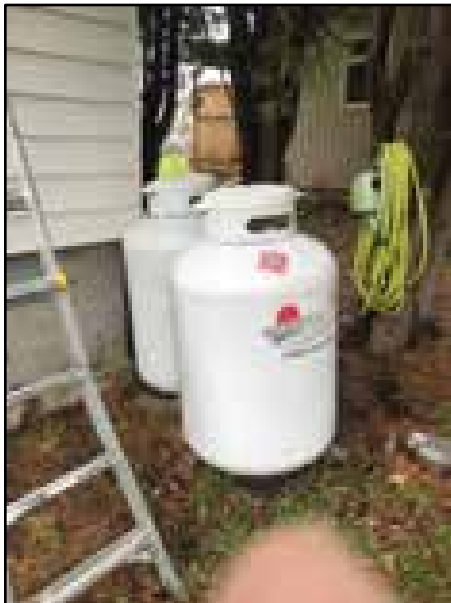
Figure 22-1

Double propane cylinders located at right corner of home. Cylinders appear to be in good condition.

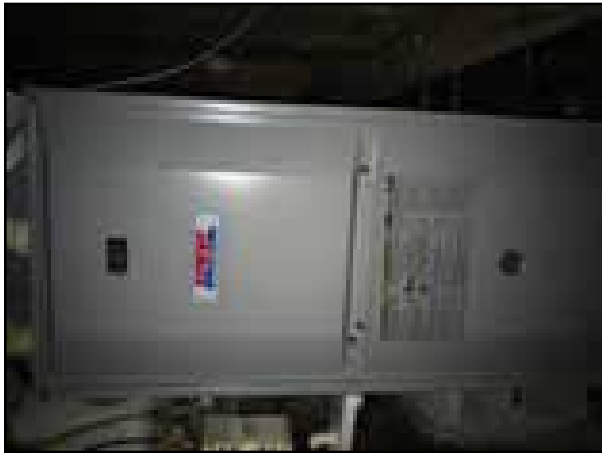
Figure 23-1

Forced air gas furnace located in crawlspace of home. Estimated age of furnace is approximately 13 years. Estimated life expectancy of a forced air gas furnace is approximately 25 years.

The furnace was running and in good working condition at the time of the inspection.

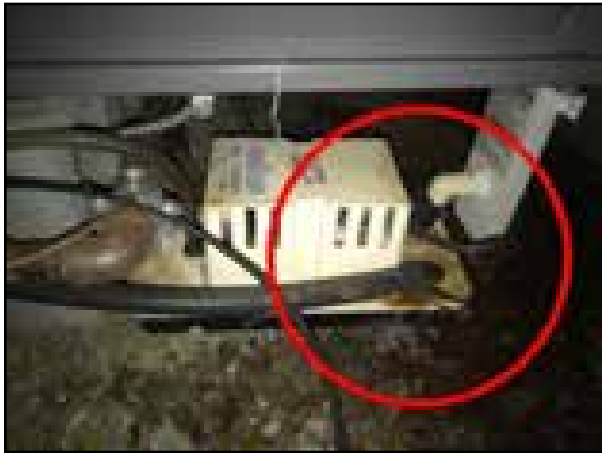
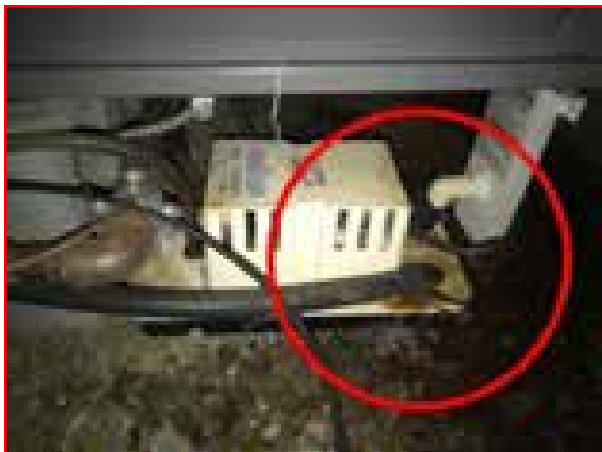
Figure 24-1

Condenser pump located below furnace appears to be in operable. Reservoir has filled and is leaking in crawlspace. Recommend replacing.

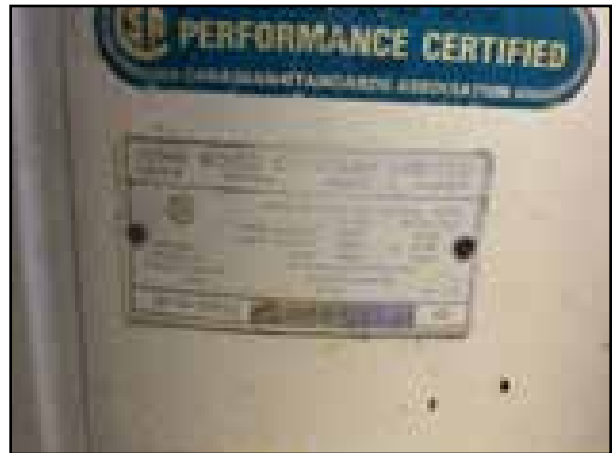
Figure 26-2

Older electric hot water tank located inside home. Hot water was tested in the sinks during the inspection.

Although the hot water tank appears to be in working order replacing with a new or updated unit would increase efficiency.

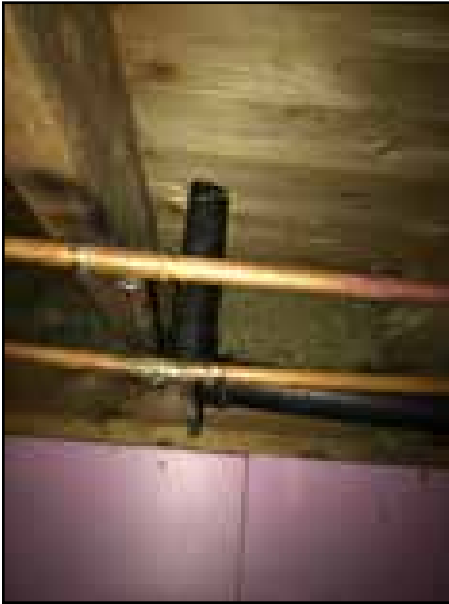
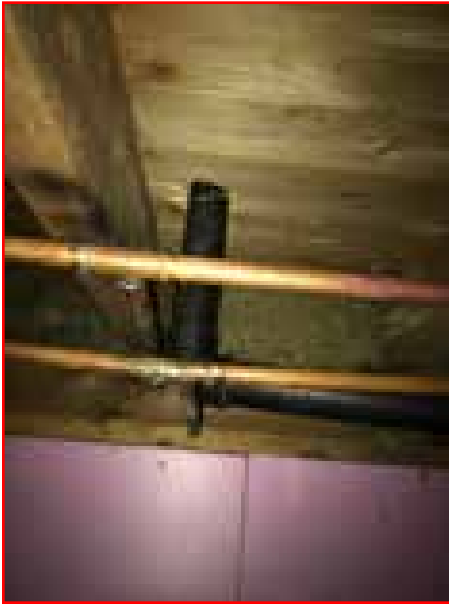
Figure 28-1

Kitchen sink drain appears to travel across the crawlspace and exit through the cinderblock wall.

Grey water should be tied into septic system. Recommend plumber repairs.

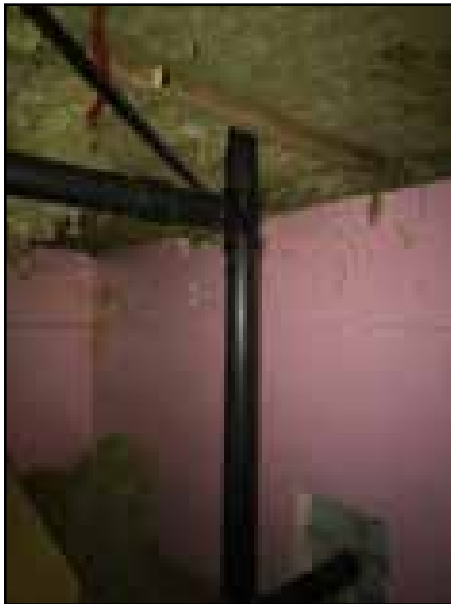
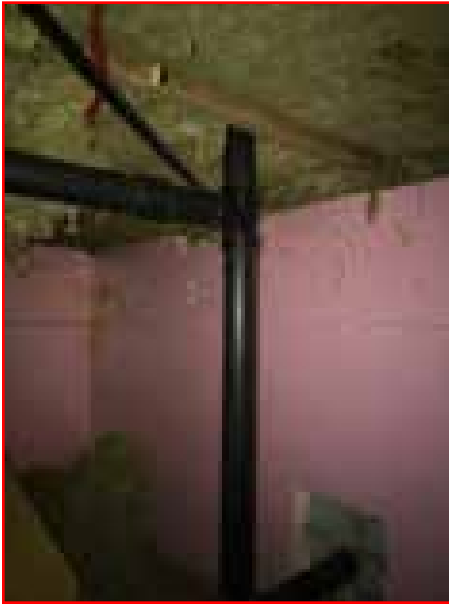
Figure 29-1

Shower drain descends into crawlspace and exits the home through cinderblock wall.

This drain should also be tied into the septic system. Recommend plumber repairs.

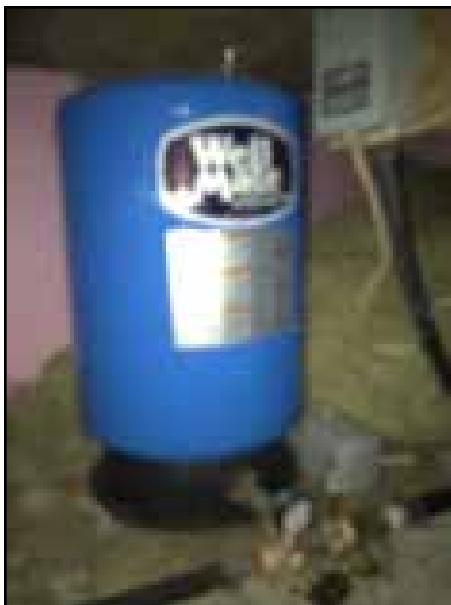
Figure 30-1

Pressure tank located in crawlspace is in good condition at the time of the inspection. Water pressure throughout the home appears to be adequate.

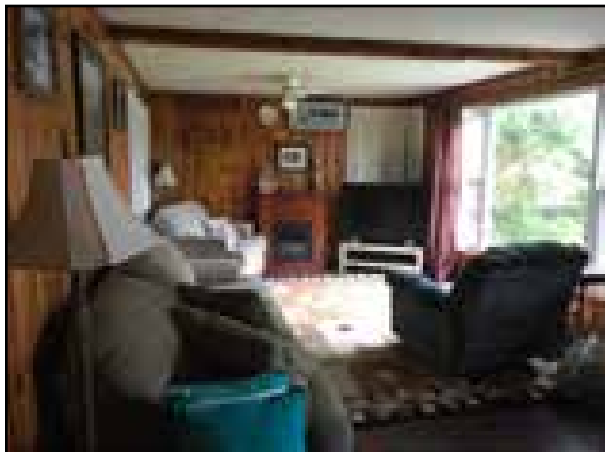
Figure 32-1

Right hand light switch near door not operational. Toggle appears ceased.

All else is in good working condition.

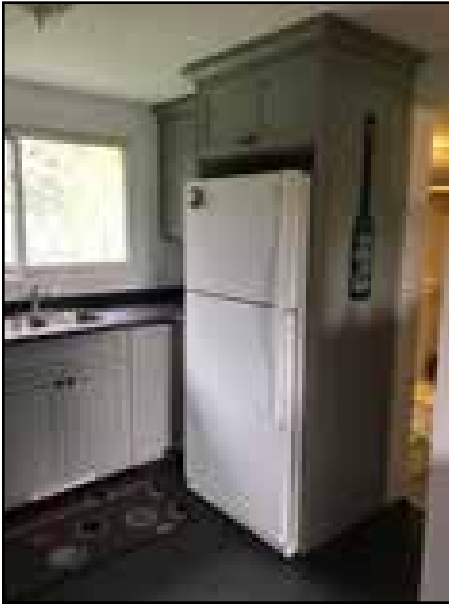
Figure 33-1

Cabinets and counters are in good condition.

No leaks present at sink, drain or faucet.

Appliances are in good working condition at the time of the inspection.

Electrical outlets on either side of sink should be replaced with GFCI receptacles.

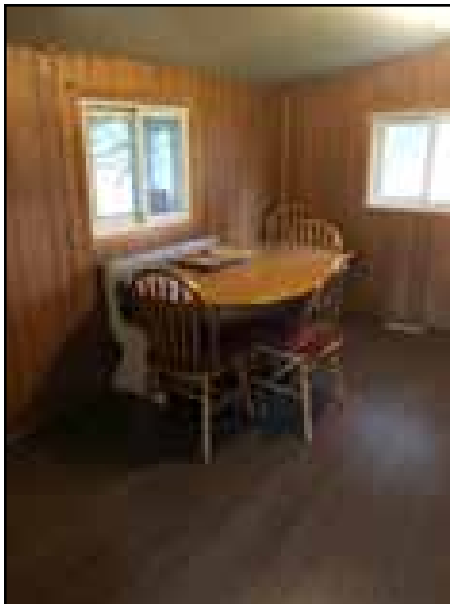
Figure 34-1

Everything is in good overall condition.

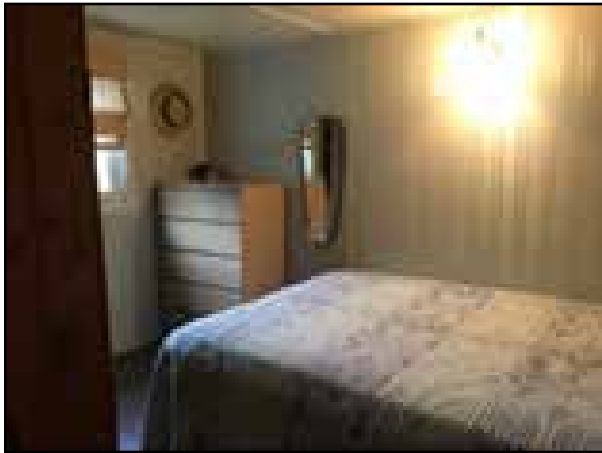
Figure 36-1

Older wallpaper separating from the walls. This appears to be an age issue.

Appears that the ceiling sagged over many years. Likely cause is humidity over time. To repair the ceiling will likely require replacing.

Lack of electrical outlets within the room. Recommend adding outlets on each wall.

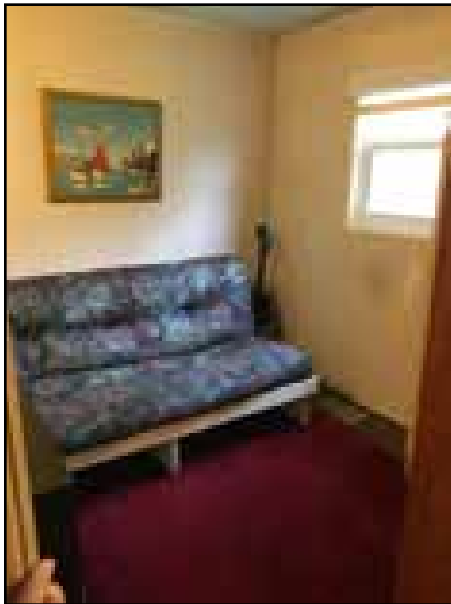
Figure 37-1

Electrical outlet should be replaced with newer receptacle. Current outlet does not have a ground access. Recommend adding an outlet to each wall as well.

Stain along back wall appears to be old. Moisture reading were taken and it is not a current issue.

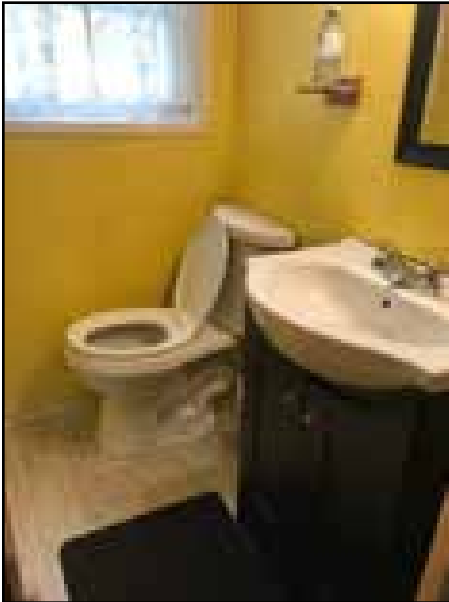
Figure 38-1

No leaks at sink, drain or faucet.

Recommend addition of a GFCI receptacle as there is not outlet in the room.

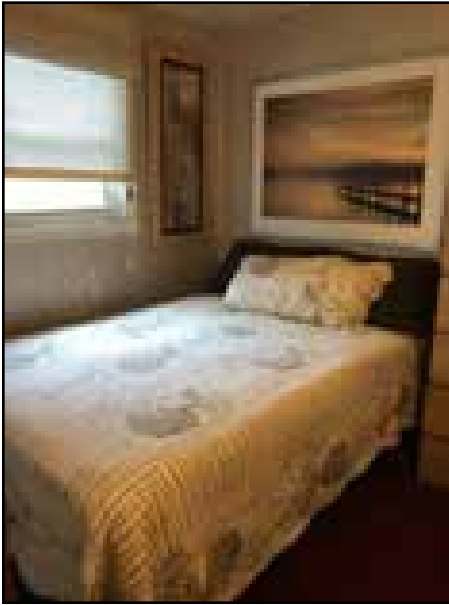
Figure 39-1

Staining on ceiling appears to be from old issue.

All else is in good working condition.

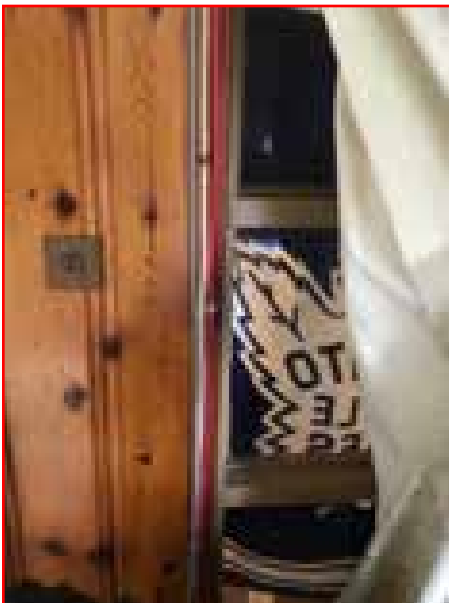
Figure 20-1

Comment 20:
Electrical wires running along living room wall should be encased in a conduit as they travel more than 24" exposed.

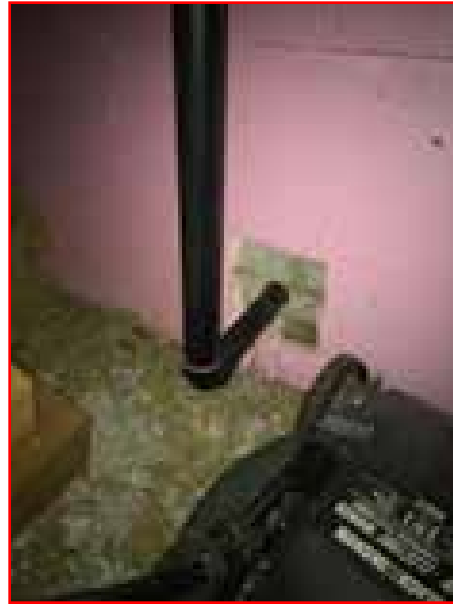
Figure 29-2

7) Shower drain descends into crawlspace and exits the home through cinderblock wall.

This drain should also be tied into the septic system. Recommend plumber repairs.
