Inspection Report

6972 hwy 35
Coboconk Ontario K0M 1K0

Date: 3/30/2021	Time: 01:00 PM	Report ID: 03-30-21
Property: 6972 hwy 35 Coboconk Ontario K0M 1K0	Customer: David Donais	Real Estate Professional: David Donais Kawartha Waterfront Realty

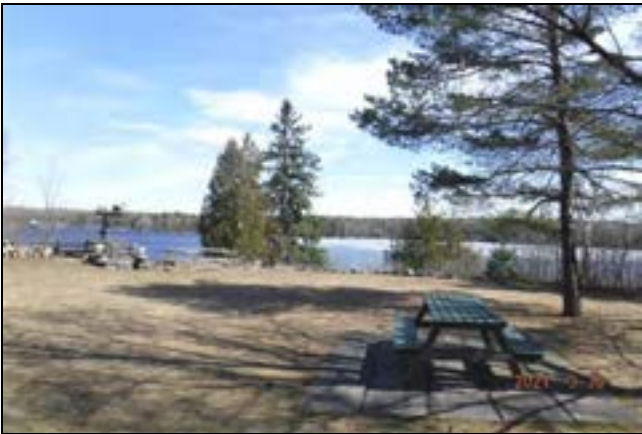
1.0 (1) The lot is level with a drop with stairs to the lake area and dock.

1.0 Item 1(Picture) Level lot

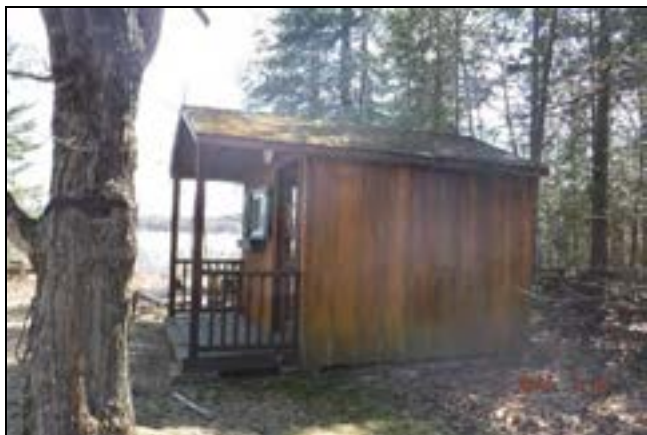
(2) The bunkie near the lake is a 2 x 4 structure, uninsulated and the roof requires re-shingling. Item 2(Picture)

1.0 Item 2(Picture) Re-Roofing Required

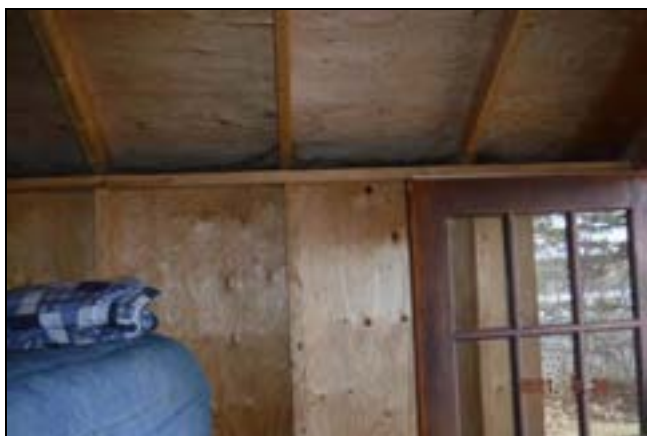
1.0 Item 4(Picture) Bunkie Interior

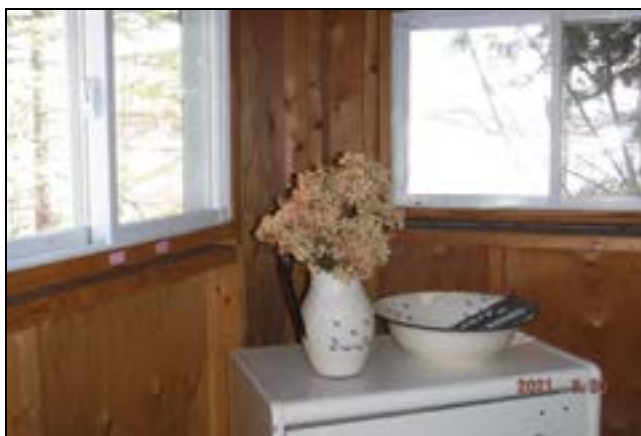
1.0 Item 5(Picture) Windows in Bunkie

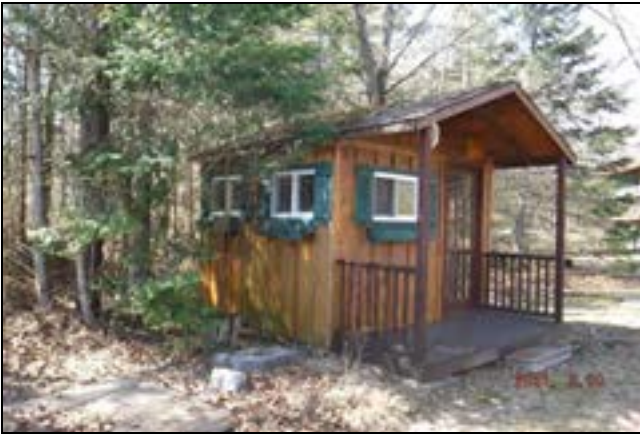
1.0 Item 6(Picture) View of Bunkie

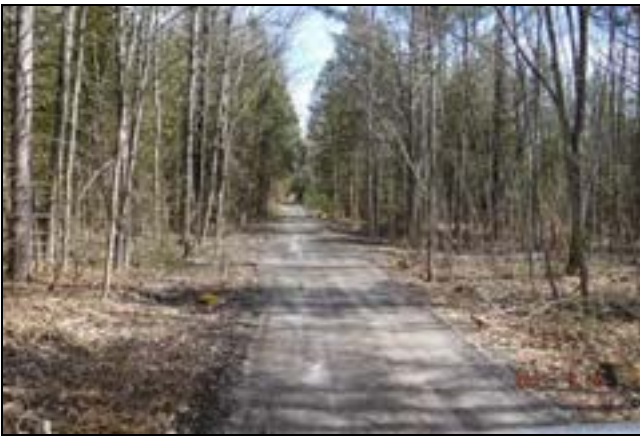
1.2 There is a shared road way from Hwy #35. There is a separate drive that has a metal gate. The gate was not lockable.

1.2 Item 1(Picture) Driveway

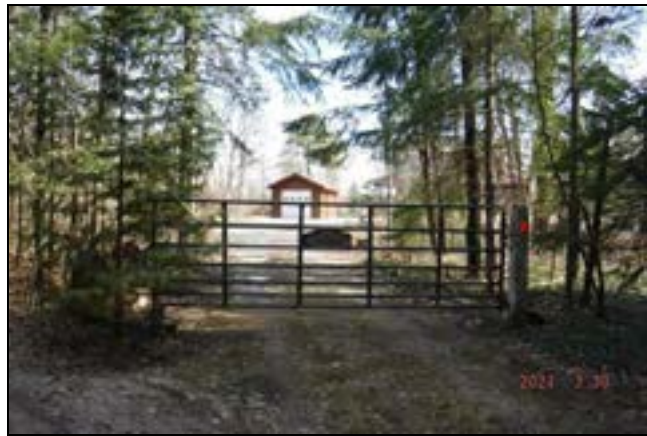
1.2 Item 2(Picture) Gate entrance

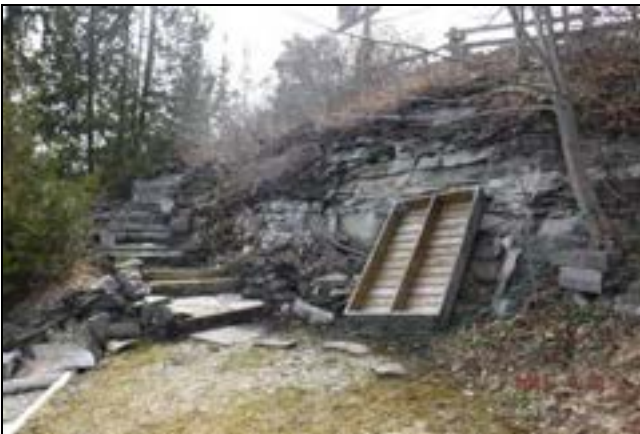
1.4 There is some level land at the lake area. Item 1(Picture)

1.4 Item 1(Picture) Lake Front area

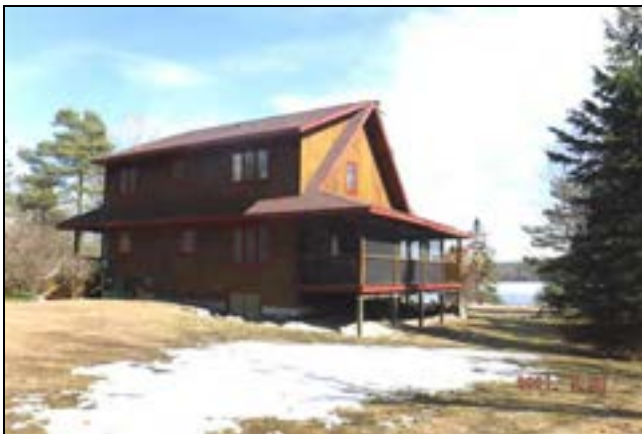
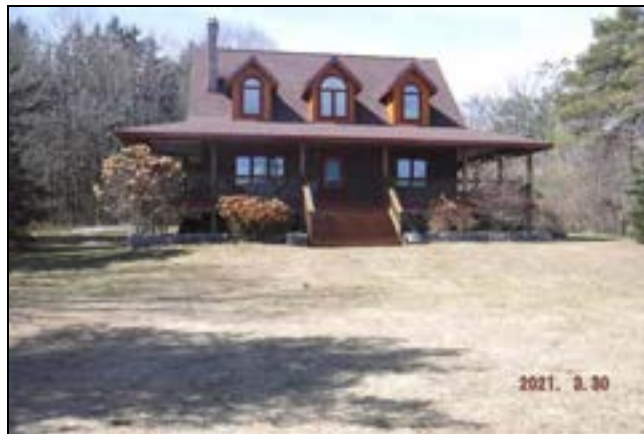
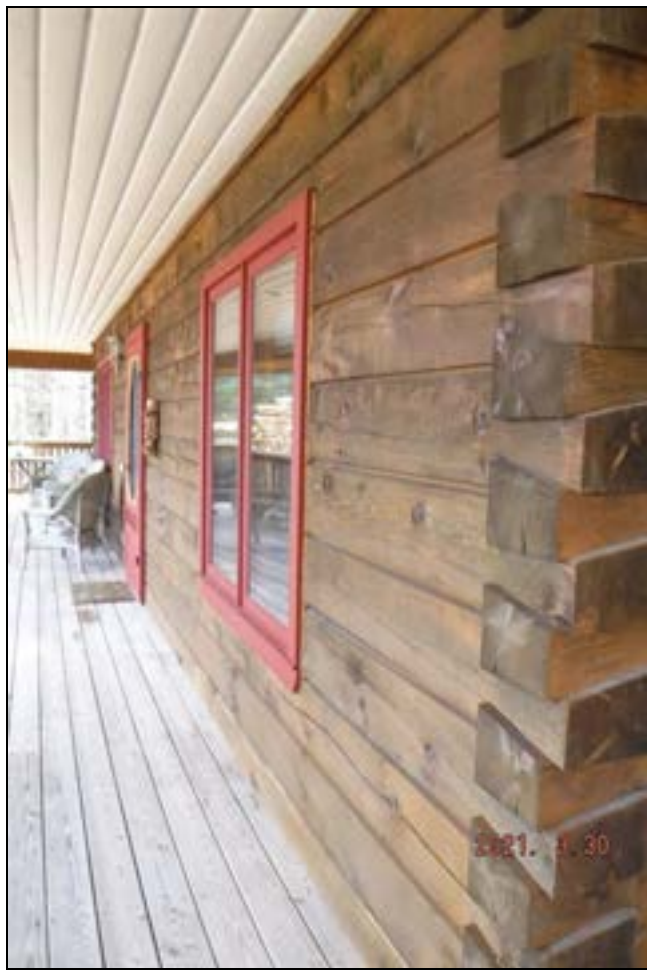
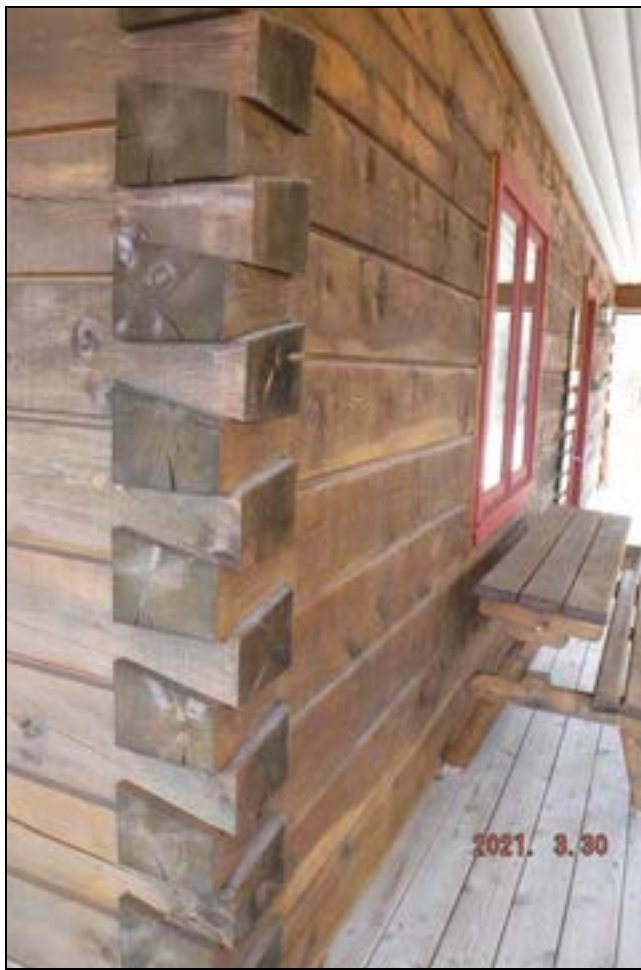
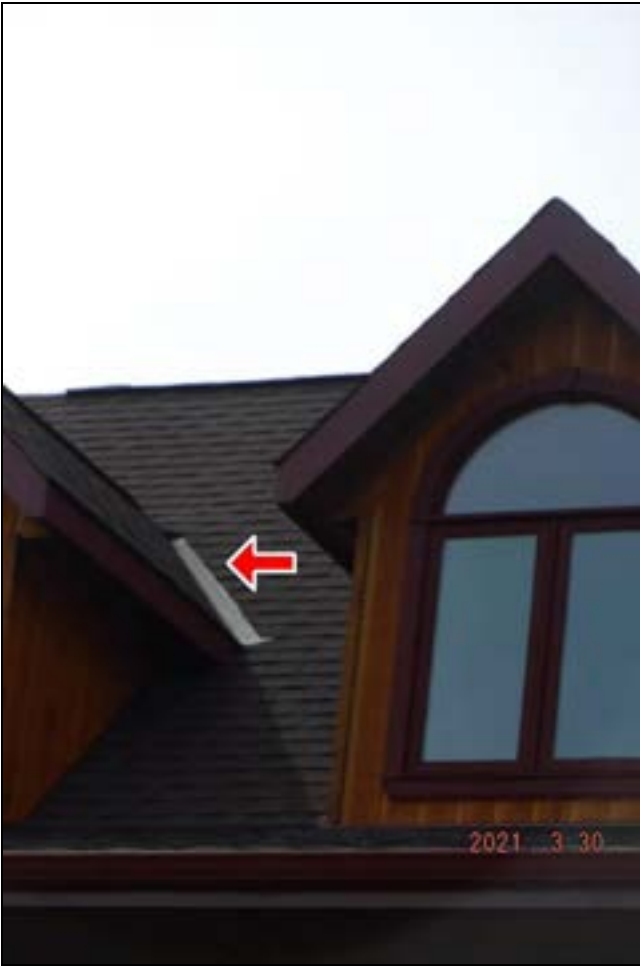
2.0 (1) The exterior of the house is Log and matching wood planks. Wood will require maintenance. Consult professionals to determine the best treatment for the wood siding over the years.

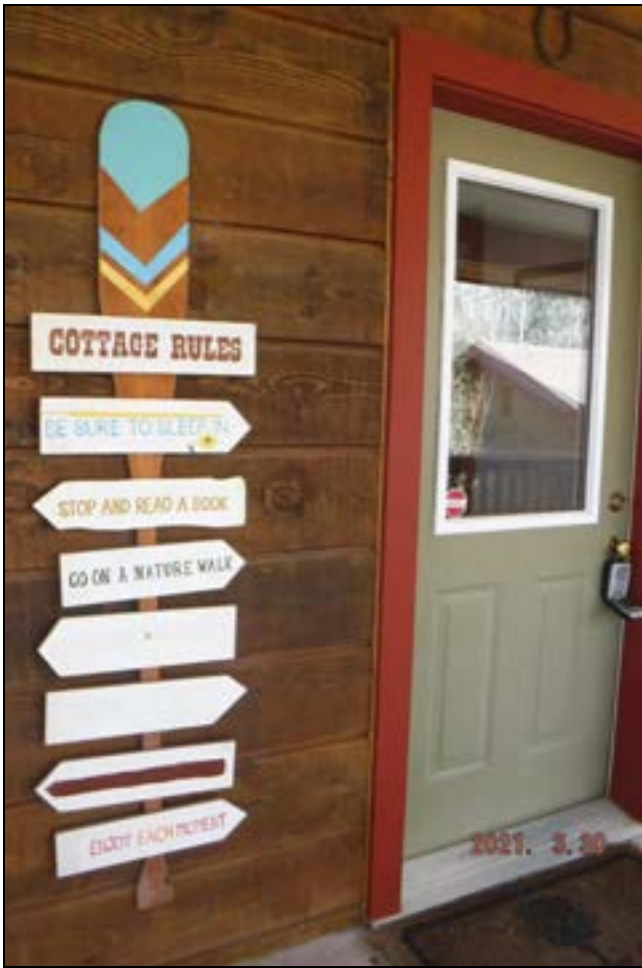
(2) The entrance doors are metal and in good working condition.

2.0 Item 6(Picture) Side Door Entrance

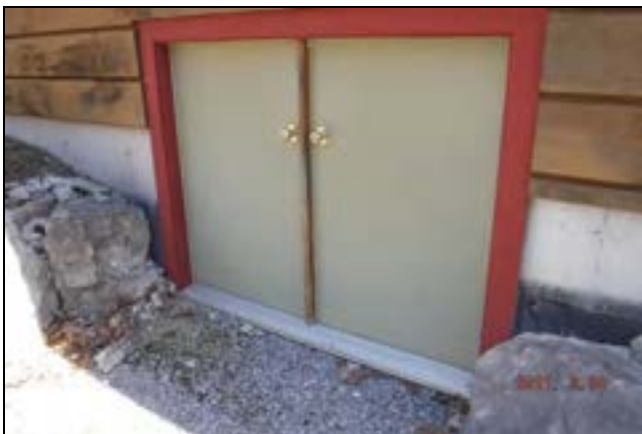
2.1 There are are double short doors that lead to the basement area and stairs.

2.1 Item 1(Picture) Basement exit/entrance

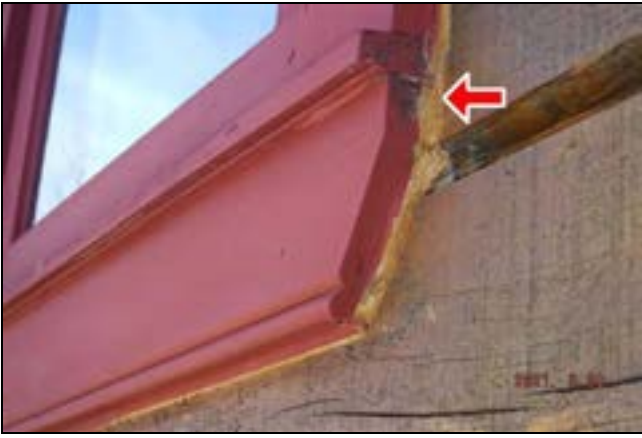
2.2 The caulking around the windows is in good condition. Monitor and maintain.

2.2 Item 1(Picture) Trim caulking

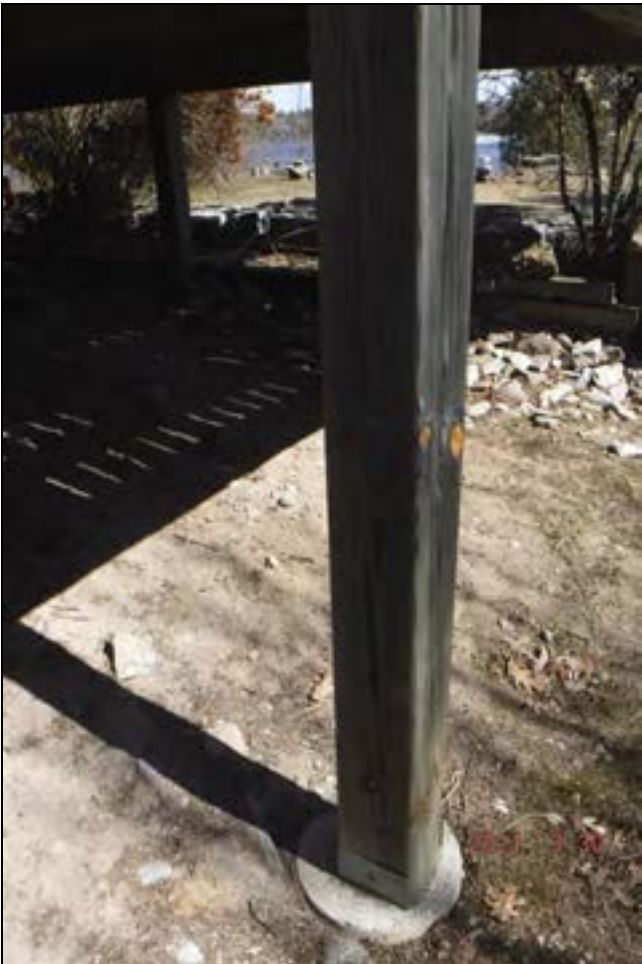
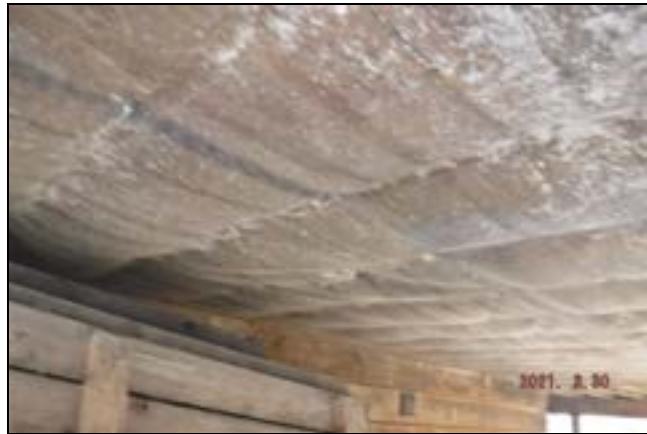
2.4 (1) The deck is supported by wood piers in concrete footings. There is screening under the screened porch part of the deck to keep out insects.

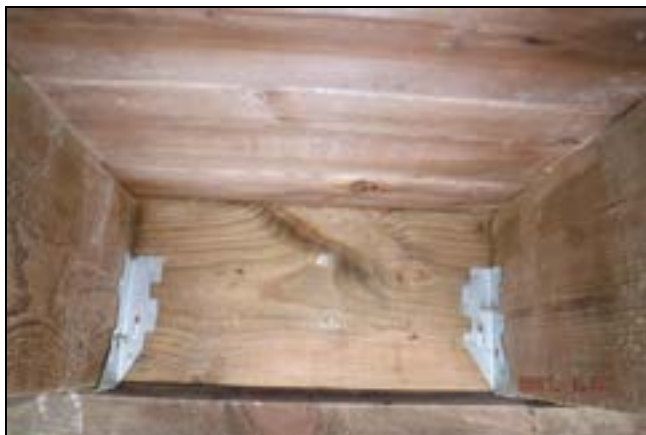
(2) The deck is secured to the house and the hangers are properly hung for the floor joists. Item 3(Picture)

2.4 Item 3(Picture) Deck construction

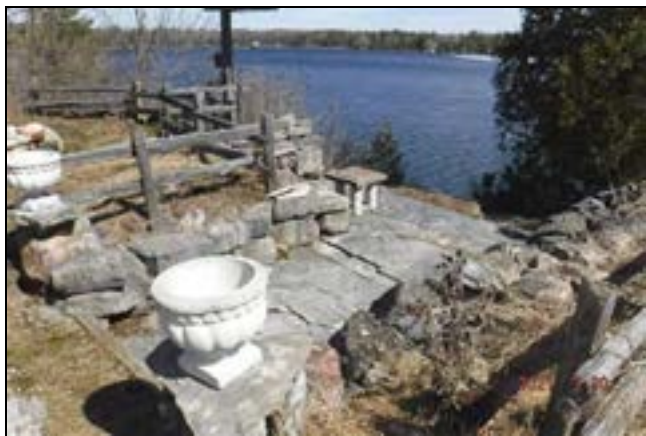
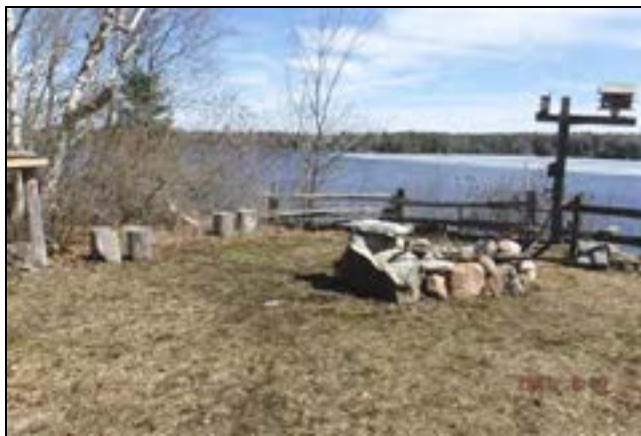
(3) There is a stone path constructed to the water. There is a stone built fire pit located in the yard.

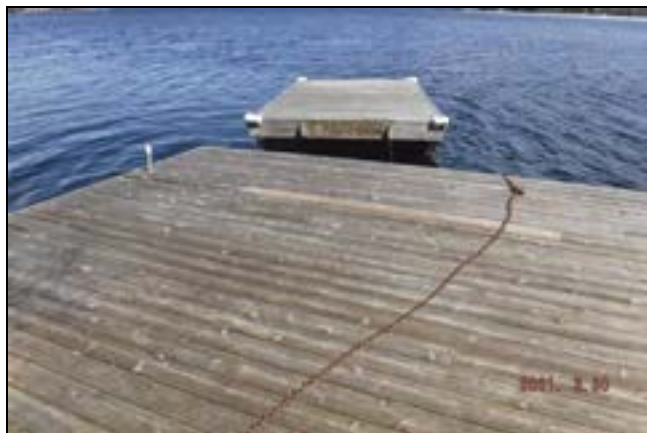
(4) There is a wooden dock attached to the land and a wood floating dock that attaches to the main dock. It is not yet attached to the main dock as the ice is recently out. Item 8(Picture)

2.4 Item 8(Picture) Dock area

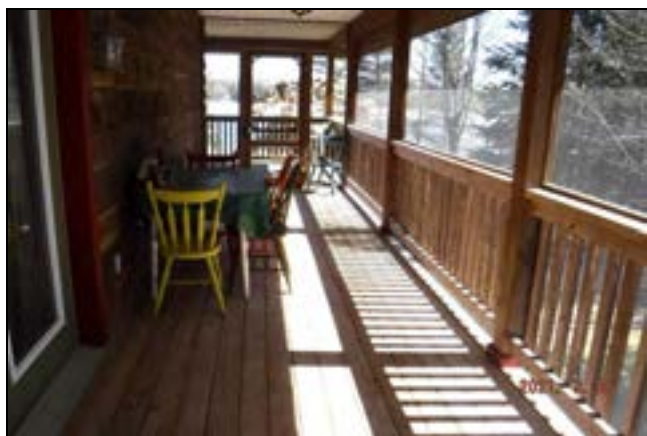
(6) Item 12(Picture) There is a screened in area on the south side of the deck. Item 12(Picture)

2.4 Item 12(Picture) Screened Porch area

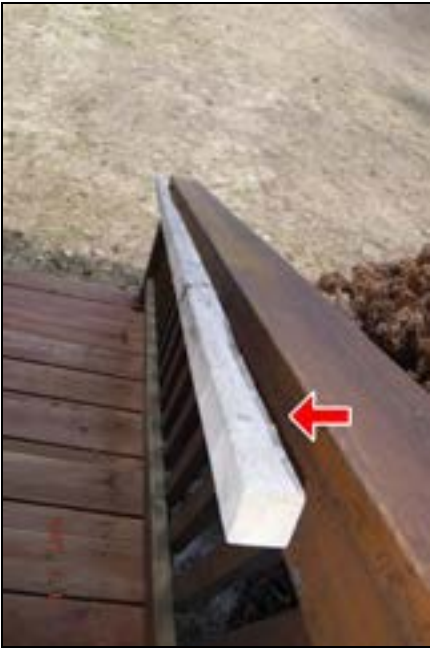
(7) 2 x 4 railings were added for easier grip along the stairs to the deck.

2.4 Item 13(Picture) Deck railings

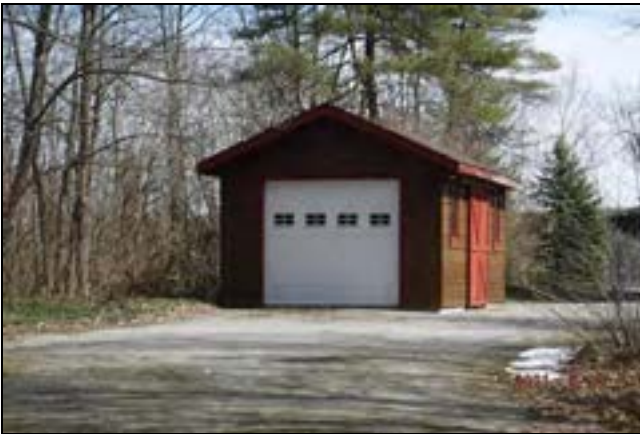
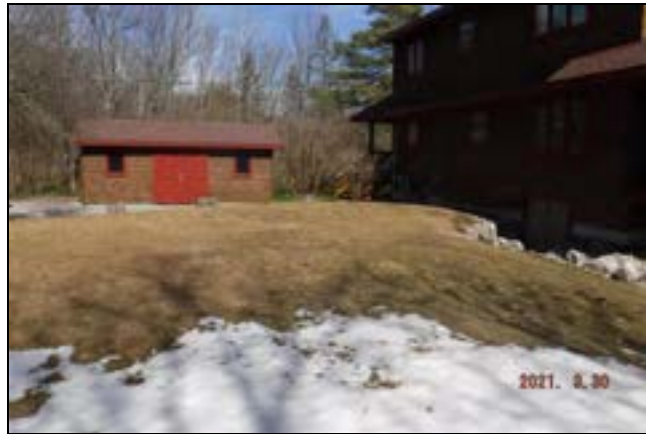
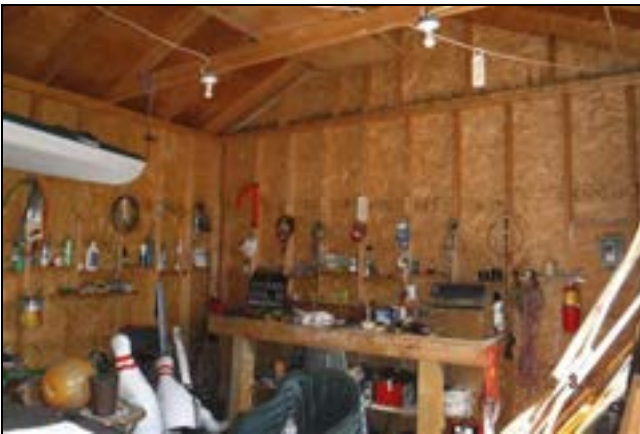
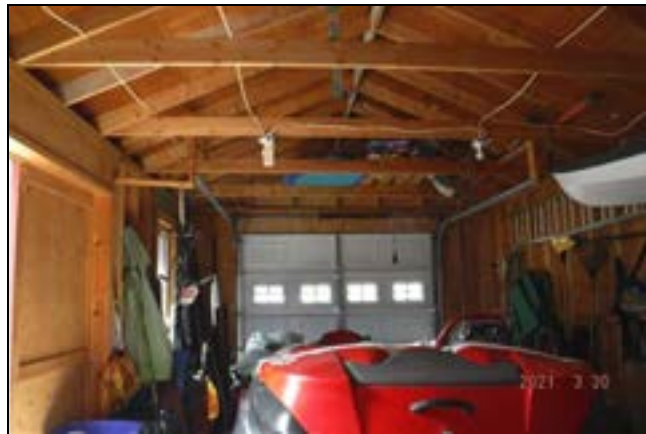
2.5 (1) There is a 2 x 4 constructed garage. There is a metal garage door. There are holes in the siding which appear to be from woodpeckers. It is important to keep the wood siding and logs treated so insects will not penetrate the wood leading to woodpecker damage.

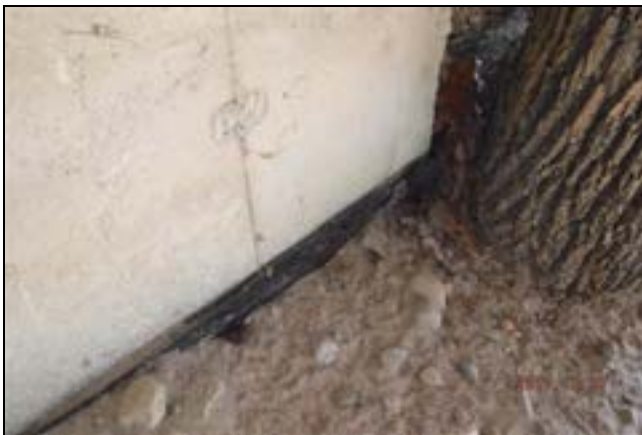
3.0 There is poured concrete basement foundation.

3.0 Item 1(Picture) Concrete foundation

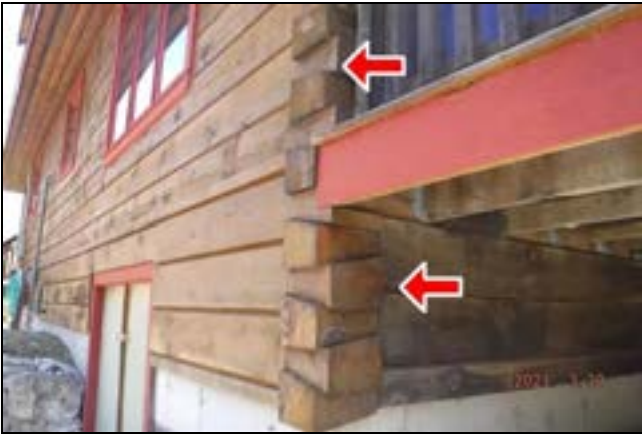
3.2 The main floor is log construction. The upper basement siding is matching wood board siding. Item 1(Picture)

3.2 Item 1(Picture) Log & wood siding

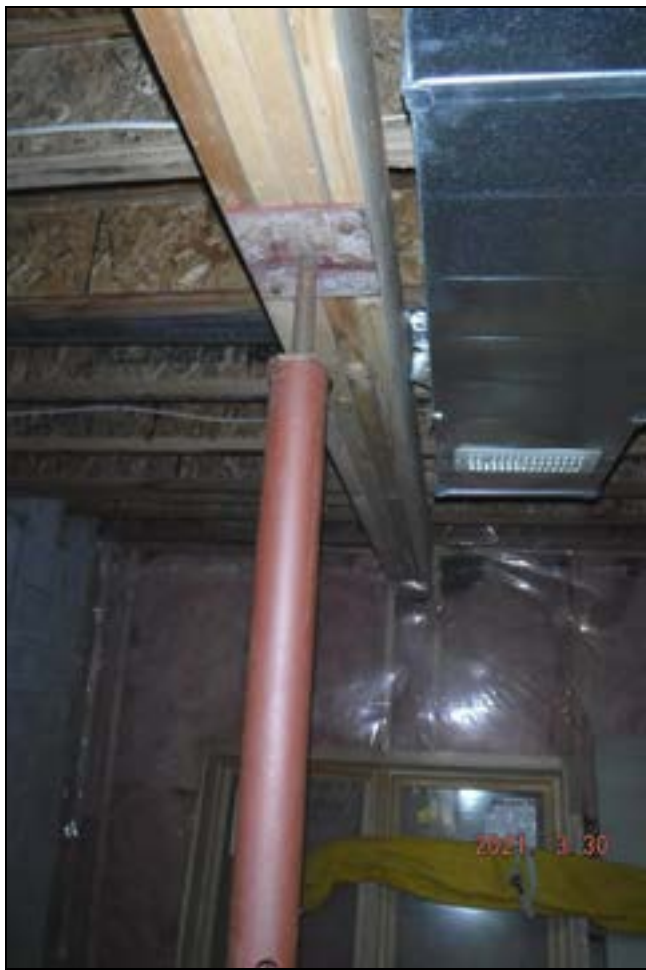
3.3 There are engineered joists flooring and a built wood center beam supported by jack posts.

3.3 Item 1(Picture) Centre beam

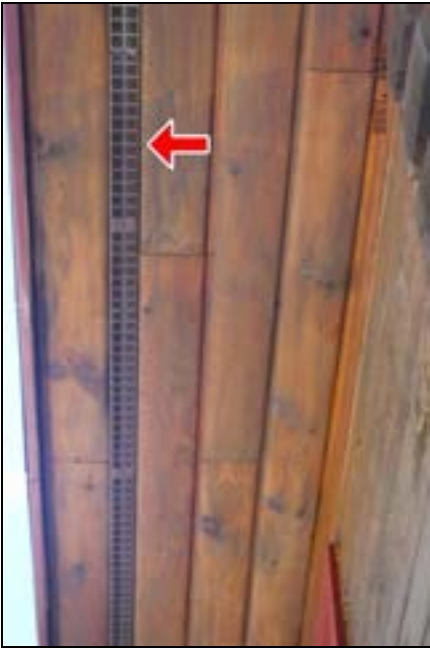
4.2 There was metal cladding soffits and fascia.

4.2 Item 1(Picture) Soffit Venting

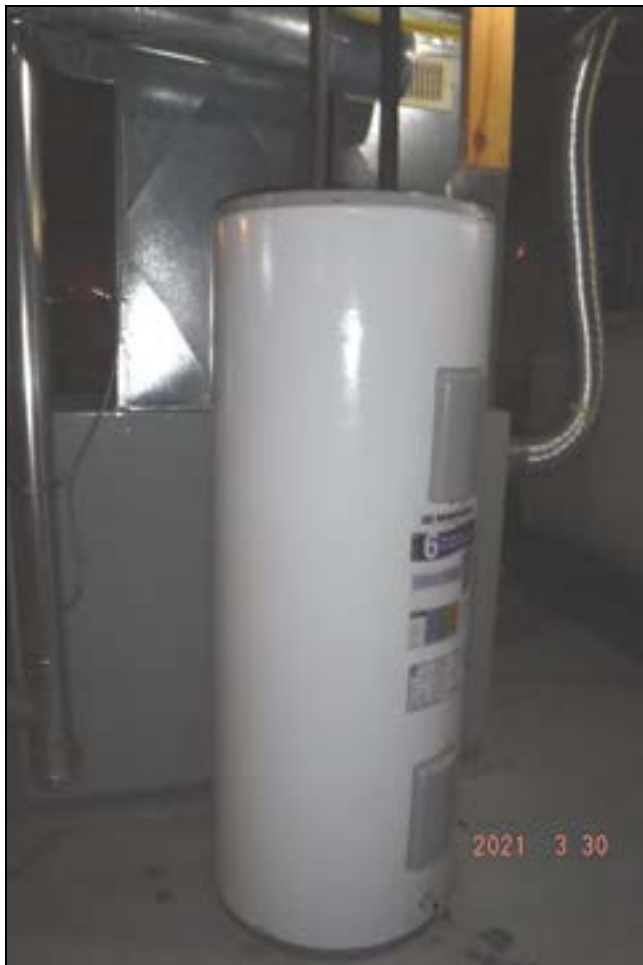
5.4 Item 1(Picture) Hot water tank

5.4 The hot water tank is a Moffat GSW Model # 6G90SDE1 Serial # S0937F705054. Add an extension to the pressure temperature release valve to 6 to 12 inches from the floor. This is a safety concern to assure that if it releases it does not release at face level.

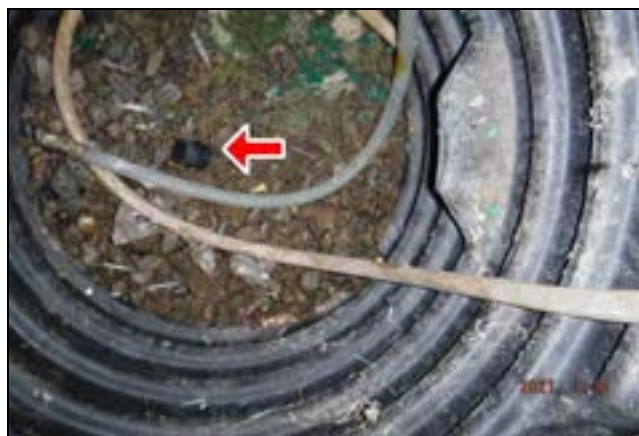
5.5 There was no sump pump in the sump pump well in the basement. Consider adding. There appeared to be a hose size hole in the bottom of the well which may be for natural drainage. Further investigation is required. There is a dehumidifier that empties into the well. The well was dry at the time of inspection. Item 2(Picture)

5.5 Item 2(Picture) Well interior

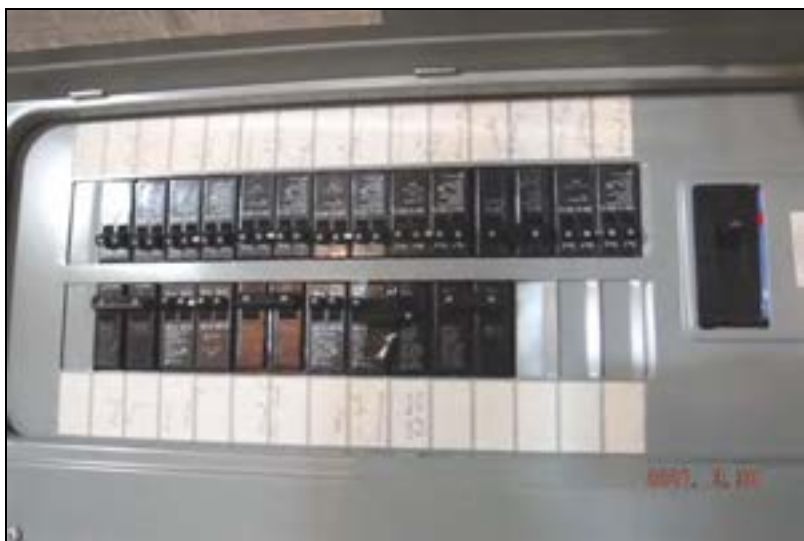
6.2 (1) Item 1(Picture) The main panel is located in the basement in the corner of the hydro entrance. It is a 200 amp service. There is a breaker of a dishwasher which is in the off position. There is no dishwasher installed in the kitchen. The breaker is off to the pony panel near the lake. This breaker and pony panel are for the lights and jet pump into the lake. This jet pump brings water to a tap near the house for exterior use i.e watering the lawn. The breaker did not appeared to be GFCI protected. It is strongly recommended that GFCI protection be added for hydro near the water/lake. Upgrading the panel at the storage cabinet by the dock is recommended for safety.

6.2 Item 1(Picture) Main Panel

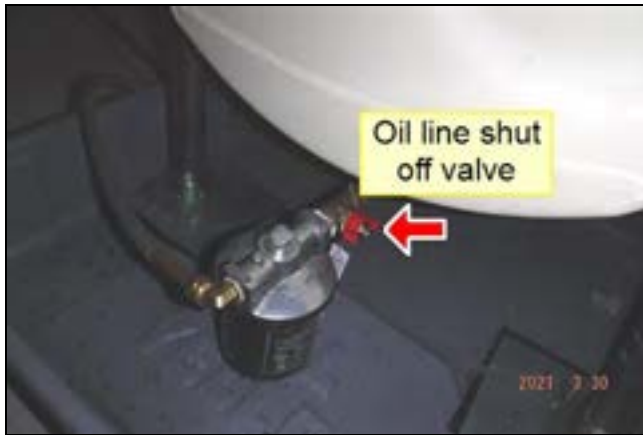
7.0 Item 7(Picture) Oil line shut off

(2) **The protective cover over the oil line is no longer continuous.** This line should be replaced with a protected sheathing for safety. Consult a professional oil technician to bring replace this line with the code approved type. **This is to help prevent oil leak if the copper is damaged.** Item 7(Picture)

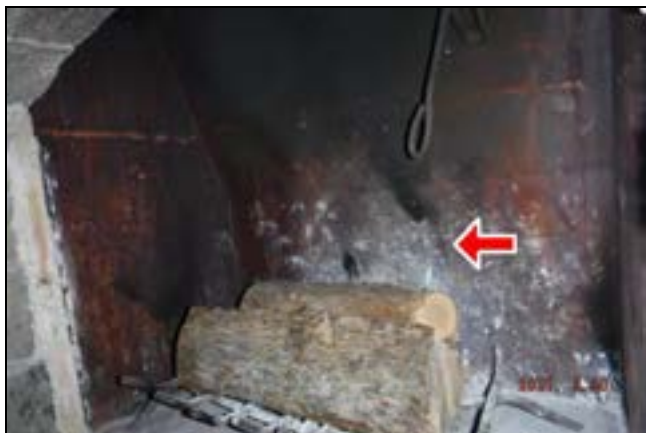
7.4 (1) There is a built in stone fireplace with heat duct. The metal is warped at the back but appears well sealed at the corners. It is recommended that the chimney be cleaned annually by a professional at the end of each heating season. **This is important to prevent chimney fires.**

7.4 Item 3(Picture) Some warping of steel

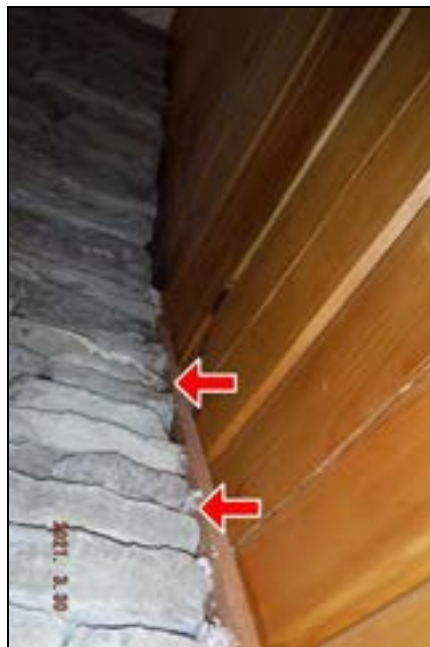
There is often a draft where the fireplace meets a back wall. It appears that insulation was used to attempt addressing a potential draft. Consult a fireplace expert on how to improve this potential draft area safely. Item 4(Picture) INSulation was visible on the hearth. Item 5(Picture)

7.4 Item 4(Picture) Insulation

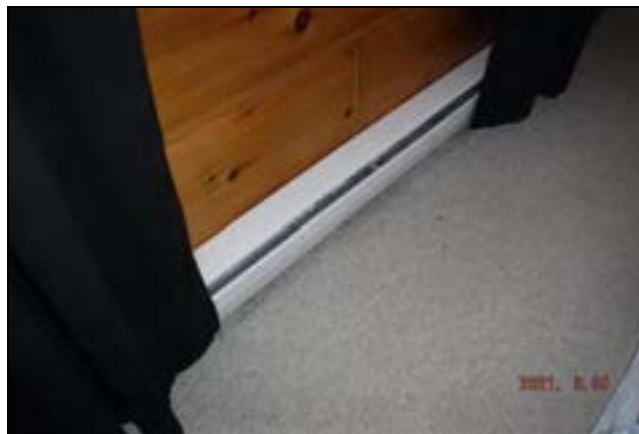
7.7 There is baseboard heating in the two second floor bedrooms and the 2nd floor bathroom. They are all in working condition. Recommend removing curtains in contact with the heating units. This is a safety concern. Also consider turning off

7.7 Item 2(Picture) Curtains at bsbd heaters

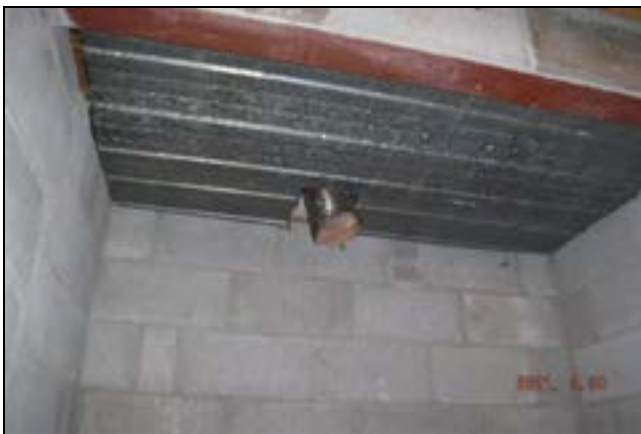
7.10 There is an option to add a heating appliance in the basement. See liner for chimney flue exposed. Item 1(Picture)

7.10 Item 1(Picture) Flue to chimney

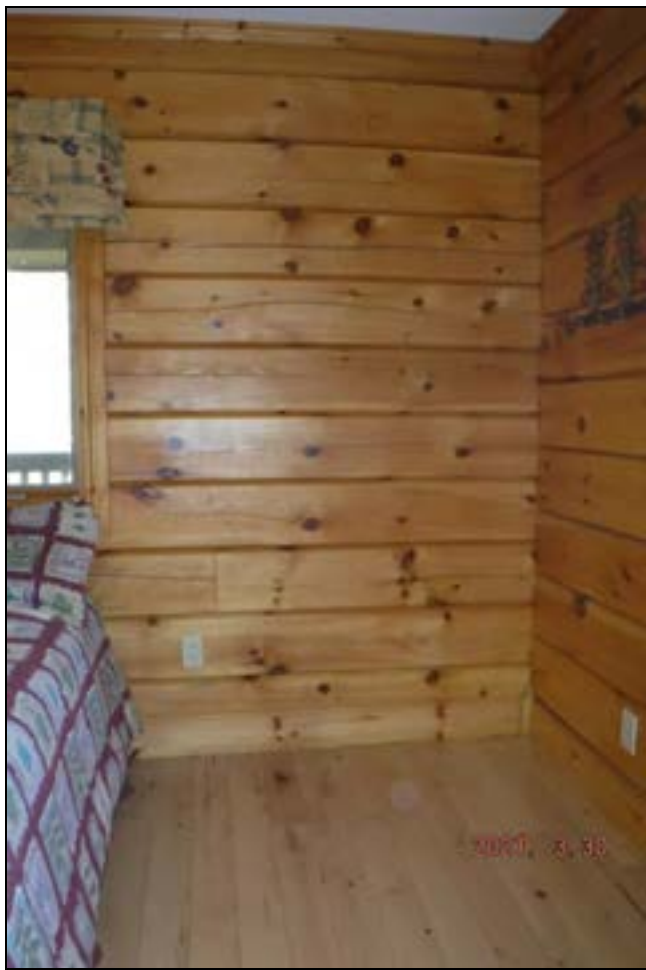
8.1 Item 1(Picture) Log Walls

8.1 There are log walls on the main floor and drywalled walls in other areas. The basement is insulated with R 12 fibreglass and vapour barrier but not finished.

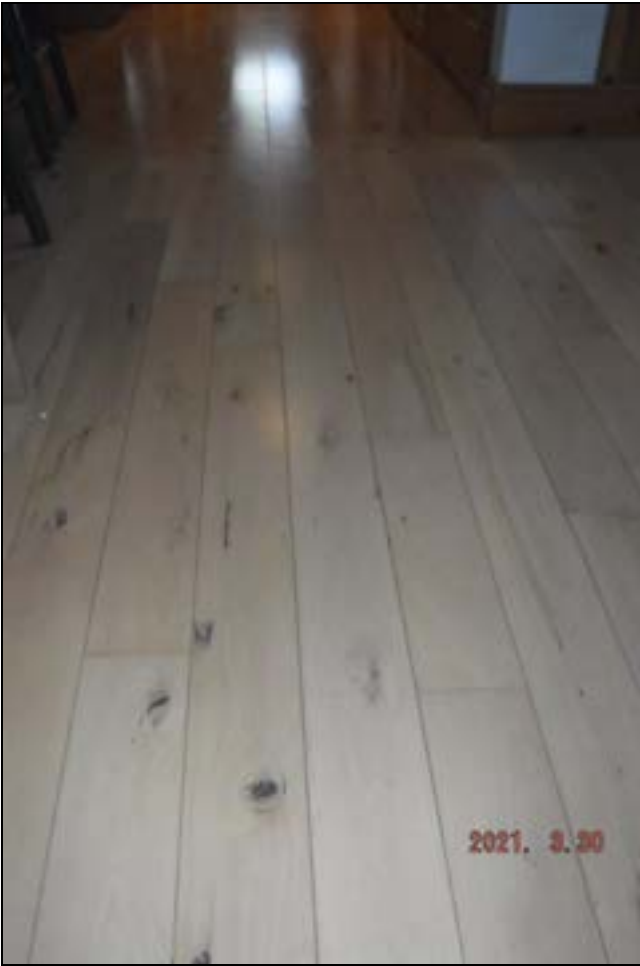
8.2 Item 1(Picture) Floating floor Main level

8.2 The flooring is a wood looking floating floor on the main level and carpeted on the second floor.

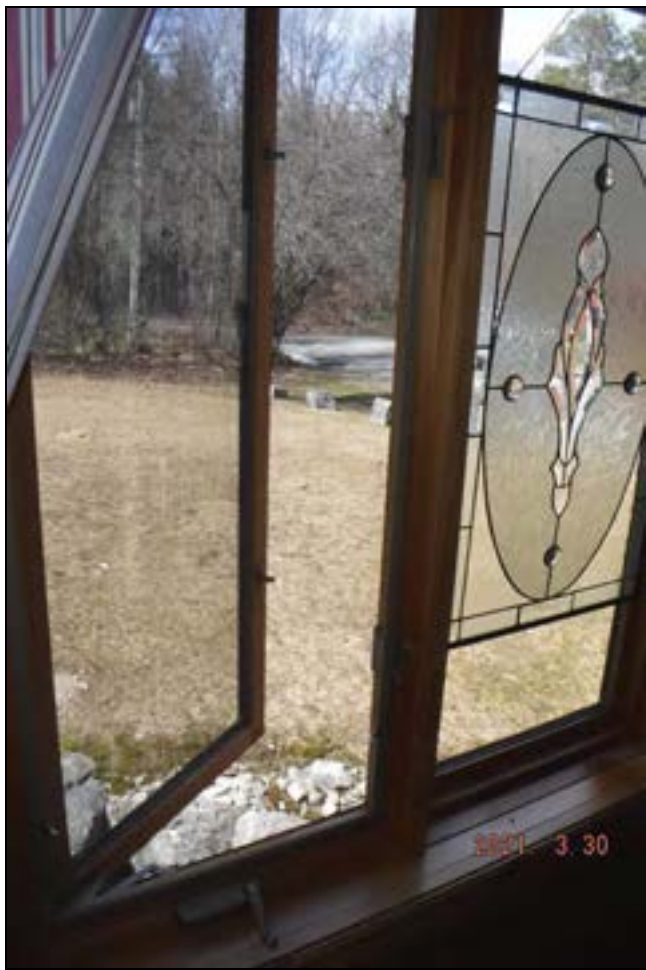
8.6 Item 1(Picture) Hinged double pane

8.6 (1) Windows tested were all in working condition. One window on the second floor living area was missing a screen. Item 1(Picture)

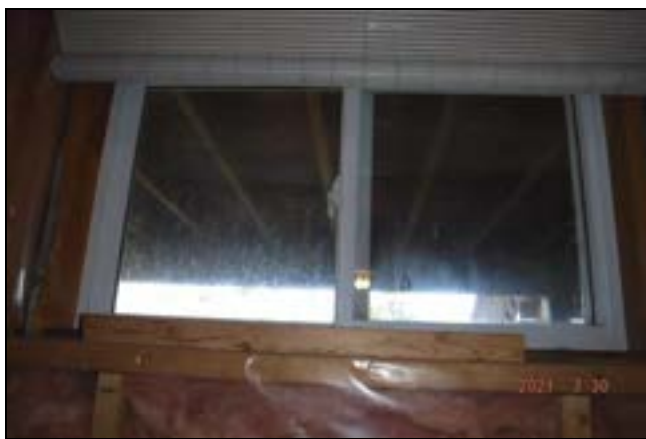
8.6 Item 2(Picture) Basement window

(2) There are vinyl sliding windows in the basement.

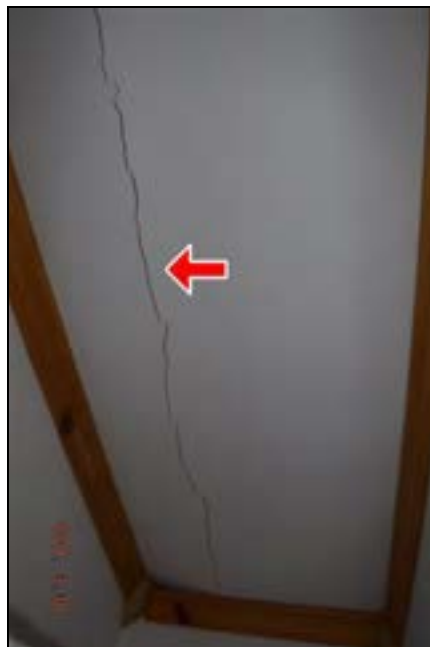
8.7 Item 4(Picture) Bedroom closet

(3) There was a crack in the drywall ceiling in the main floor bedroom closet. The cause was not determined. There did not appear to be a continuation of the crack in any other areas.

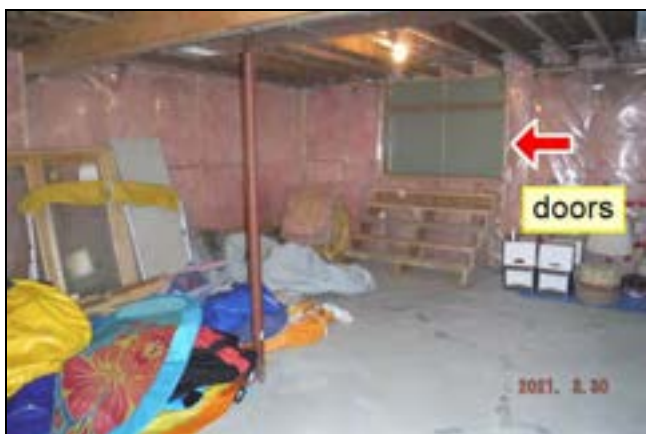
8.7 Item 5(Picture) Basement view.

(4) The basement wall was not visible from the interior. It is insulated with fibreglass insulation and a vapour barrier.

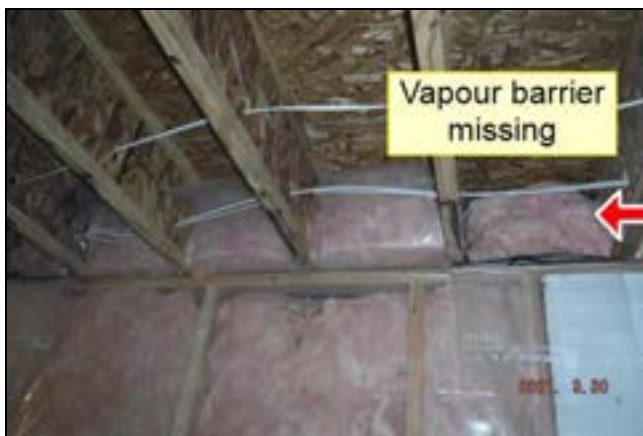
9.0 Item 1(Picture) Insulation of basement

9.0 The header areas of the basement are insulated with fibreglass batt. The vapour barrier requires continuation and sealing. See Keeping the Heat In booklet, available online for information in insulation of header areas.

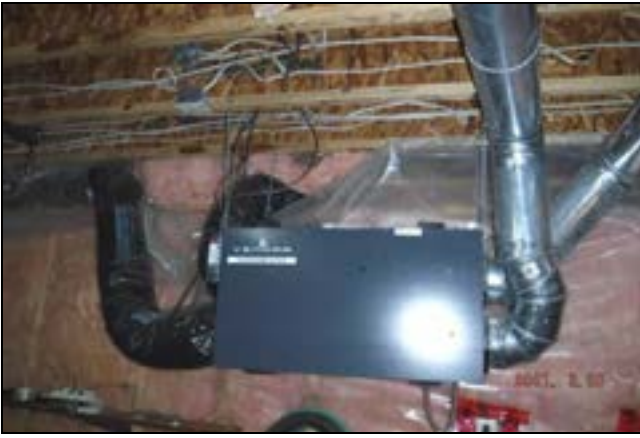
9.2 Item 1(Picture) Venmar Constructo

9.2 There is a heat recovery ventilator (HRV) for energy savings and air quality. This should be cleaned on a regular basis as required. See manufactures instructions for maintenance. Item 2(Picture) Item 3(Picture) Item 4(Picture)

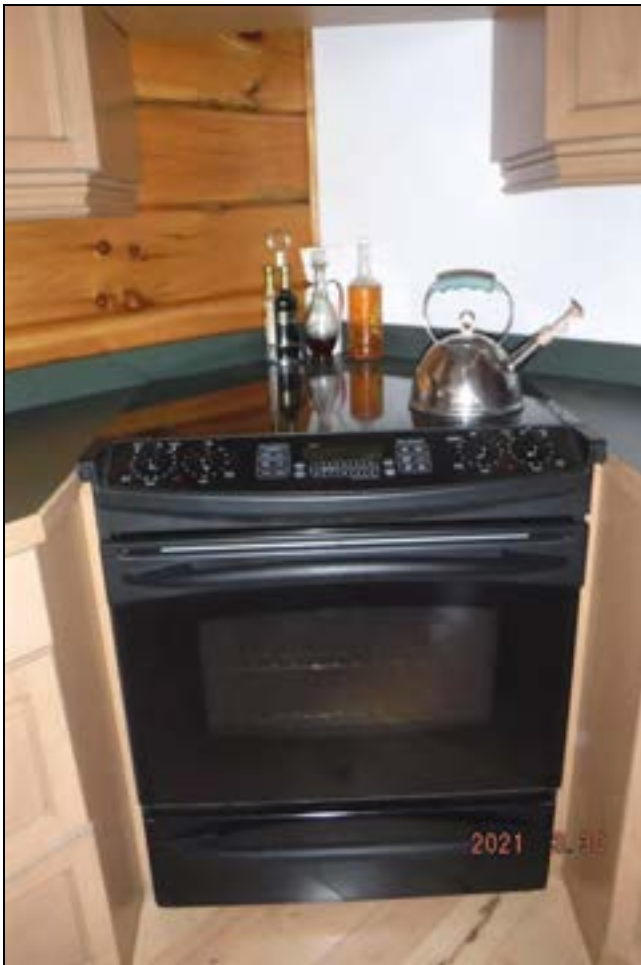
10.0 Item 1(Picture) Corner stove

10.0 The STove is a GE Profile. The burners are in working condition. The oven is clean.

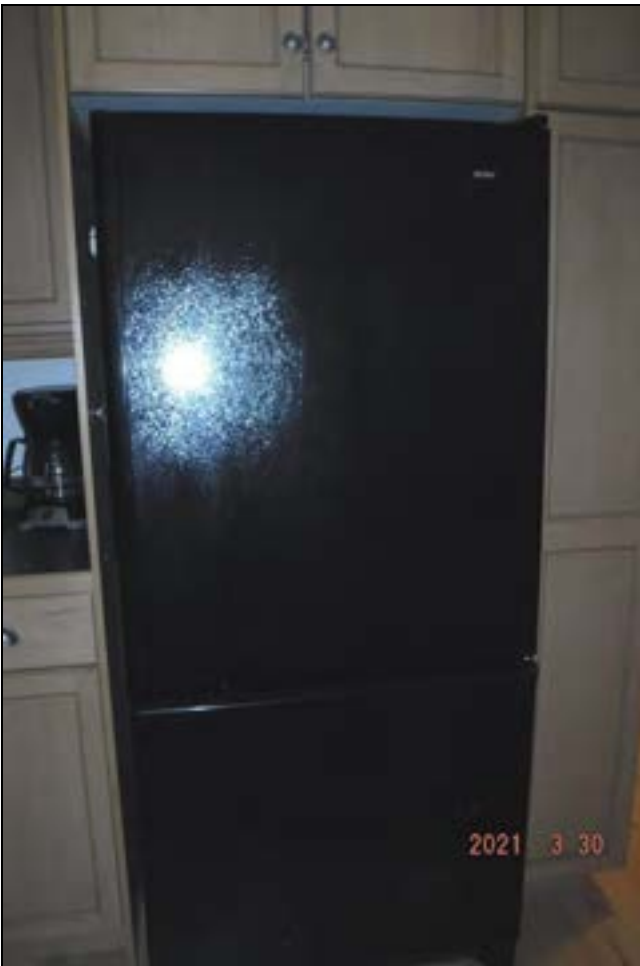
10.1 Item 1(Picture) Refrigerator

10.1 The Kenmore refrigerator has a pull out freezer below. It was operating and cold but no items were in the refrigerator or freezer. Recommend adding Kawartha Dairy Ice Cream. The model number is M569.71819101 and Serial # 11158303AC.

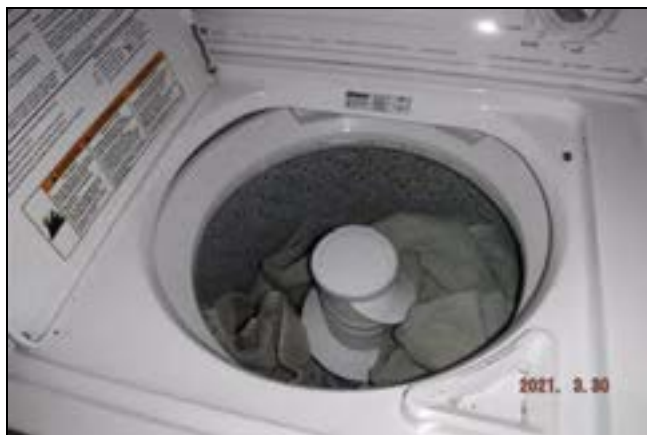
11.0 Item 1(Picture) Washer.

11.0 The washer and dryer is located on the main floor in the bathroom area. The washer was not tested. There were clothes in it indicating it was used regularly. The model number is 22722101 and the serial number is CM1279052.

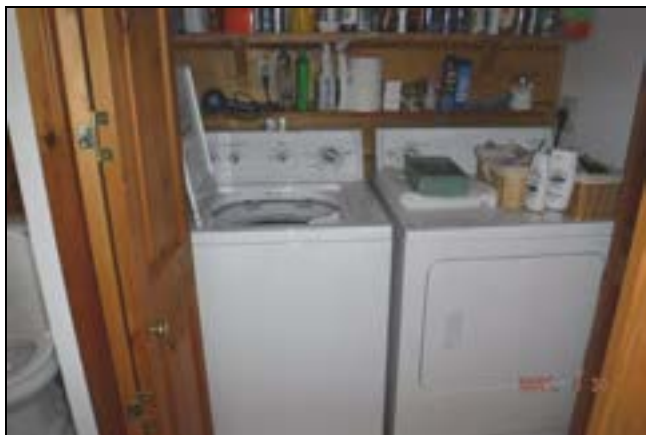
11.1 Item 1(Picture) Washer and Dryer

11.1 The dryer was tested. The drum turning was noisy. The model number is 110C62832101 and serial number MM2303363.
