AE Home Inspection Services

Inspection Report

1070 Sunrise Dr

Inspected on Mon, May 3 2021 at 2:30 PM

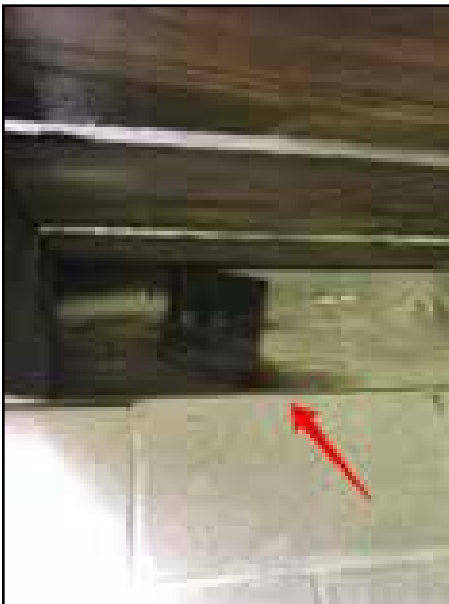
Figure 1-3

Main entry to home is in good overall condition. Elevated wooden deck at entry is aging but in working condition.

Support posts rest on concrete pads, ledger lagged to building.

recommend refinishing wood with a good exterior paint to help protect the wood and prolong the life of the deck.

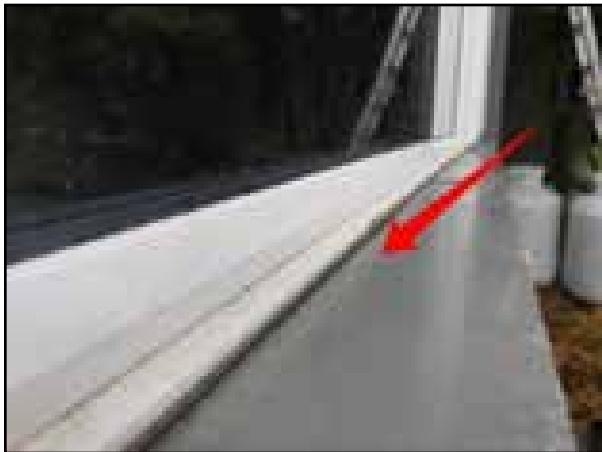
Figure 2-3

Windows on the home are in good overall condition. No signs of damage to seals.

Sill a long bottom of large front window lean slightly backwards towards the home. Recommend annual inspection of caulking to ensure moisture does not get into the home. Reseal as required.

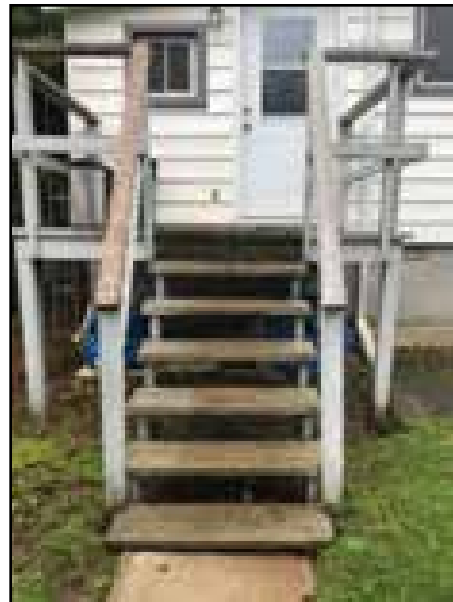
Figure 4-2

One of the support posts is angled on concrete pad. Recommend re-leveling concrete pad to ensure stability.

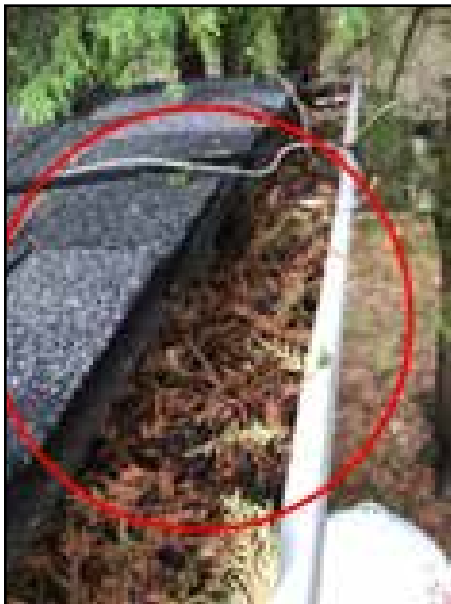
Figure 8-3

Gutters on the home are in good overall condition. Minor amounts of debris remaining in trough, recommending routine cleaning.

Large amounts of debris remains in trough under trees at right hand side of home. Recommending cleaning to maintain water flow.

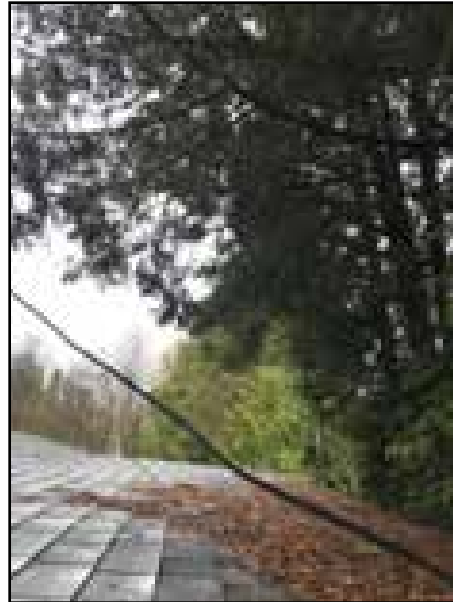
Figure 9-2

Low slope roofing along right hand side of home has some tree debris.
Recommend cleaning to protect the life of the shingles.

Recommend trimming of cedar trees along the side of roof to limit the amount of branches making contact with home.

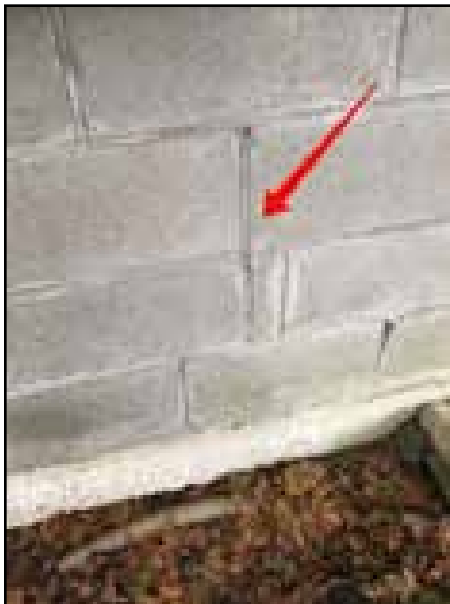
Figure 11-3

Concrete block foundation around the property is in good condition. No signs of any major structural issues.

Common settling cracks can be seen in mortar joints, recommend resealing as needed.

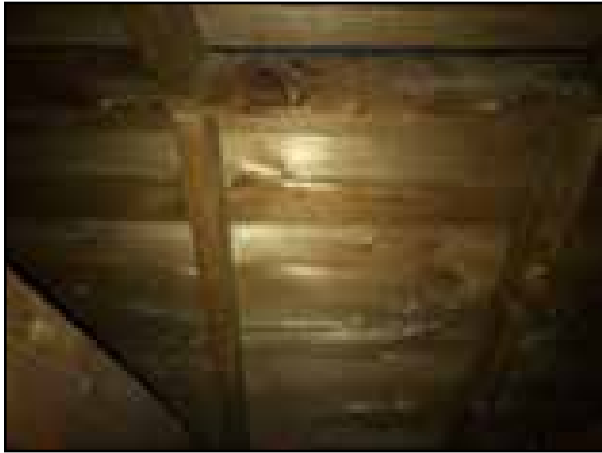
Figure 13-1

Roofing structure is in good condition at the time of the inspection. No signs of structural issues could be seen.

No signs of moisture issues or discoloration.

No signs of mold or mildew at the time of the inspection.

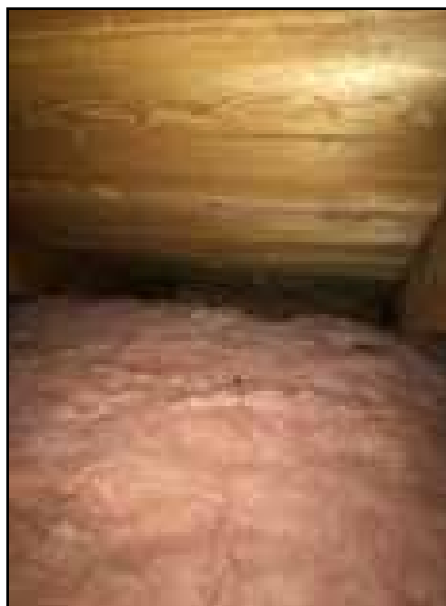
Figure 15-2

Recommend pulling fibreglass insulation back from the soffit area to improve airflow.

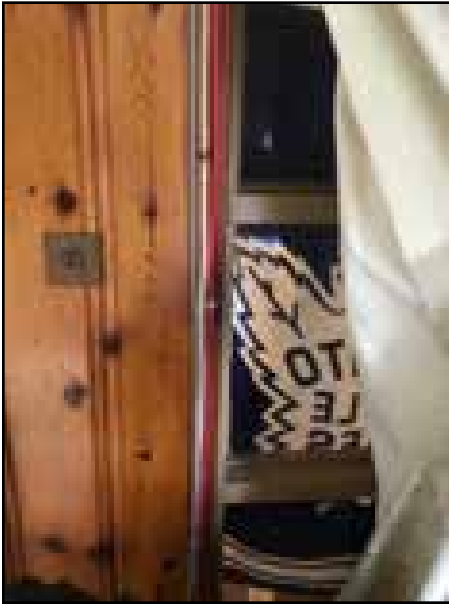
Figure 20-1

Comment 20:
Electrical wires running along living room wall should be encased in a conduit as they travel more than 24" exposed.

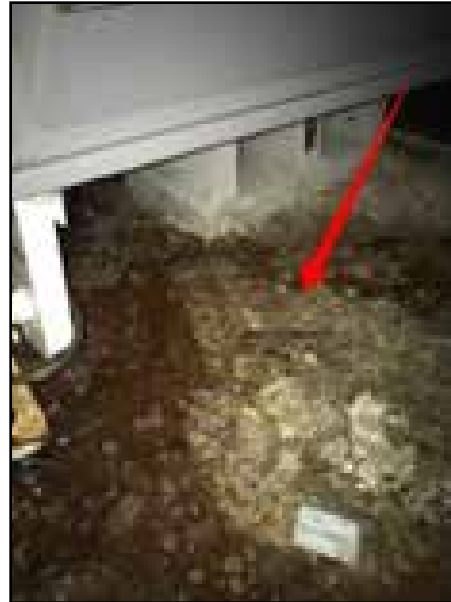
Figure 24-2

Condenser pump located below furnace appears to be in operable. Reservoir has filled and is leaking in crawlspace. Recommend replacing.

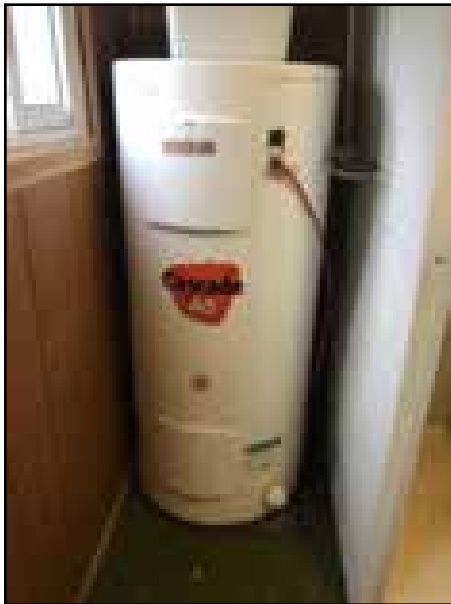
Figure 26-1

Although the hot water tank appears to be in working order replacing with a new or updated unit would increase efficiency.

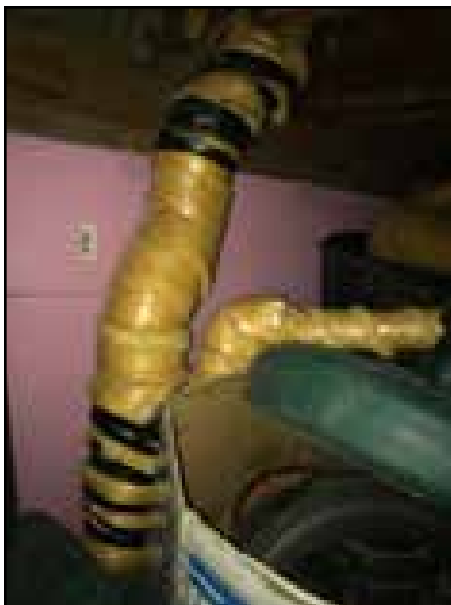
Figure 27-1

Drain to septic in crawlspace has been covered with insulation. This is a good way to help prevent any pipes from freezing during the winter months.

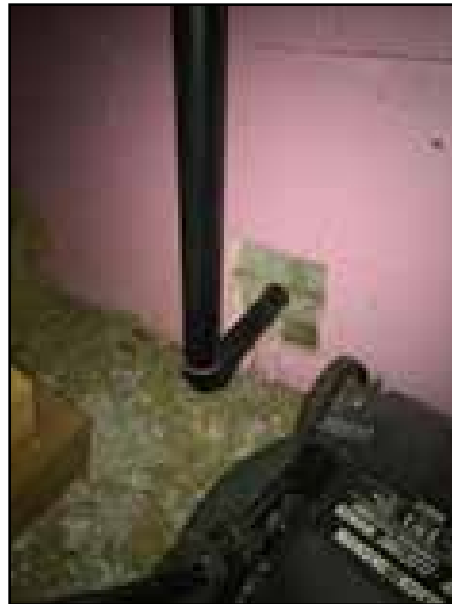
Figure 29-2

This drain should also be tied into the septic system. Recommend plumber repairs.

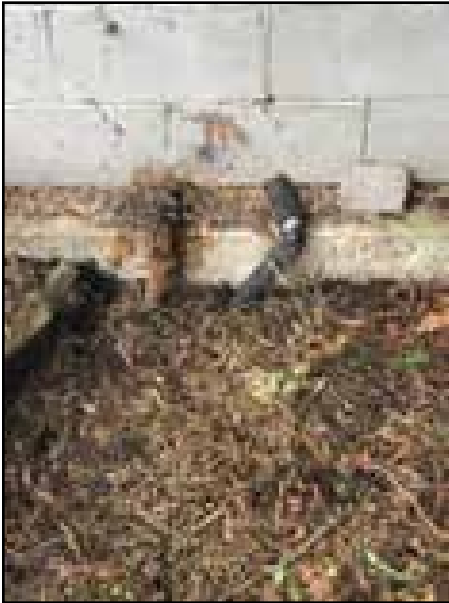
Figure 31-1

Well pipes located along front right corner of home are exposed to the exterior elements. Heat lines are a good idea to help her vent water intake lines from freezing during winter months.
