Inspection Report

Property Address:
30 Matheson Road
Woodville/Bolsover Ontario K0M2T0

Know Your Home Inspections Inc.

Date: 4/5/2021	Time: 02:00 PM	Report ID: 04-05-21
Property: 30 Matheson Road Woodville/Bolsover Ontario K0M2T0	Customer: Ron Young Joan Young	Real Estate Professional: David Donais Kawartha Waterfront Realty

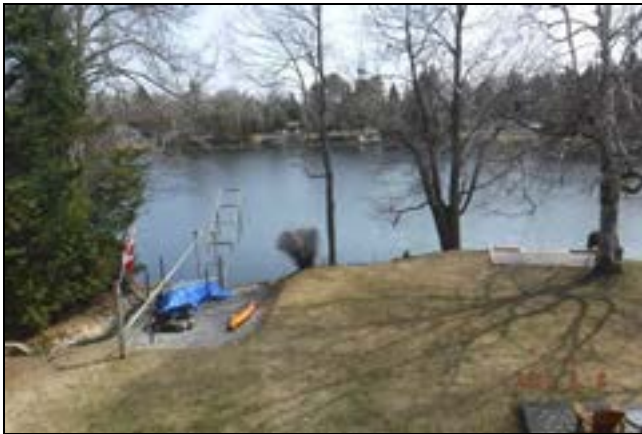
1.0 There is a low slope of the lot towards the water. There is a gradual decline at the location of the boat docking system and at the other corner of the lot. Item 1(Picture)

1.0 Item 1(Picture) Low slope to water

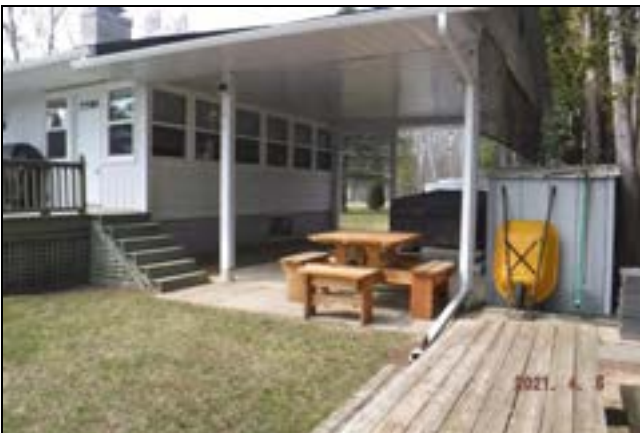
1.5 There is a carport attached to the house. It is supported by wood beams. The roof structure was not visible as the ceiling has a clad finish. Item 1(Picture)

1.5 Item 1(Picture) Carport

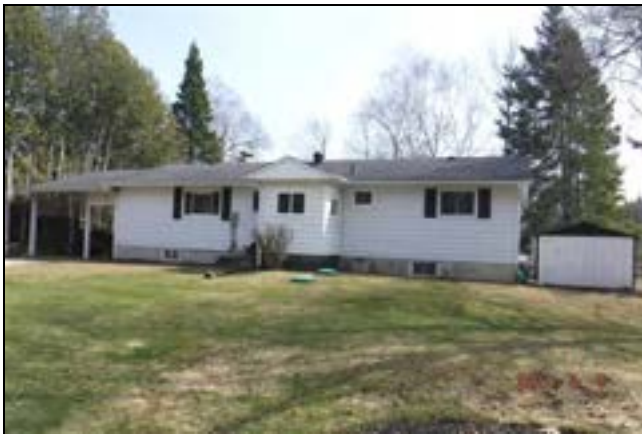
2.0 The siding is aluminum.

2.0 Item 1(Picture) View from Road Side

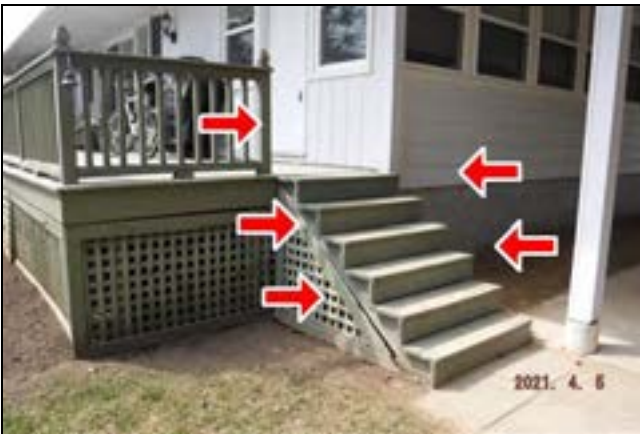
2.4 Item 1(Picture) Add Railings

2.4 (1) Add railings to the stairs at the front concrete porch entrance, the each set of stairs to the back deck. This is a safety concern. Item 1(Picture) Item 2(Picture) Item 3(Picture)

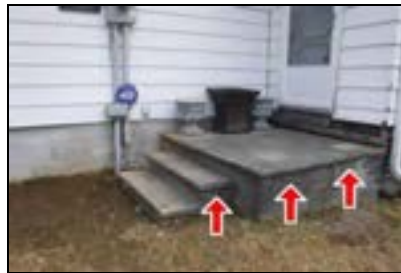
2.4 Item 2(Picture) Add railing

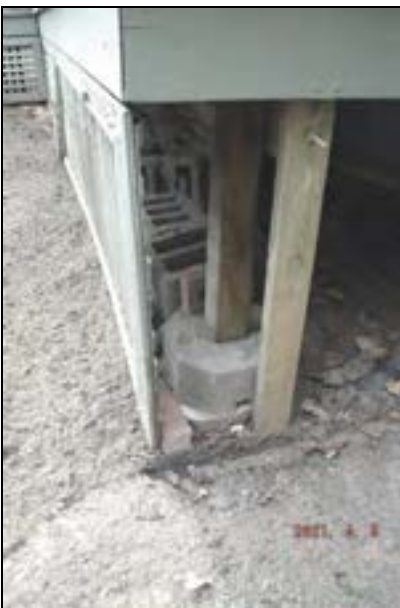
2.4 Item 3(Picture) Deck structure

(2) The railing on the deck is not 42 inches high for safety. Newer deck railings would be installed at 42 inches high to prevent adults from falling over. It is well secured to the deck. It is made out of wood and requires regular maintenance. Item 3 (Picture)

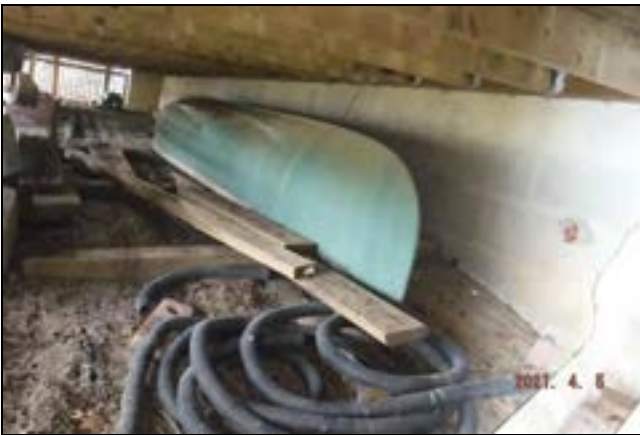
(3) The deck is secured to the house with proper lag bolt attachments. The deck hangers are properly installed.

2.4 Item 6(Picture) Under deck

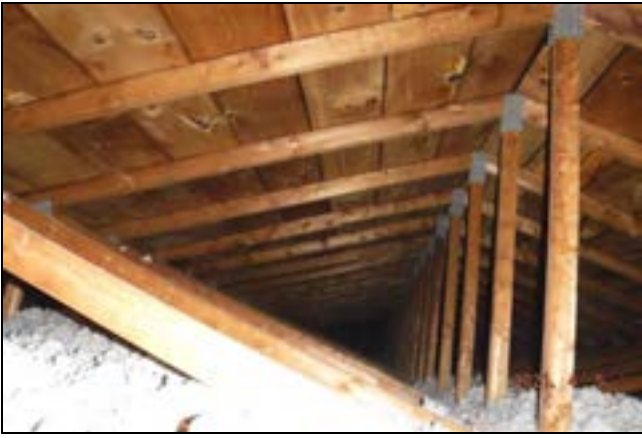
3.5 The attic is engineered trusses and Board sheathing.

3.5 Item 1(Picture) Attic view

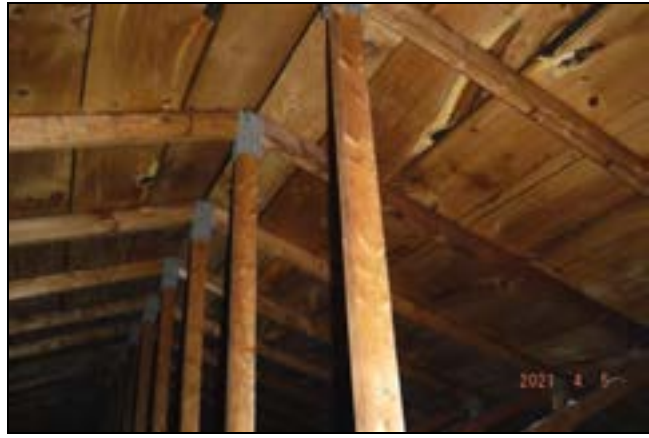
3.5 Item 2(Picture) Attic view

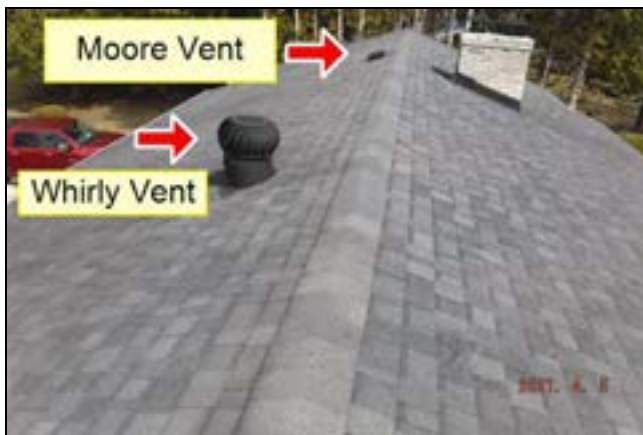
4.0 Item 1(Picture) Roof view

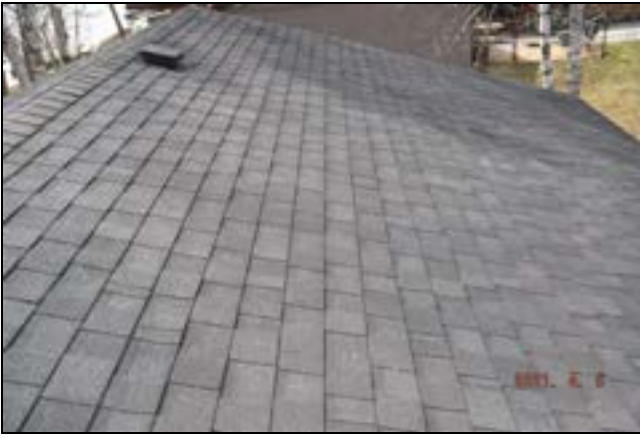
4.0 Item 5(Picture) Roofing

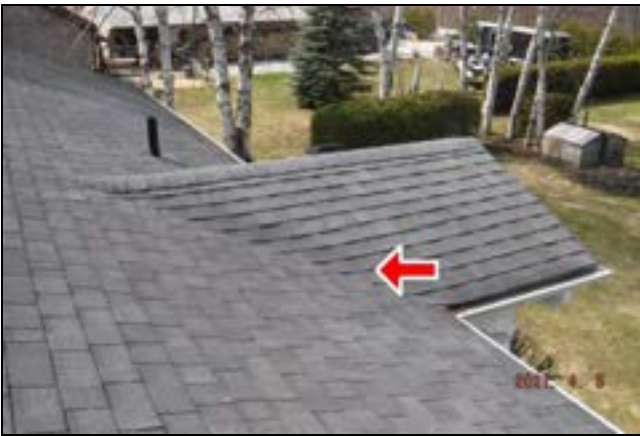
4.1 There are roof valleys at the enclosed porch area. OK Item 1(Picture) .

4.1 Item 1(Picture) Closed valley sytem

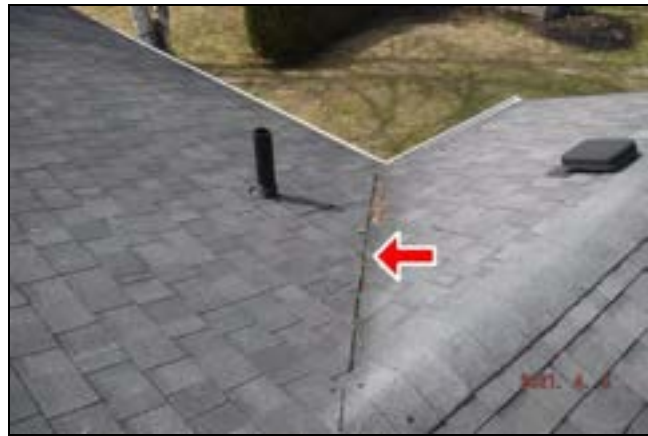
4.1 Item 2(Picture) Closed valley

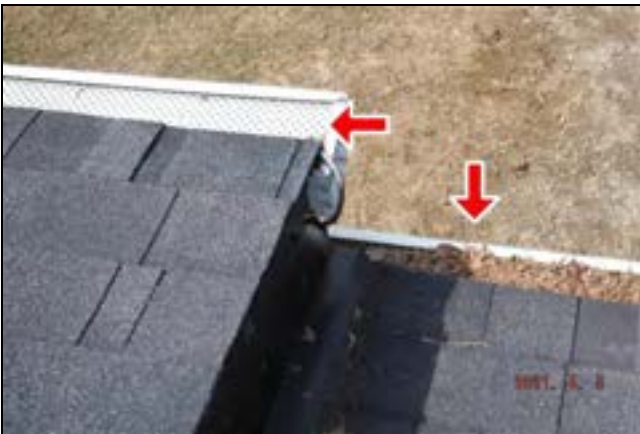
(2) The house has a system to prevent leaves from gathering in the eaves troughs. There are no leaves preventing water from flowing through the house eaves troughs. The carport does not have eaves trough system to prevent leaves from blocking. Clean leaves out of the eaves trough above the carport. Item 2(Picture)

4.3 Item 2(Picture) Eaves troughs

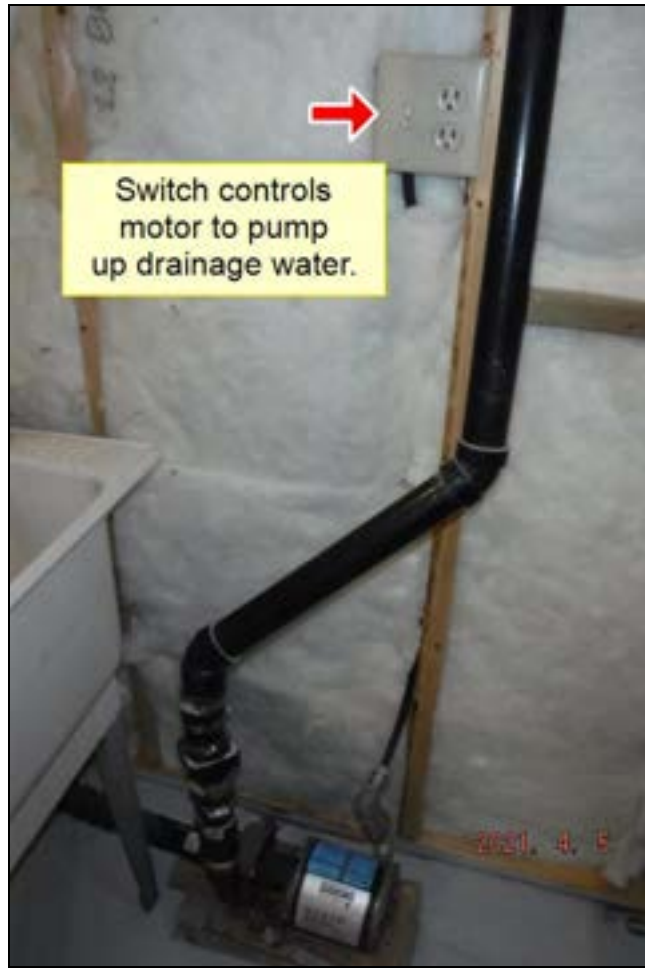
(3) Laundry tub is in the basement. Item 5(Picture)

5.0 Item 5(Picture) Manual pump up

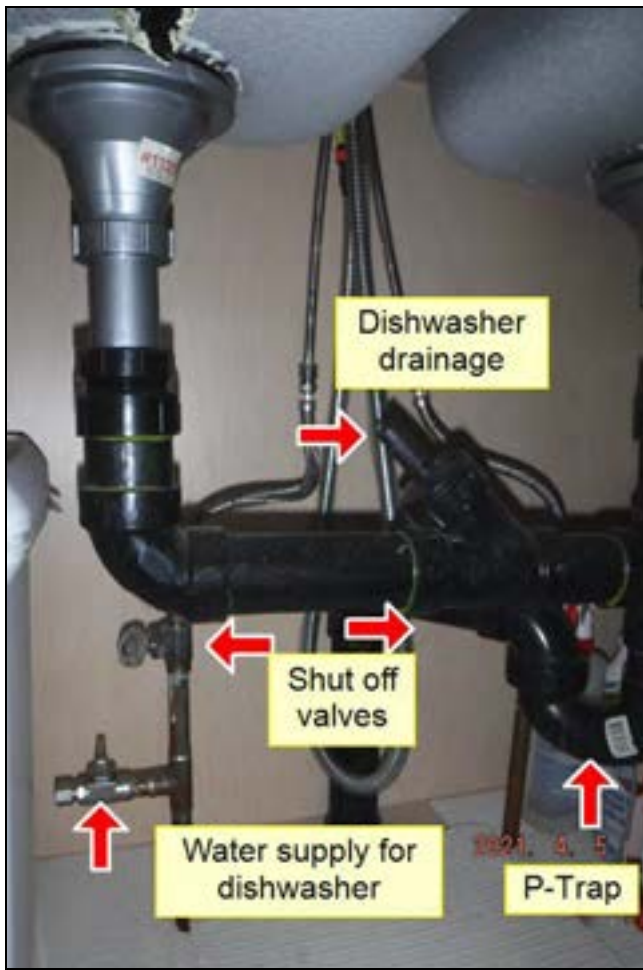
(4) The plumbing under the kitchen sink is in working condition. Item 6(Picture)

5.0 Item 6(Picture) Under kitchen sink

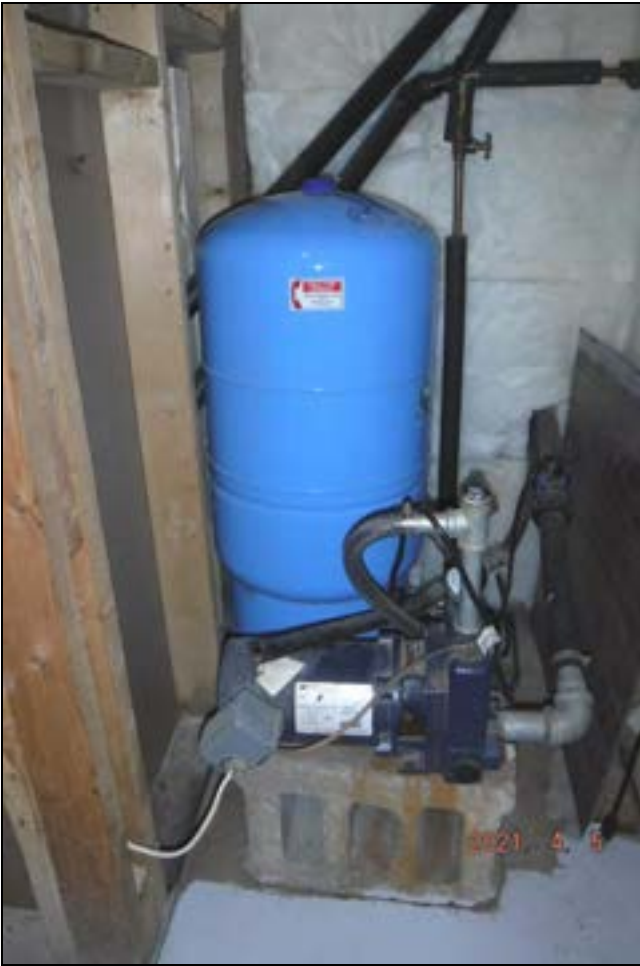
5.1 Item 1(Picture) Water entrance

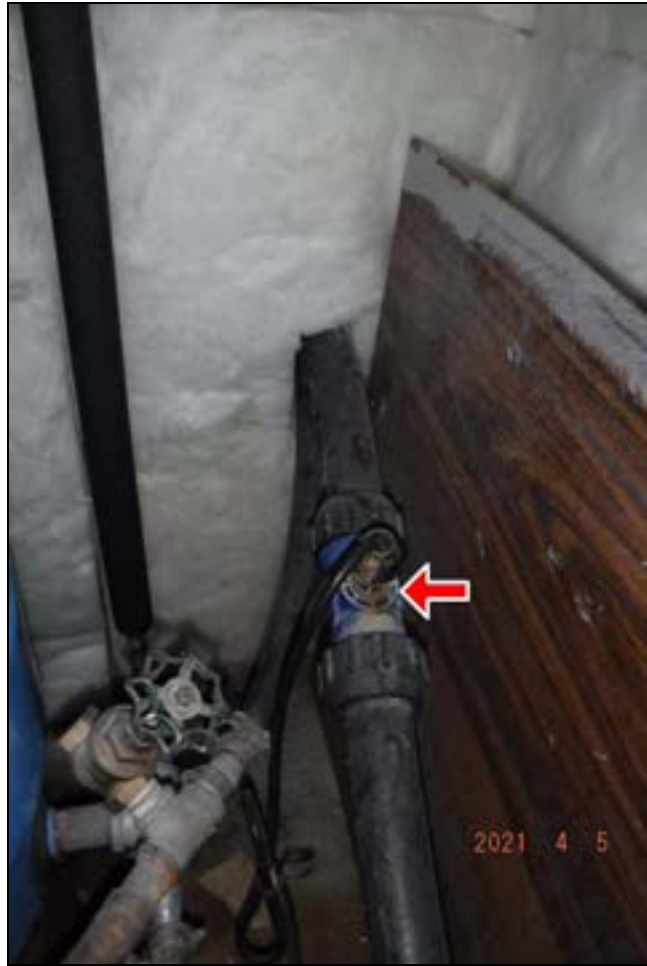
5.1 Item 2(Picture) Heat line

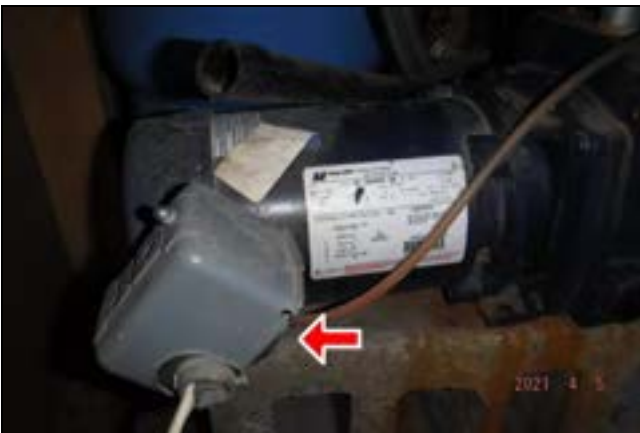
5.1 Item 3(Picture) Relay switch

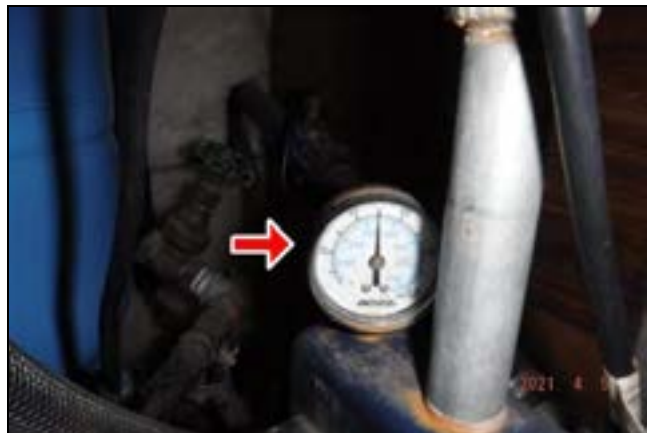
5.1 (1) The water supply is from the river/lake. There is a heat line to prevent the supply water from freezing in the winter. There is a relay switch to set the water pressure. This should be done by a qualified plumber or electrician. This regulates at what water pressure the pump will call for more water and increase the pressure supplied by the blue pressure tank. This is a typical rural water intake system where there is no municipal water service. The pressure gauge will go up and down as the water is used. Item 4(Picture) The pressure tank identifies a local company, Kelsey's plumbing.

5.1 Item 4(Picture) Pressure gauge

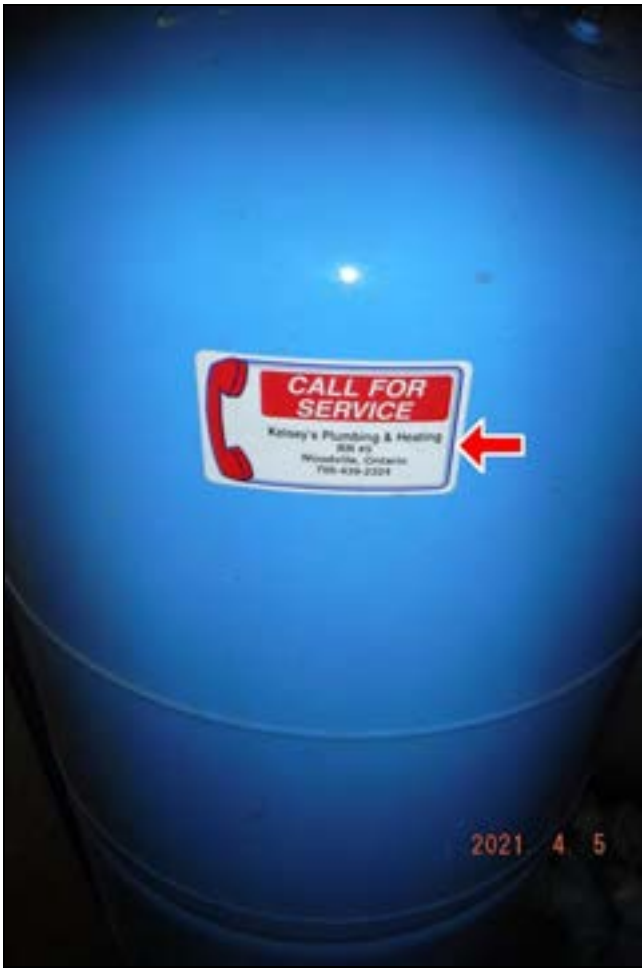
5.1 Item 5(Picture) Pressure tank

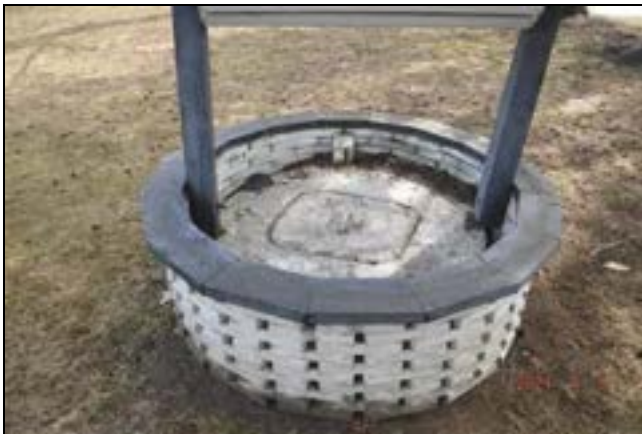
(2) There is a dug well. It was reported that the well is no longer used as water is pulled from the river now. Consider removing it if it is not going to be used in the future.

5.1 Item 6(Picture) Dug well.

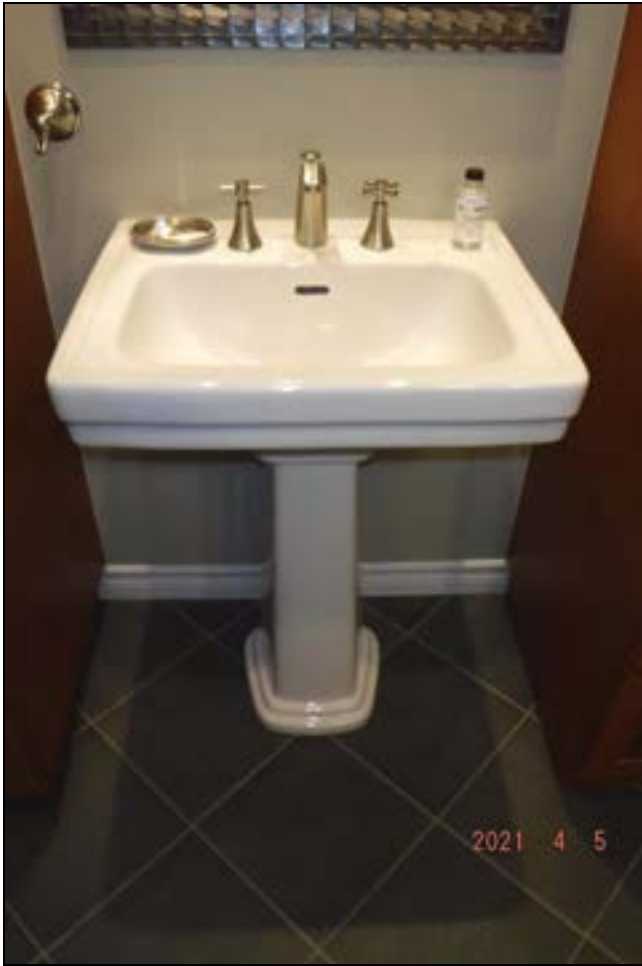
5.3 Water appliances had stop valves.

5.3 Item 1(Picture) Bathroom sink

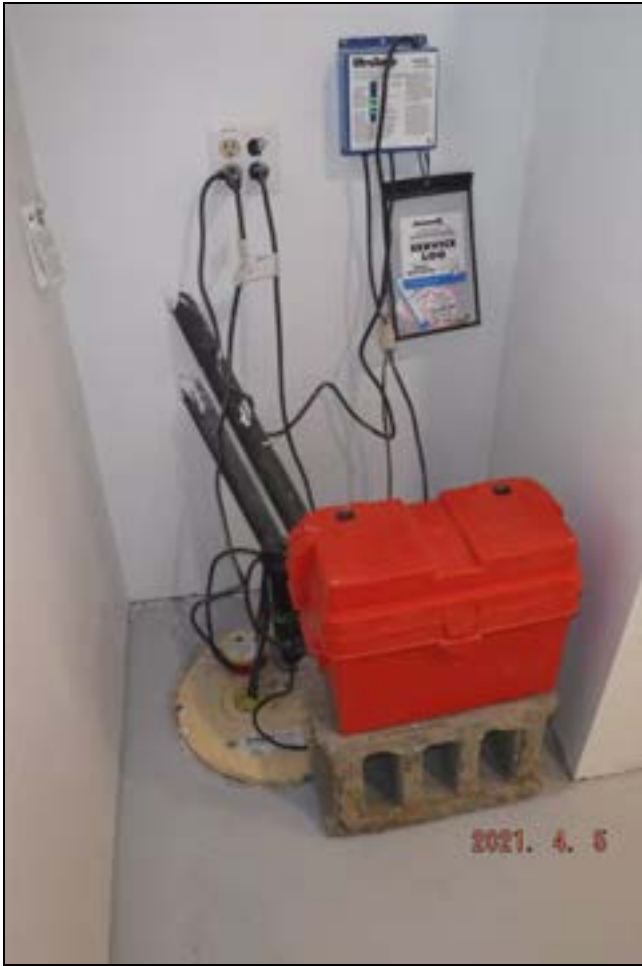
5.5 (1) There is a Clark installed system around the full foundation to keep the basement dry through all seasons. There are two sump pump wells that collect water from drainage under the flooring perimeters and direct it away from the house to the water's edge and off to lower ground at the side of the house. The system has alarms and is backed up by batteries in case of a power outage. This system is effective in areas near water with high water tables. It was installed by Clark's Basements. There is a clean out location if needed.

5.5 Item 1(Picture) Sump pump-Battery-Alarm

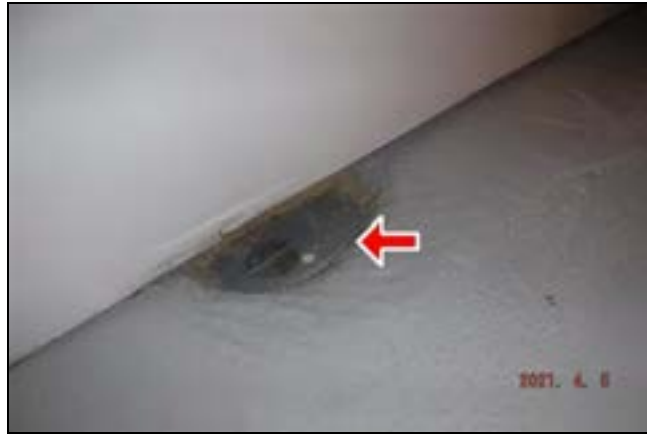
5.5 Item 2(Picture) Clean out location

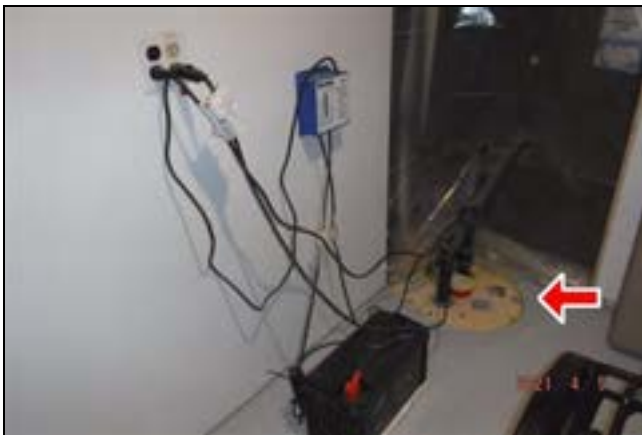
5.5 Item 3(Picture) Sumppump-alarm-battery

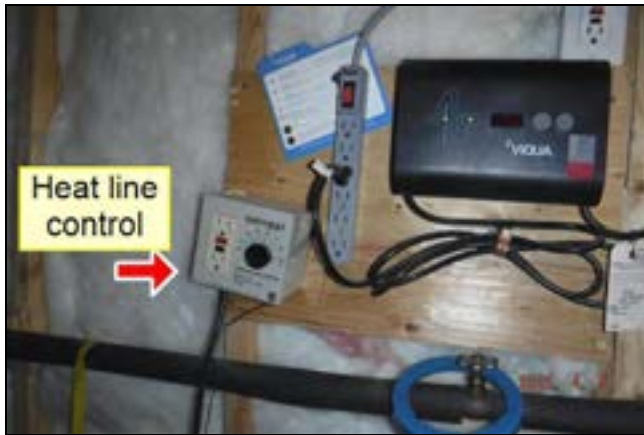
5.5 Item 4(Picture) Water system support

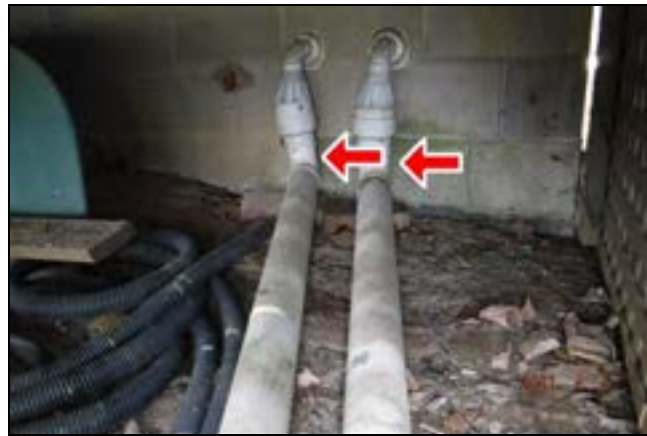
(3) There is a whole house water system. Consult the manufacturer or a plumbing on how to maintain the system. There are also good youtube videos on how to manage the system. This is a common system to assure good safe drinking water in rural areas. Item 6(Picture)

5.5 Item 6(Picture) Drainage to lake

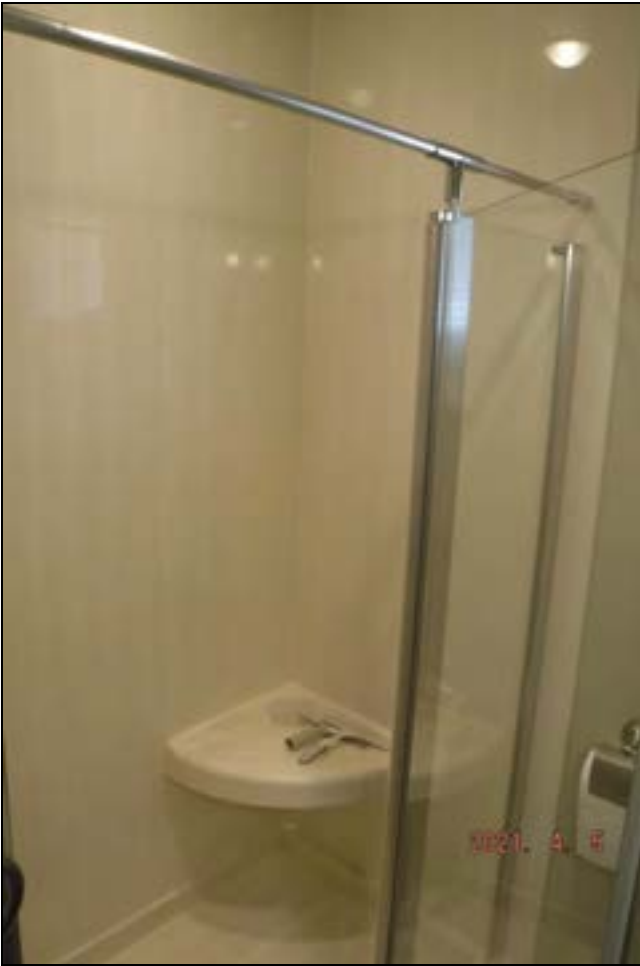
5.6 Item 1(Picture) Shower with seat

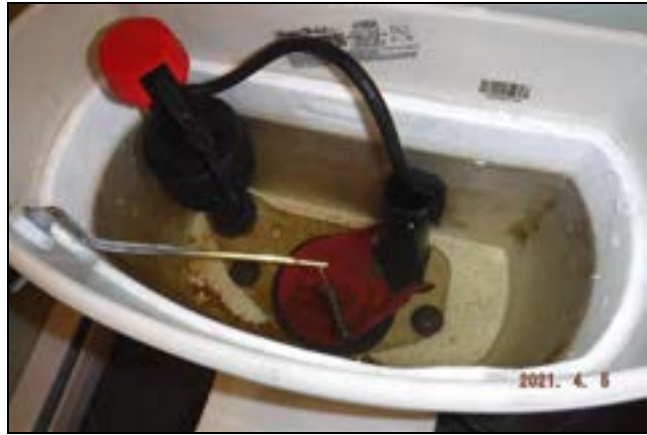
5.6 Item 2(Picture) Toilet tank

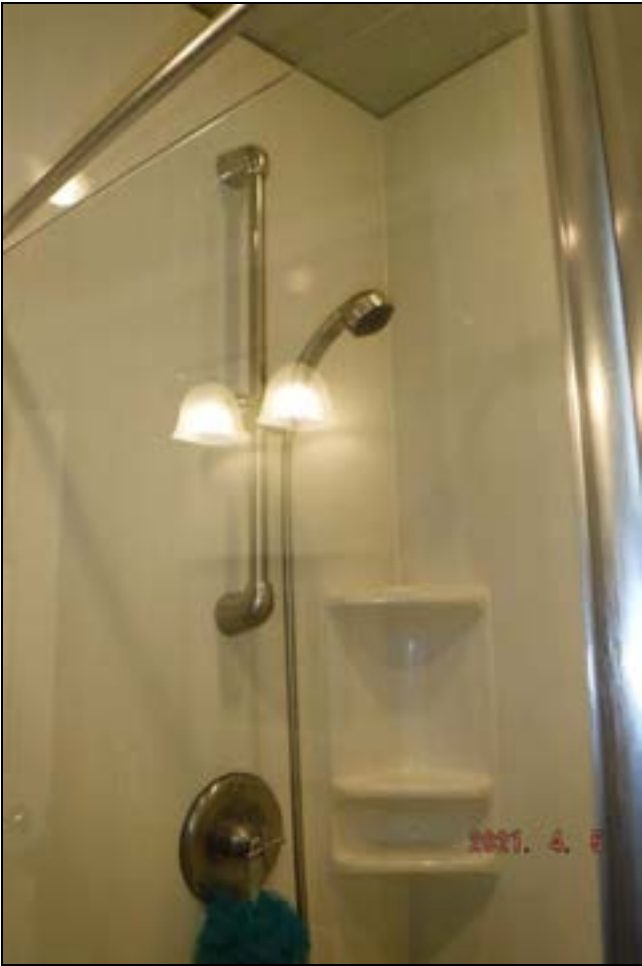
5.6 Item 3(Picture) Shower view.

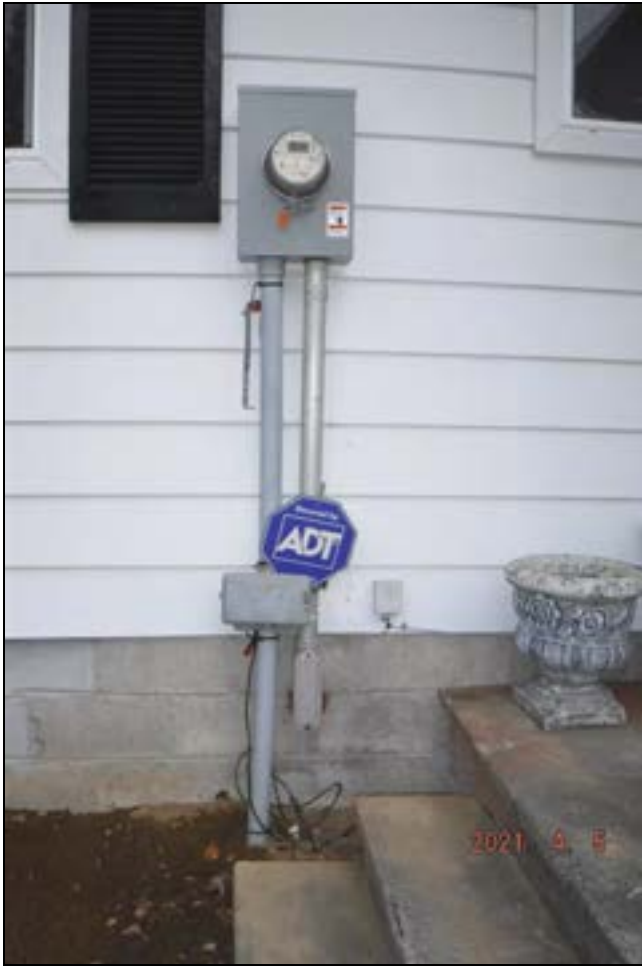
6.0 The hydro line and bell line service are underground. Item 1(Picture)

6.0 Item 1(Picture) Service entrance

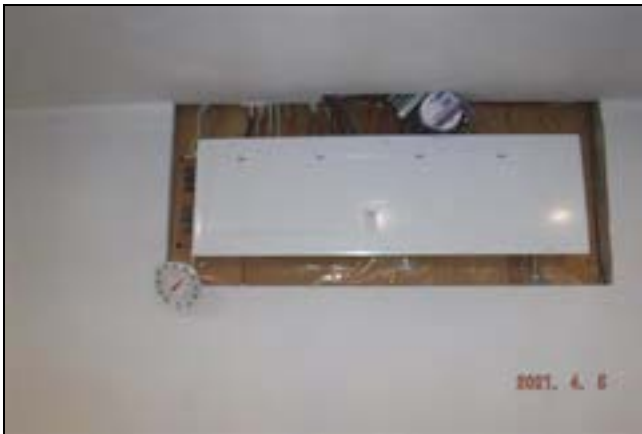
6.2 The main panel is located in the basement. The main shut off for the full house is on the right. It is a 200 amp service. Item 2(Picture) All breakers were on and working except the washer and dryer as these appliances are not installed.

6.2 Item 1(Picture) Hydro panel

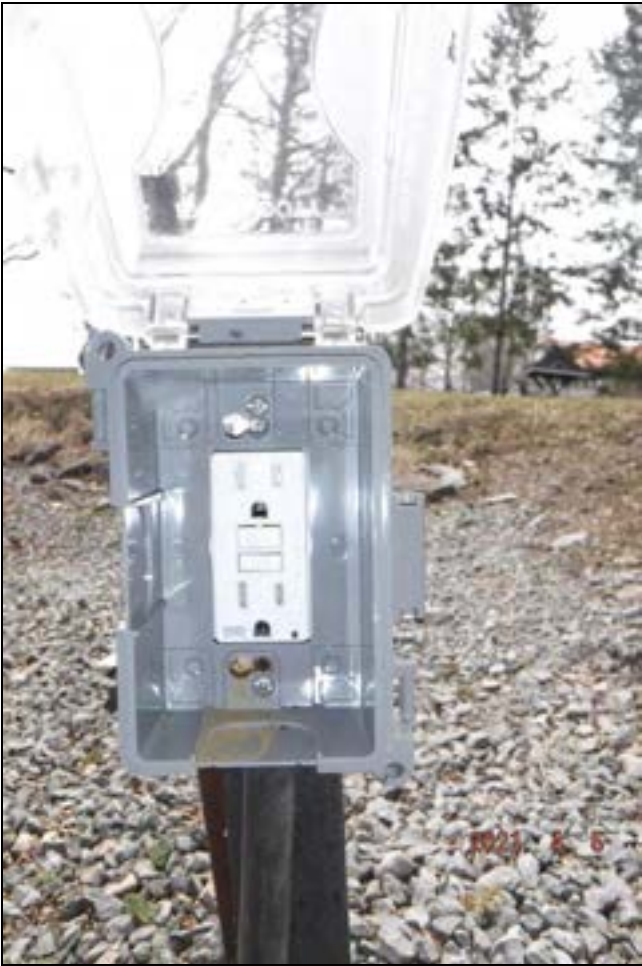
6.8 There is a GFCI protected receptacle near the boat dock system.

6.8 Item 1(Picture) Exterior outlet

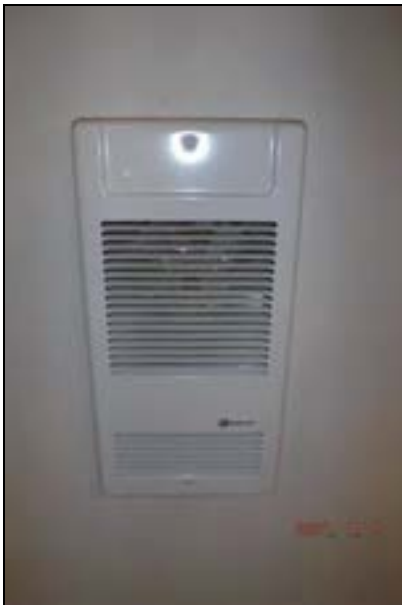
7.0 The house is heated with electric baseboards and in wall electric heaters with fans. Item 1(Picture) Item 2(Picture) Item 3 (Picture)

7.0 Item 1(Picture) Bsmt In wall heater

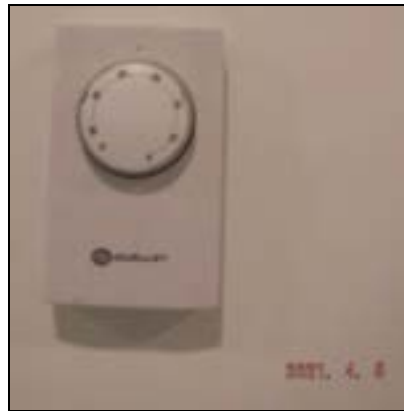
7.0 Item 2(Picture) Wall mount control

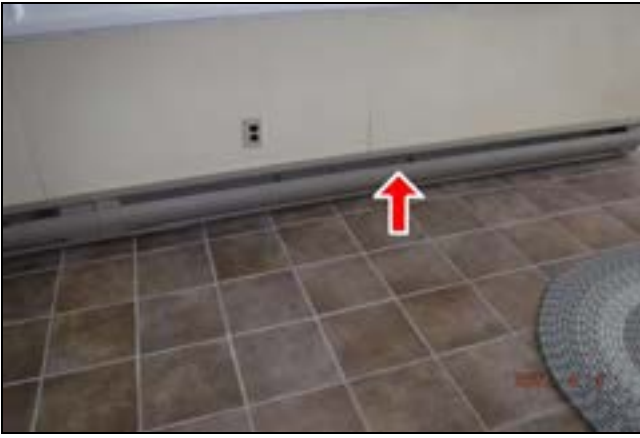
7.0 Item 3(Picture) Electric Baseboard

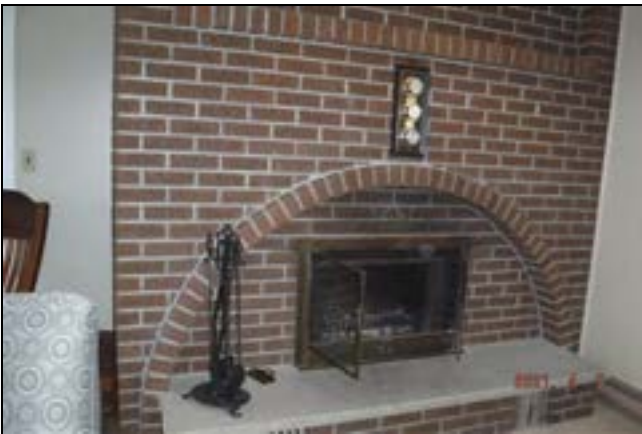
7.3 Item 1(Picture) Fireplace

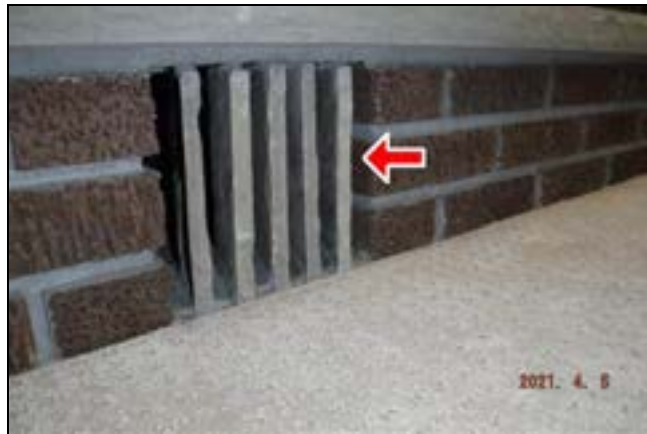
7.3 There is a built in fireplace in the living room area. It was built at the time the house was constructed. There is a natural air flow heat ventilator to increase heat from the unit to the room. Item 2(Picture) There is a bend in the metal lining - likely from overheating - but it remains a continuous metal fire box. Monitor. The draft system was in working order. Item 4(Picture) The location of the clean out could not be located due to the finished drywall around the fireplace structural support in the basement. Locate clean out. The metal cover was not secured and could easily be removed when cleaning or lost in this clean out vent. Improve. Item 5(Picture)

7.3 Item 2(Picture) Room Air circulation

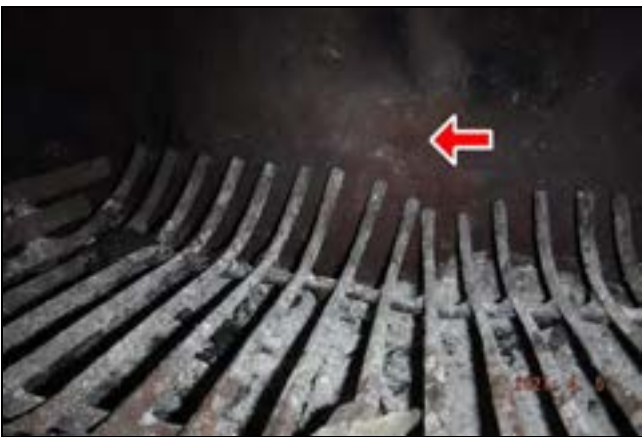
7.3 Item 3(Picture) Metal fire box

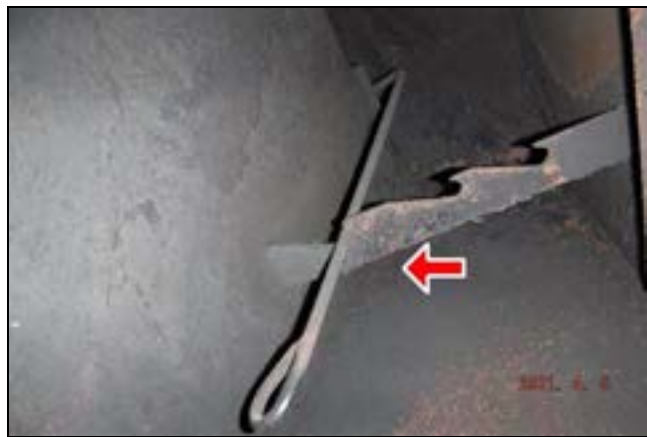
7.3 Item 4(Picture) Manual draft system

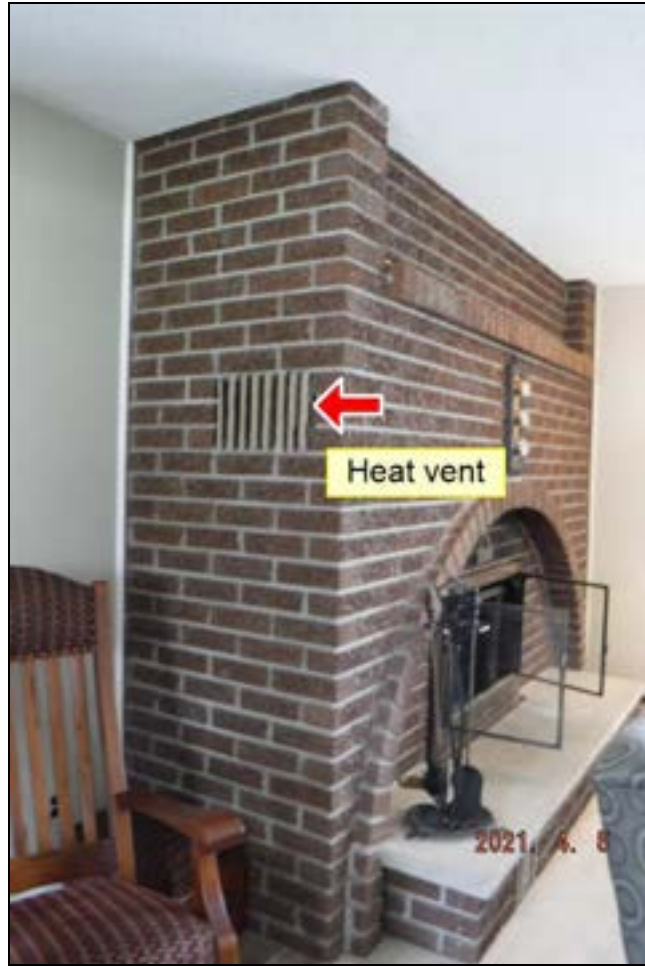
7.3 Item 6(Picture) Side view of fireplace

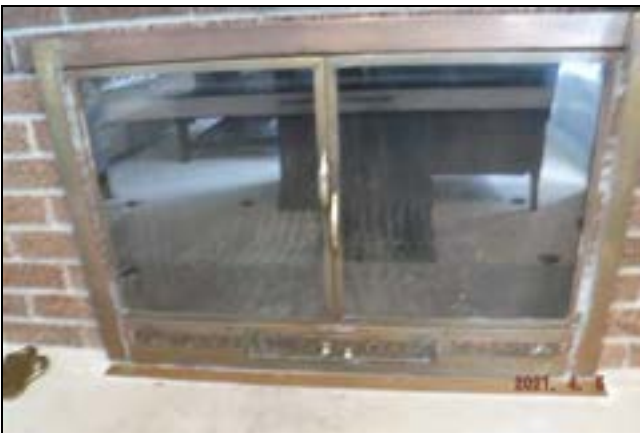
7.3 Item 7(Picture) Glass doors

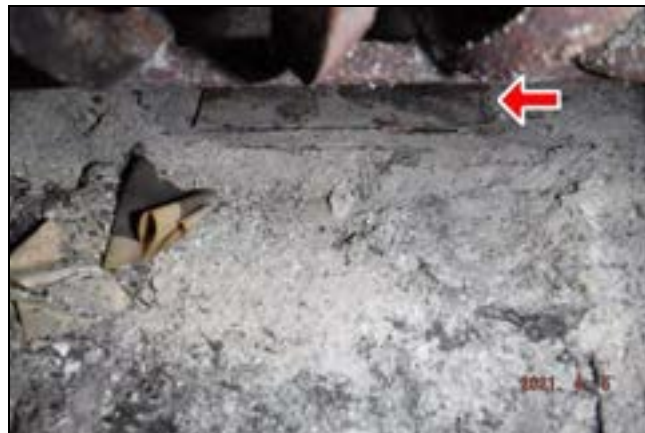
7.3 Item 8(Picture) Metal Cover

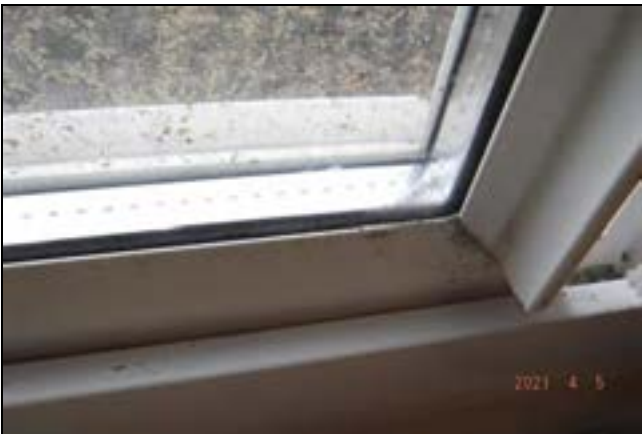
8.6 There are two kinds of window installations. The oldest windows were dated 2001. The newer windows are low e argon for energy efficiency. Item 1(Picture) Item 2(Picture)

8.6 Item 1(Picture) 2001 double window

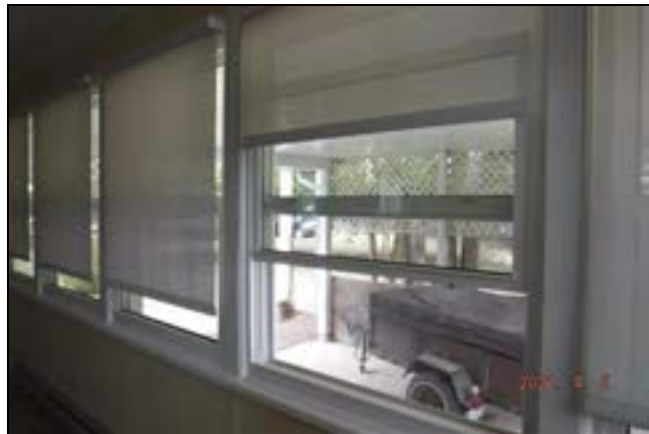
8.6 Item 2(Picture) Low E Argon windows

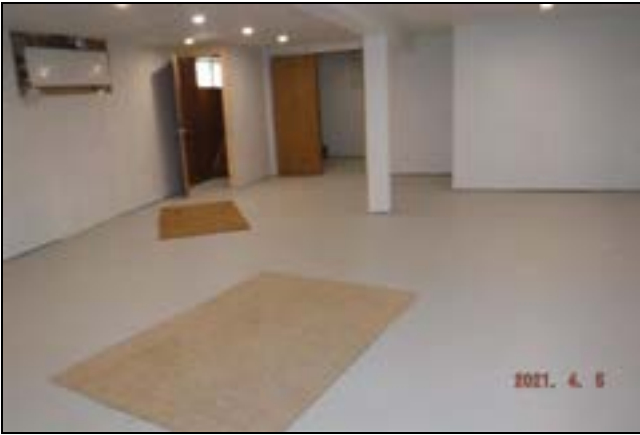
8.7 Item 1(Picture) Basement area

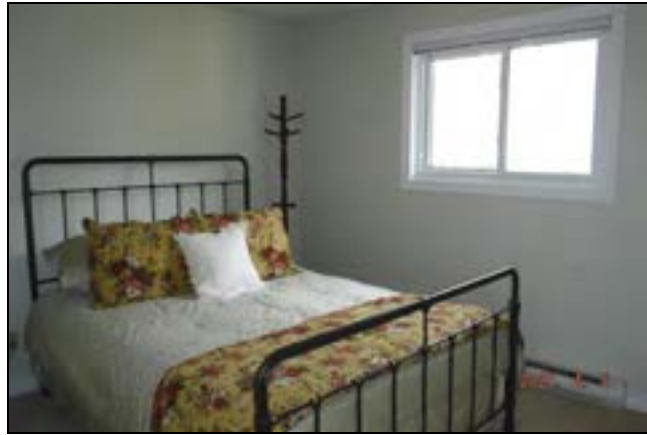
8.7 Item 2(Picture) Bedroom Area

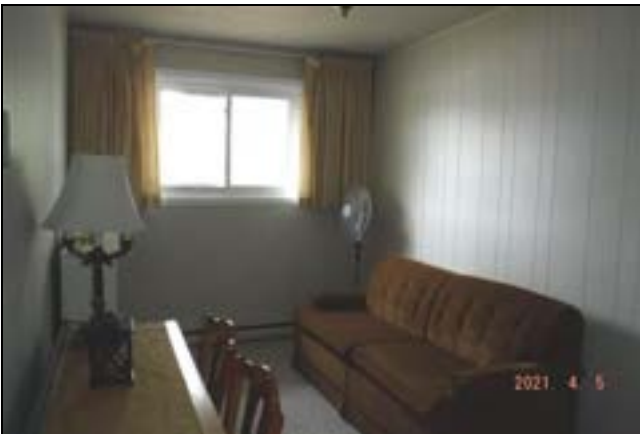
8.7 Item 3(Picture) Den area.

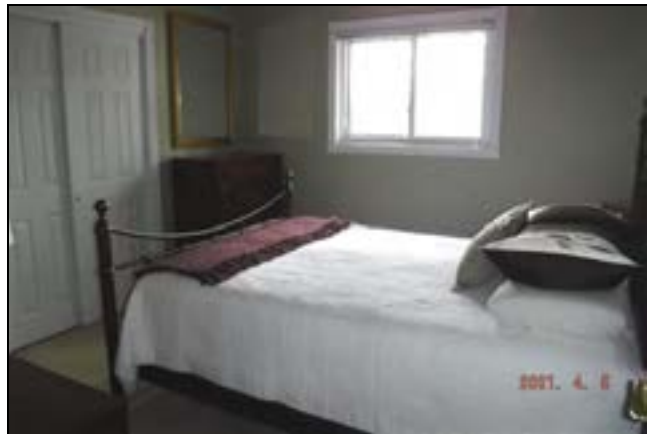
8.7 View of finished basement Item 1(Picture) Item 2(Picture) There is one room, the den, that is paneling. Item 4(Picture)

8.7 Item 4(Picture) Bedroom Area.

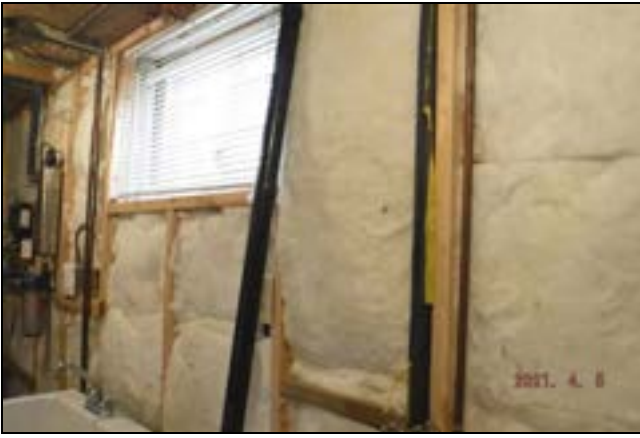
9.0 Item 1(Picture) R 12 insulation

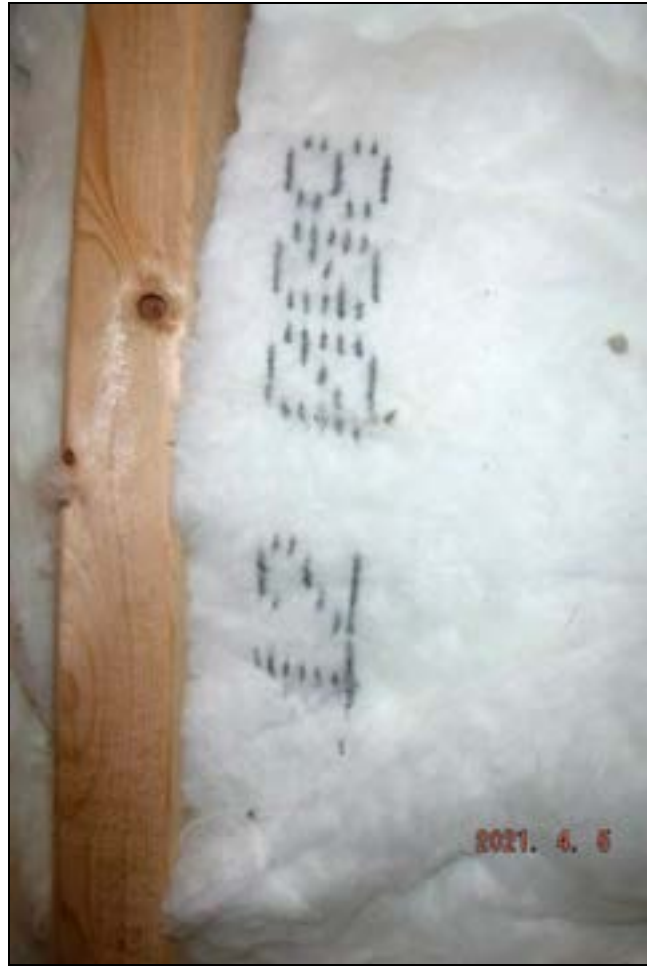
9.0 (1) Item 2(Picture) The utility room shows 2 x 4 framing with R 12 batt insulation. The finished basement area is reported to be the same wood construction type with batt insulation and vapour barrier and drywall.

9.0 Item 2(Picture) R 12 insulation value

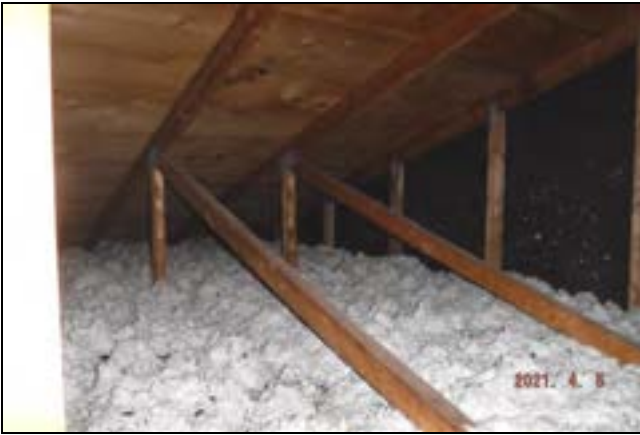
9.0 Item 3(Picture) Cellulose insulation

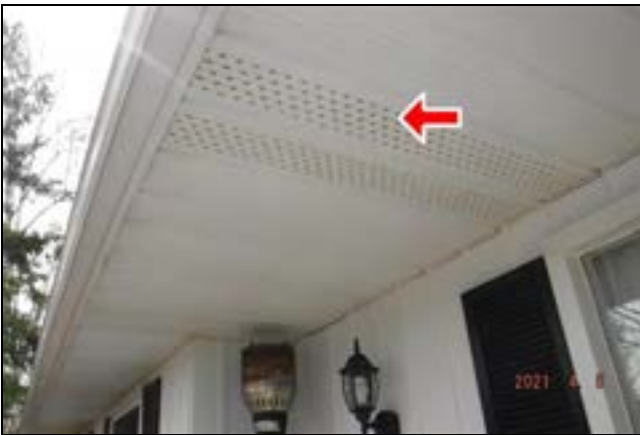
9.1 The attic has soffit venting and passive moore vents. There is also a turbine vent for the attic area.

9.1 Item 1(Picture) Soffit venting

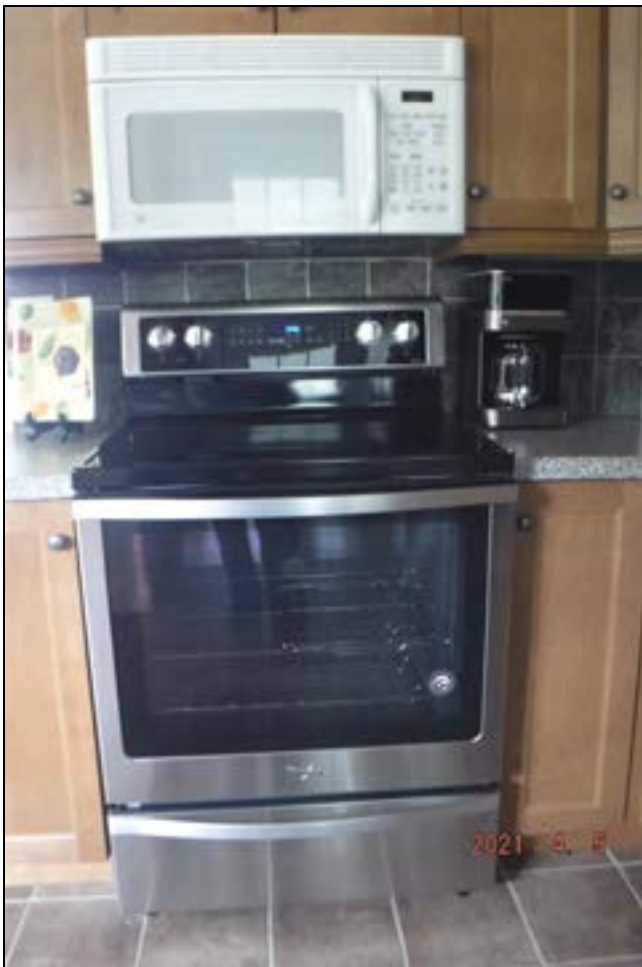
10.0 Item 1(Picture) Stove

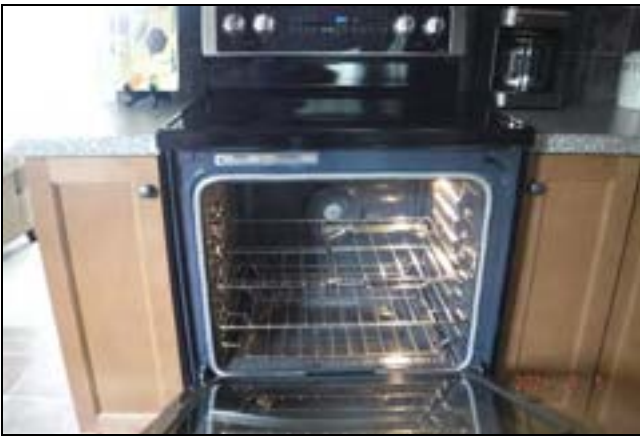
10.0 The Whirlpool stove is in operating condition. The oven is in clean condition. Item 3(Picture)

10.0 Item 3(Picture) Oven View

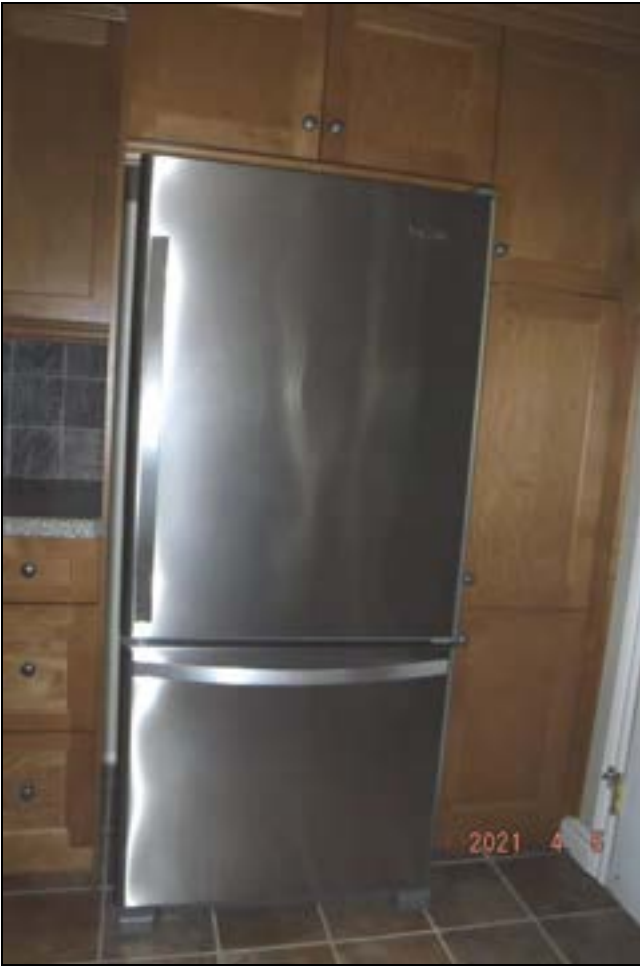
10.1 Item 1(Picture) Refrigerator
