Inspection Report

Property Address:
30 Matheson Road
Woodville/Bolsover Ontario K0M2T0

Know Your Home Inspections Inc.

Date: 4/5/2021	Time: 02:00 PM	Report ID: 04-05-21
Property: 30 Matheson Road Woodville/Bolsover Ontario K0M2T0	Customer: Ron Young Joan Young	Real Estate Professional: David Donais Kawartha Waterfront Realty

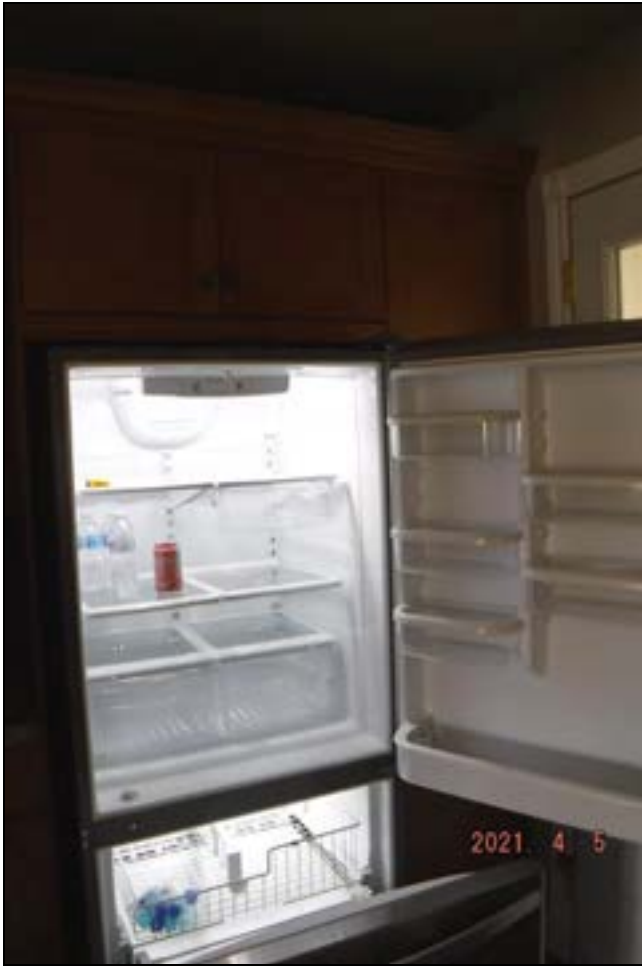
10.1 The refrigerator is a Whirlpool. Freezers run best when full of food. Recommend adding Kawartha Dairy Ice Cream. Item 3(Picture)

10.1 Item 3(Picture) Interior view

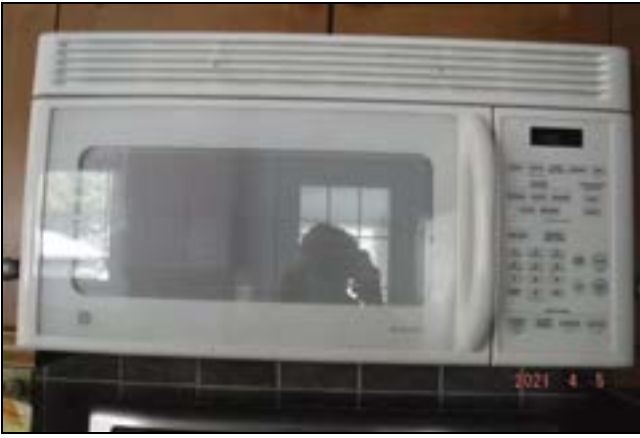
10.4 The microwave is built in above the stove. It includes a recirculating fan and light. Item 1(Picture)

10.4 Item 1(Picture) GE microwave

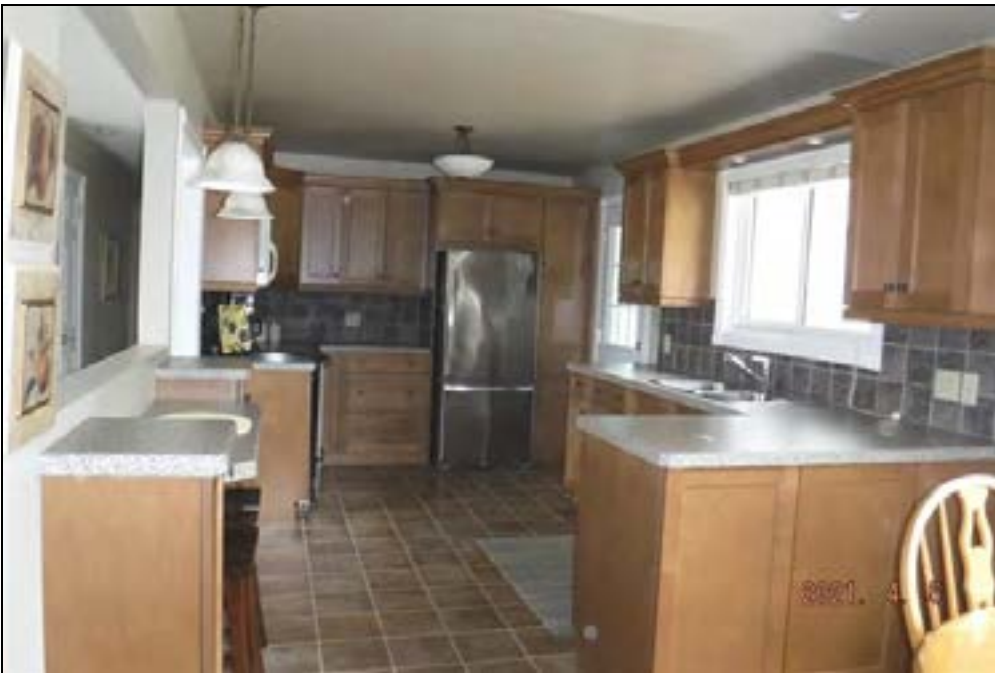
10.5 The kitchen is open concept to a dining area. Item 1(Picture) Item 2(Picture) Item 3(Picture)

10.5 Item 1(Picture) Kitchen View
